Australian Air Publication **721.79**

## ROYAL AUSTRALIAN AIR FORCE

# VAMPIRE MODIFICATIONS

(Nos 101 to 200)

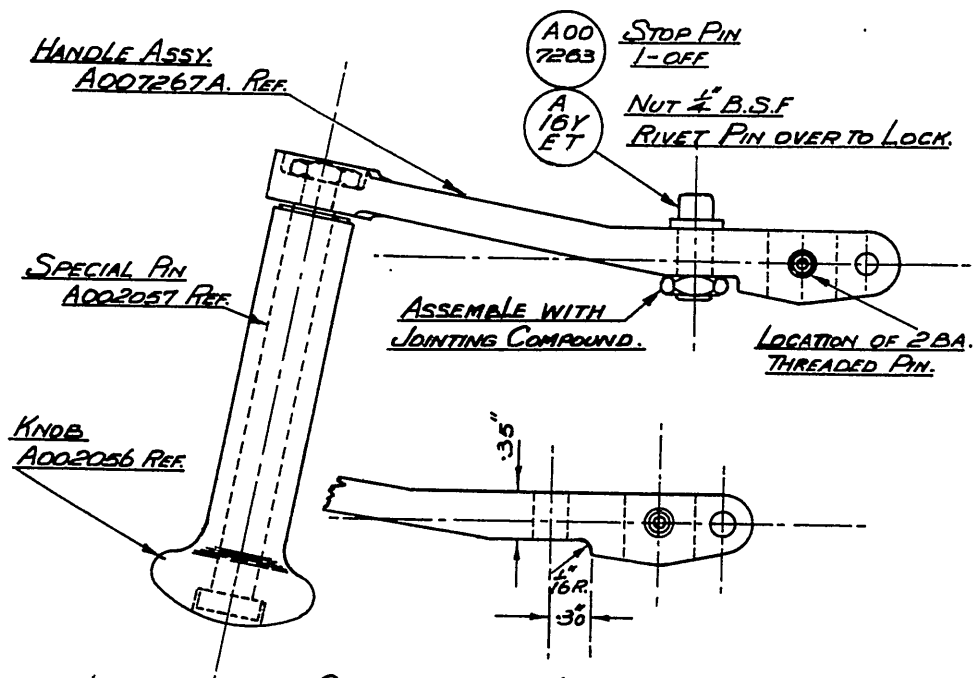
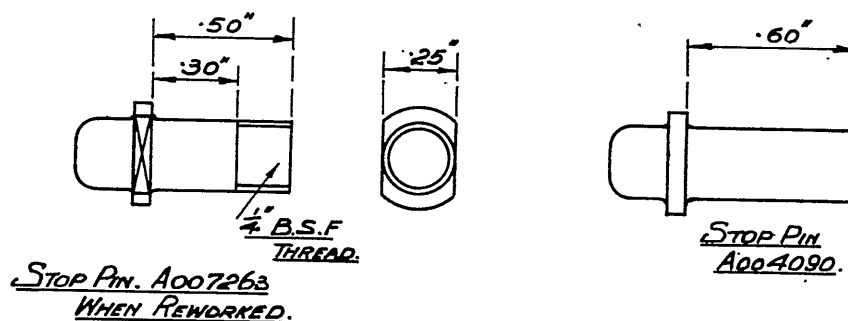
CANOPY WINDING HANDLE.  
REWORK OF CRANK AND STOP PIN.

1. This modification authorizes the introduction of a re-designed stop pin for the canopy winding handle. Due to excessive wear on this pin, which will cause inadvertent opening of the canopy, an easier method of replacement is required.

CRANK OF HANDLE ASSY. A002054 A. TO BE  
REWORKED TO ABOVE DIMENSIONS.  
TREAT REWORKED AREA WITH  
ZINC CHROMATE PRIMER.

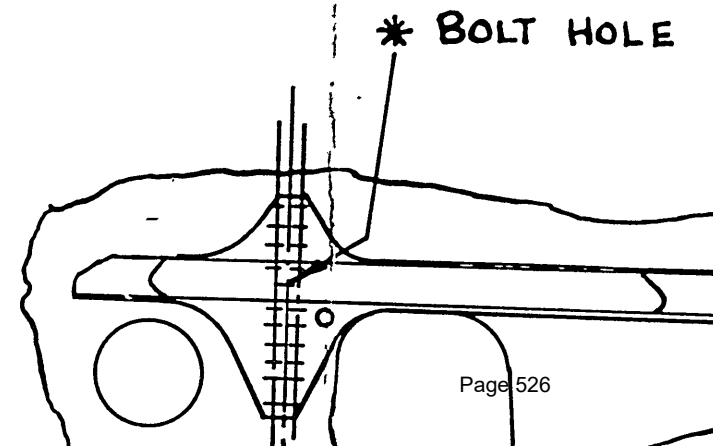
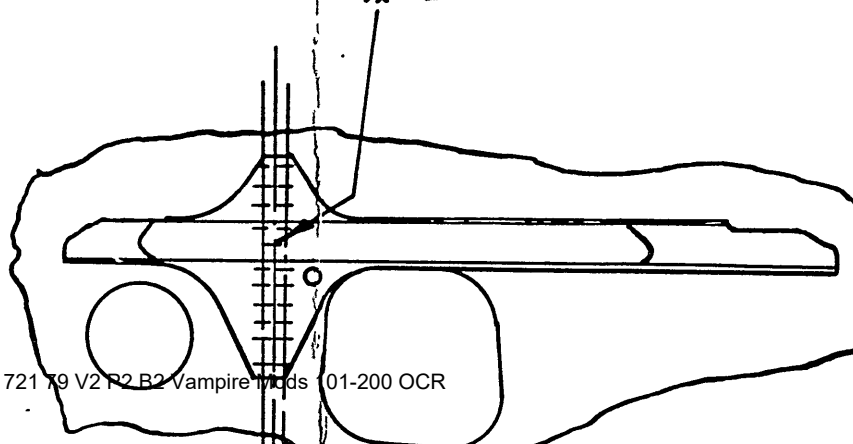
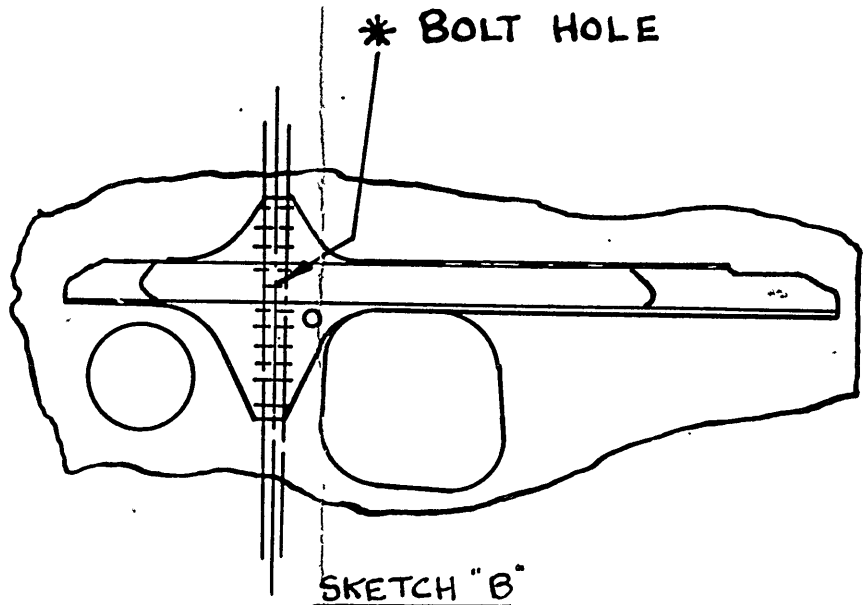
SKETCH 'A'

has been made, Rib 2 should be carefully examined for signs of damage. Access to the inboard side of the rib age should be thoroughly assessed so that the appropriate repair scheme may be selected from the information to be checked for buckling in the panel immediately above the undercarriage attachments, and, if damaged, repaired

It should be noted that the main web is on the outboard of the rib and is of thinner gauge than the reinforcing plate.

In the case of Vampire trainers, where Mod. Vamp. 698 (retrospective version) is being carried out, the reinforcing plates to ROOD.397 should also be fitted.
