Hunter GA Mk.11 and PR Mk.11 Aircraft – Alighting Gear – Brake Units AH 50247 and AH 50248 – Introduction of locking plate assy. AH 083817 in lieu of AH 082987 (27G/6900)

(Mod No Hunter 1278)

Hunter GA Mk.II and PR Mk.II - Main Undercarriage - Mk. 2
Maxaret installations AH.50720 and AH.50721. To provide for
Removal and Replacement of Maxaret Units (Dunlop Mod. No.3160)

Hunter MK.GA MK.11 & PR MK.11 Aircraft - Alighting Gear - Main Undercarriage To Introduce Jack 103665001 (Port), (Ref.No. 27Q/) and 103665002 (Starboard), (Ref.No.27Q/), in lieu and by conversion of 07965.P.A03 (Port) (Ref.No.27Q/1877) and 07965.S.A03 (Starboard) (Ref.No.27Q/1878).

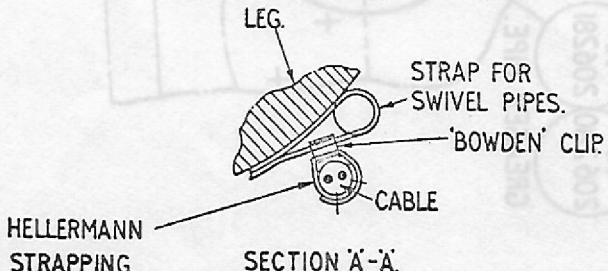
BOWDEN CLIP TO BE SECURED AROUND UPPER STRAP FOR SWIVEL PIPES. HELLERMANN STRAPPING TO FASTEN ELECTRICAL CABLE TO BOWDEN CLIP AS SHOWN. SEE SECTION A-A

VIEW LOOKING OUTBOARD AT TOP OF U/C. LEG.
(PORT DRAWN. STBD. OPP. HAND)

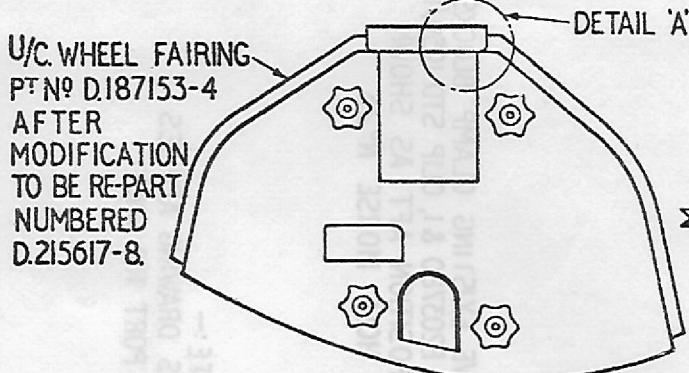
DRAWING N°.
AP.101B-1309-2/B5/76
Sheet 2

VIEW LOOKING OUTBOARD ON
MAIN U/C WHEEL FAIRING.
(PORT AS DRAWN. STBD. OPP. HAND.)

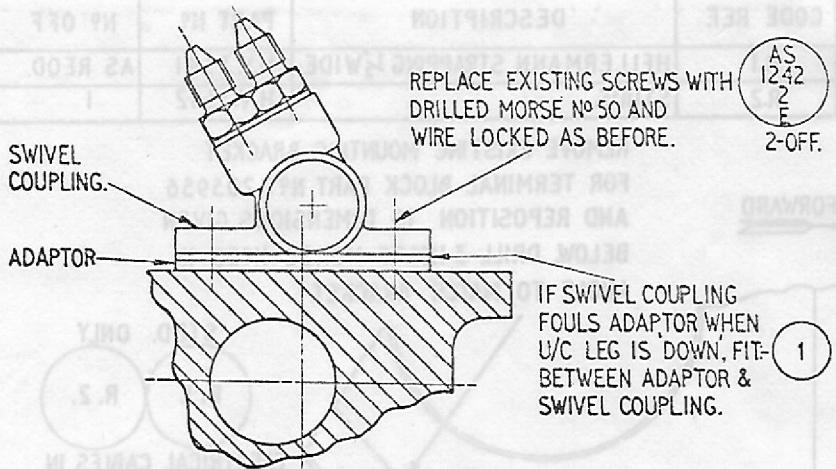
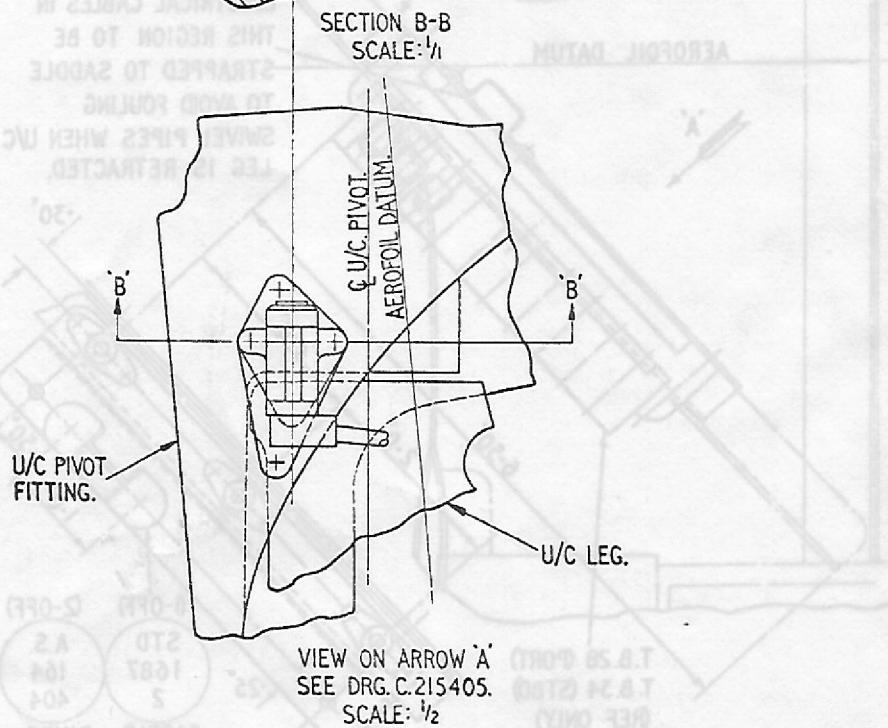
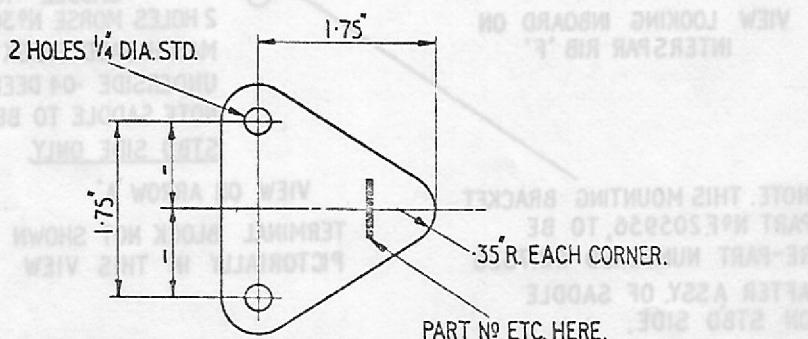
NOTE. THIS MOUNTING BRACKET
PART NO F.205956, TO BE
RE-PART NUMBERED F.217326
AFTER ASSY. OF SADDLE
ON STBD SIDE.

PORT DRAWN - STBD OPP HAND.
