Contents List

A.P.4347L, Vol. 2
Leaflet No. H.1

Hunter GA. Mk.11 Aircraft-Fuel System - De-fuelling Cock, Locking Improved

Hunter G.A.Mk.11 and P.R.Mk.11 Aircraft-Fuel System-Air Supply-To introduce Non-Return Valve, Part No. 708AA25/B (Ref.No.27FC/145562) in lieu and by conversion of NRV. Part No. 708AA17/B/1 (Ref.No. 27F/7869). Part A: In Air Pressure Line to Engine. Part B: In Air Pressure Lines to Wing Tanks.

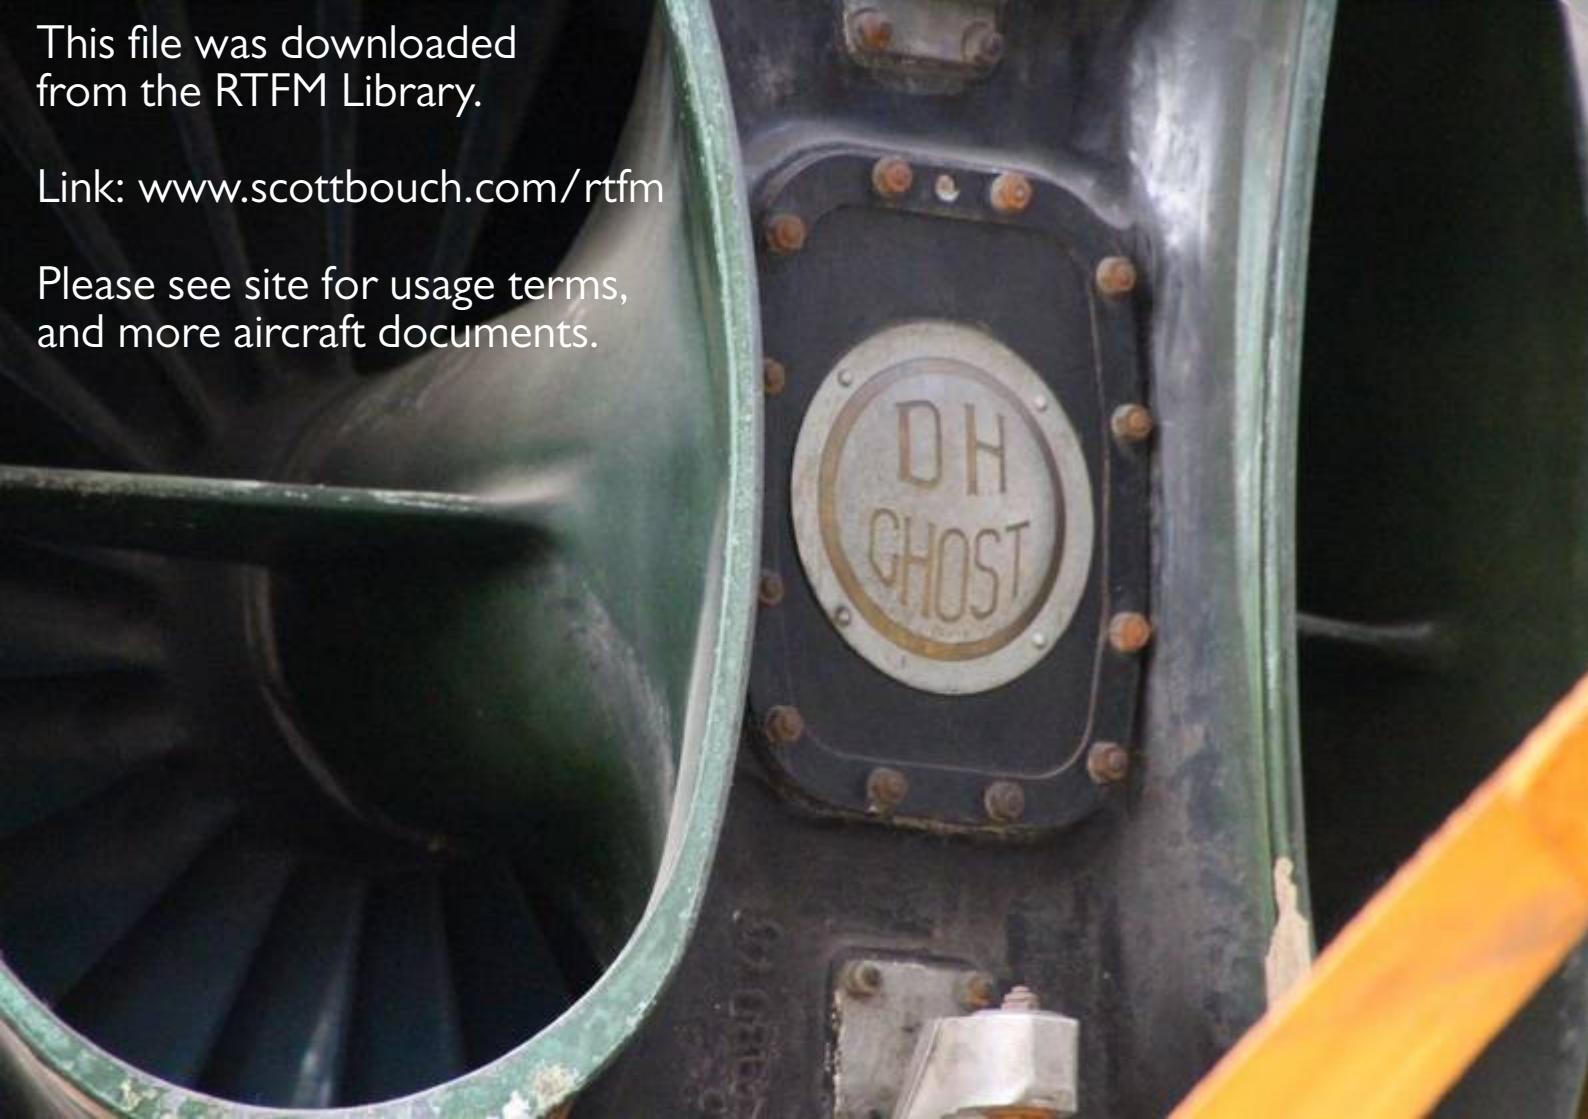
Drawing No. A.P.4347L/H.1/62 is incorporated in this leaflet.

To prevent the possibility of engine flame-out due to the de-fuelling cock not being fully closed, a locking latch is introduced to ensure that the cock is fully closed before final locking.

- (1) Remove the engine starter access door.
- (2) Locate the de-fuelling aercock, Type SP.42, Saunders Valve Co. Ltd., Part No. 42.A.10, situated aft of the main spar on the port side, and fit latch, Part No. A.250121, as shown and in accordance with the instructions on the drawing.
- (3) Replace the engine starter access door.
