Chapter Seventeen

COMPRESSOR, TURBINE, AND WHEELCASE SERVICING AND MAINTENANCE

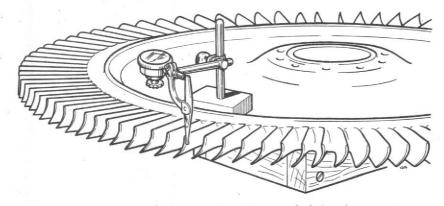
Fig. 67. Using dial test indicator to check tip rock.

- (3) Select a replacement blade which complies with the following requirements:(a) Is an easy push fit in the slot in the turbine disc and has a total tip rock
 (circumferential movement of the blade tip relative to the disc), before peening,
 which is within the limits specified in the Table of Fits and Clearances contained in
 chapter 38. Use a dial test indicator to check this as illustrated in Fig. 67. To
 overcome excessive tip rock, either select a "larger" standard blade by taking advantage of the manufacturing tolerances, or select a suitable oversize blade.

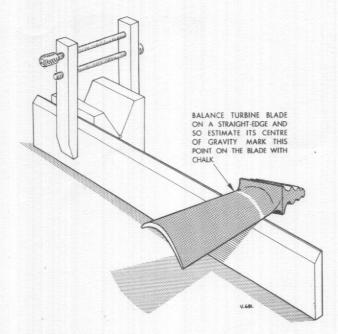
Fig. 68. Estimating centre of gravity of damaged blade.

- (1) Balance the damaged turbine blade, convex face uppermost, across a straight-edge, and so estimate the centre of gravity of the blade; mark this point on the blade with chalk, Fig. 68.

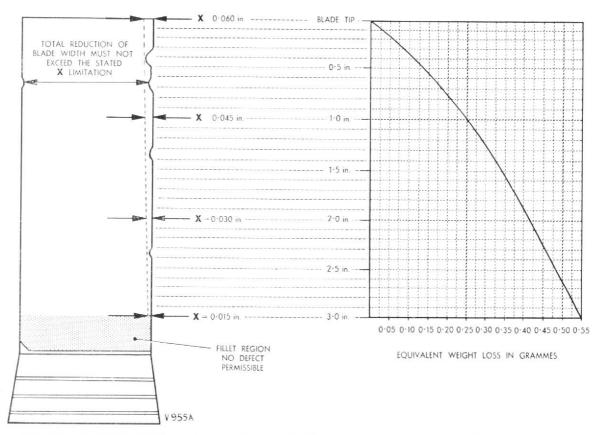
A blade which has sustained impact damage to its edges, Fig. 74, may be filed and blended, but the depth of blending must not exceed the limitations shown in the following table.

Position on blade edge	Maximum depth of blending in inches (X in Fig. 74)
Tip	0.060
1 inch from tip	0.045
2 inches from tip	0.030
3 inches from tip	0.015

Fig. 74. Blending limits for impact damage in blade edge, and graph for calculating weight loss.

Where blades have been repaired within the limits indicated in Fig. 74, reference must be made to the graph in that figure, which shows the relevant weight loss according to the length of blend. To use this graph, work from the blade tip, and note the point at which the blend commences. Follow the horizontal line across from this point to the position where it meets the curve, and read downwards to the equivalent weight loss. Repeat this procedure from the end of the blend. The difference between the two readings obtained indicates the overall weight loss for the entire blend. Application of the graph is shown in the following detailed examples:—

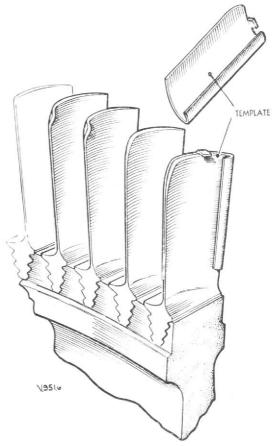
Fig. 78. Template for checking blade.

To facilitate the identification of repairable damage, a simple template, Fig. 78, may be made up from local sheet metal resources. Such a template may be used to check that damage to a blade is within the repairable limits, and also to check that the finished repair is within the acceptable limits. The use of three templates is recommended, one each to meet the requirements of the limits of repair shown in Fig. 72, 74, and 75.
