#### Chapter Eighteen

# EXHAUST SYSTEM SERVICING AND MAINTENANCE

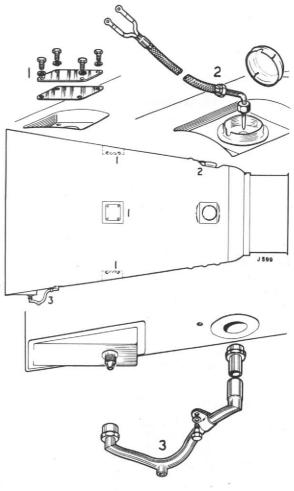
Fig. 1. Fireguard connections.

- Set bolts and blanking plates securing fireguard to exhaust cone.
- Thermocouple. 3. Fireguard drain.

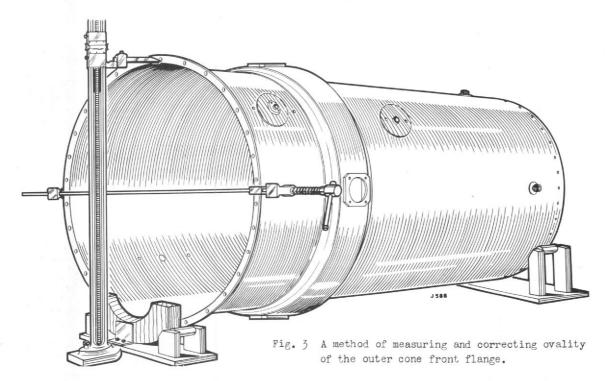
Some degree of ovality and distortion can be expected at both ends and the method used in checking this distortion and ovality is shown in Fig. 3.

This consists of rotating the exhaust cone on rollers while checking the flange bolt holes with a large height gauge. Distortion and ovality are then removed by the use of a shaped wooden block and clamps as shown in Fig. 3 and 4. Ovality of the sheet metal portion must not exceed a total indicator reading of 0.200 in., and of the flange 0.050 in. (total dial indicator reading 0.100 in.). Cracks in the flange are unlikely but if discovered, cracking from the flange bolt holes to the periphery of the flange is permissible but cracks from hole to hole justify rejection of the component.

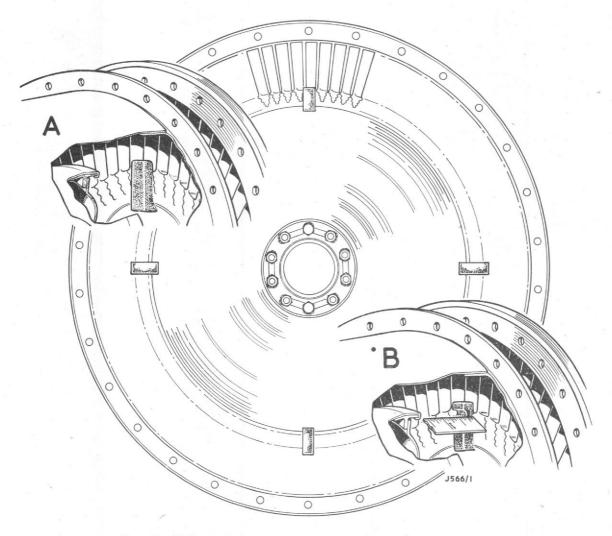
Fig. 21 Method of checking exhaust cone/turbine clearance.

- A. Appearance of plasticine before exhaust cone is fitted.
- B. Measuring thickness of plasticine after exhaust cone has been fitted and removed.

Affix four strips of plasticine equidistantly around the rear of the turbine disc as indicated in Fig.21 avoiding those positions where portions of the balancing rim have been removed. Each strip of plasticine should be approximately  $\frac{5}{8}$  inch wide and  $\frac{5}{8}$  inch thick, that is slightly thicker than the maximum permissible clearance between the disc and the inner cone. The strips should be positioned to cover the 'fir-tree' roots of the turbine blades, and should radiate inwards towards the centre of the turbine disc for a distance of about two inches. Smear the rear surface of the plasticine with French chalk, or oil, so that it does not adhere later to the baffle at the front of the inner cone. Inset A on Fig.21 shows the appearance of the plasticine at this stage.

Secure the exhaust cone to the turbine shroud by three or four of the bolts and nuts. Remove the exhaust cone and measure the thickness of the plasticine at the points of minimum clearance. Inset B shows the appearance of the plasticine after the exhaust cone has been fitted and removed. The clearance must not be less than 0.250 inch. This clearance is to be measured at the point between the rim of the inner exhaust cone and the trailing edge of the turbine blade roots. Clean off all traces of plasticine before refitting the exhaust cone finally.
