# CHAPTER 28D

## AIR-INTAKE, CENTRE HOUSING, AND WHEELCASES RENEWALS, RECONDITIONING, REPAIR, AND SALVAGE

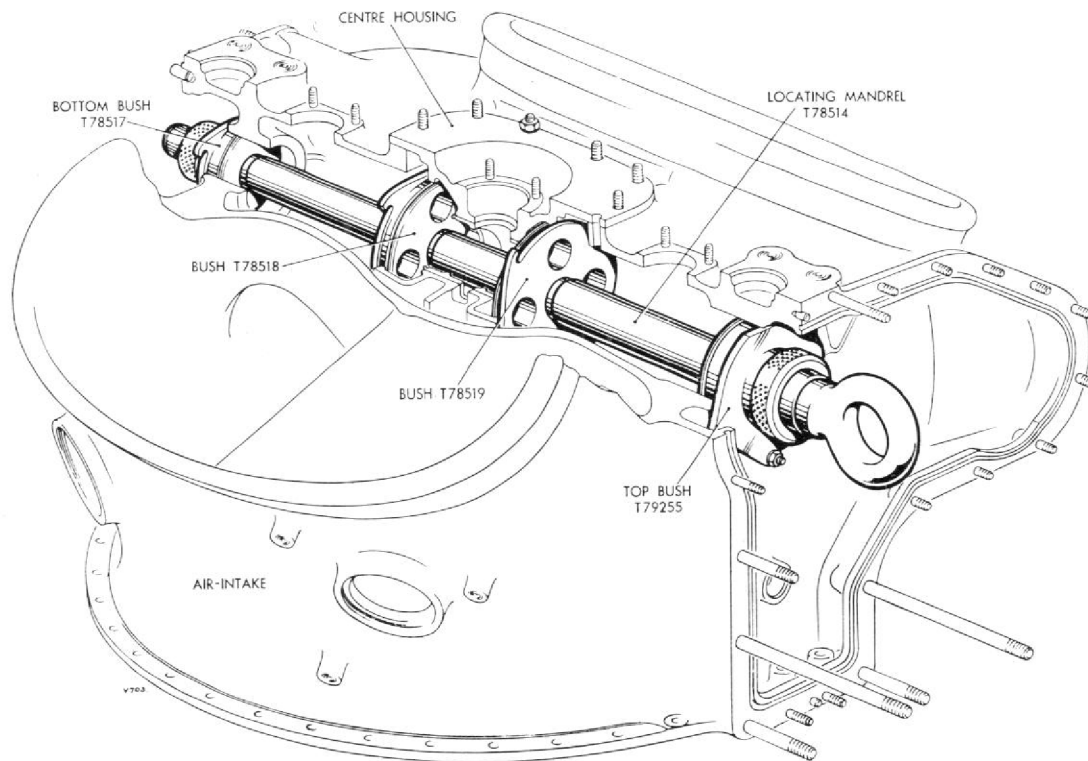
Fig. 3. Bushes and locating mandrel fitted to Ghost 48 Mk. 2 or 53 Mk. 1 components.

9. Fit the centre housing into the air-intake, aligning the dowel hole in its front flange with the corresponding hole in the air-intake.
10. Pass the small end of location mandrel T.78514 through the bush in the top vertical drive bearing housing on the air-intake, and the bushes in the centre housing, until it locates in the bush in the bottom vertical drive bearing housing. The four bushes should then be located on the four ground diameters on the mandrel, Fig 3. Gently rotate the mandrel
