Chapter 28F

CENTRE CASING AND NOZZLE RING RENEWALS, RECONDITIONING, REPAIR, AND SALVAGE

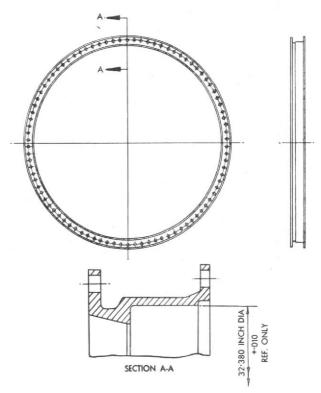
Nozzle Shrouds which have become distorted may be repaired in accordance with these instructions. It should be noted that a crack which runs from a hole towards the outer edge of a flange is permissible without repair, and any number up to all the holes may be so damaged, but if any crack extends inwards from a hole, the nozzle shroud is beyond repair.

To carry out this repair proceed as follows:-

- Stress relieve the component at 1050 deg. C. for 30 minutes.
- 2. Restore the circularity of the distorted shroud, as nearly as possible, by applying pressure internally, using shroud reforming fixture T.76958 in conjunction with a 60 ton hydraulic hand press, such as that illustrated in Fig. 11 (facing page). If this equipment is not avail-

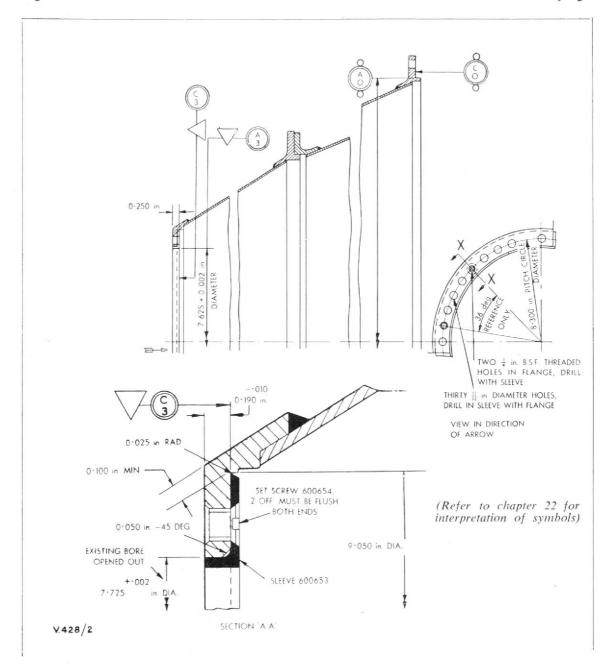
CENTRE CASING, FRONT AND REAR CONE, REAR FLANGE T.R. 312 issue 4—Mod. 751

This repair may be applied to all Ghost centre casings.

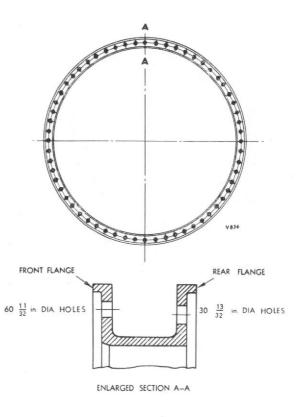
If the diameter of the recess at any point is below 23.060 inch, the nozzle ring cannot be salvaged. The bolt holes in the nozzle ring and diaphragm must not be elongated to assist the fitting of securing bolts on assembly.

On completion of this repair, etch T.R.343 adjacent to the existing part number and make an entry in the appropriate record book of the engine.
