Chapter Thirty

COMBUSTION CHAMBERS, RENEWALS, RECONDITIONING, REPAIR AND SALVAGE

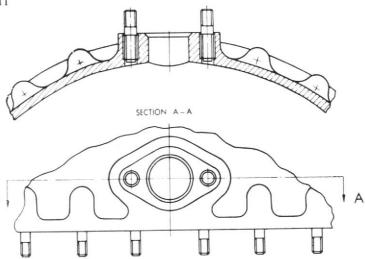
Expansion chambers in which the thread of any of the drain-boss stud holes have become damaged, may be rectified in accordance with these instructions.

- 1. Remove existing stud.
- 2. Drill right through the damaged stud hole to a diameter of 0.257 inch (letter 'F' drill).
- 3. Thread the hole to a diameter of 0.3012 inch by 26 T.P.I. Whitworth thread form to a depth of 0.525 inch. The effective diameter of the thread is to be 0.2766 + .002 inch, and the minor diameter 0.252 + .0117 inch. Counterbore the hole to a diameter of 5 inch by 0.025 inch deep.

- 4. Screw in the wire insert Part No. N.4968 and then break off and remove the tang.
- Re-fit the original stud if serviceable, or a new stud if unserviceable.
- Lightly stamp T.R.273 adjacent to the existing part number and make an entry in the appropriate record book of the engine.

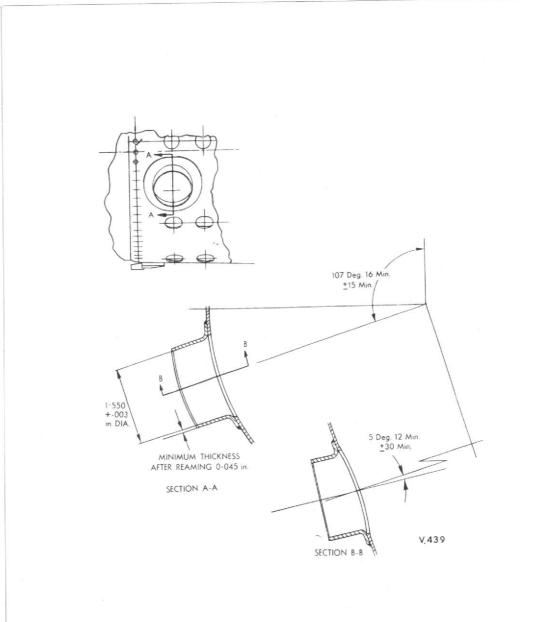
EXPANSION CHAMBER, INTERCONNECTOR BUSHES T.R. 369 issue 2—Mod. 1019

This repair may be applied to Ghost 48 Mk. 1 expansion chambers which embody mod. 1019.

- 8. Machine the bush to the dimensions shown.
- Lightly stamp T.R.369 adjacent to the existing part number and make an entry in the appropriate record book of the engine.

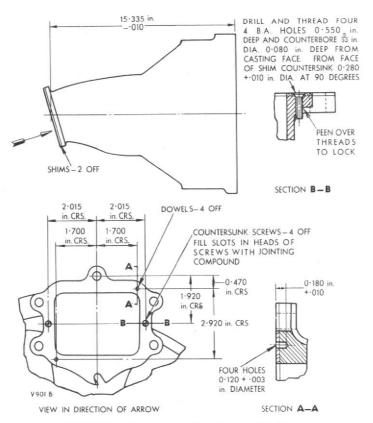
T.R.314. Expansion Chamber, inlet flanges.

EXPANSION CHAMBER, INLET FLANGES, SHIMMED.

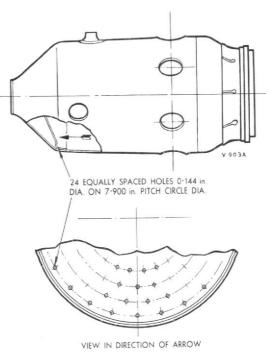
T.R.388. Flame tube and head.

If Part Number 604671 or 604672 is etched on a type 5 flame tube and head, then this assembly

has been modified to incorporate the principles of Mod. 1106.
