Chapter Thirty-one

# EXHAUST SYSTEM

## RENEWALS, RECONDITIONING, REPAIR AND SALVAGE

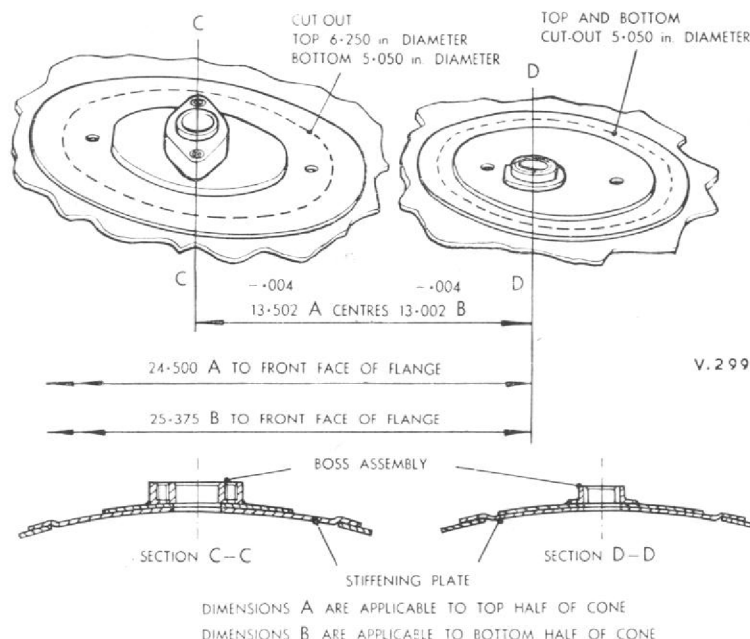
Outer exhaust cones in which the threads of any of the support tube bosses have become damaged, may be rectified by renewing the damaged boss assembly in accordance with these instructions.

If cracking occurs at the bolt holes subsequent to this repair, the cracks may be repaired up to a maximum length of 0.500 inch by argon-arc welding; the weld should be blended on both surfaces sufficiently to obviate fouling of the bolt heads or fairings during assembly. Subsequent fretting at any of the bolt holes up to a depth of 0.015 inch on the inner surface of the exhaust cone, may be rectified by argon-arc welding the fretted area and blending the weld flush with the surrounding surface.

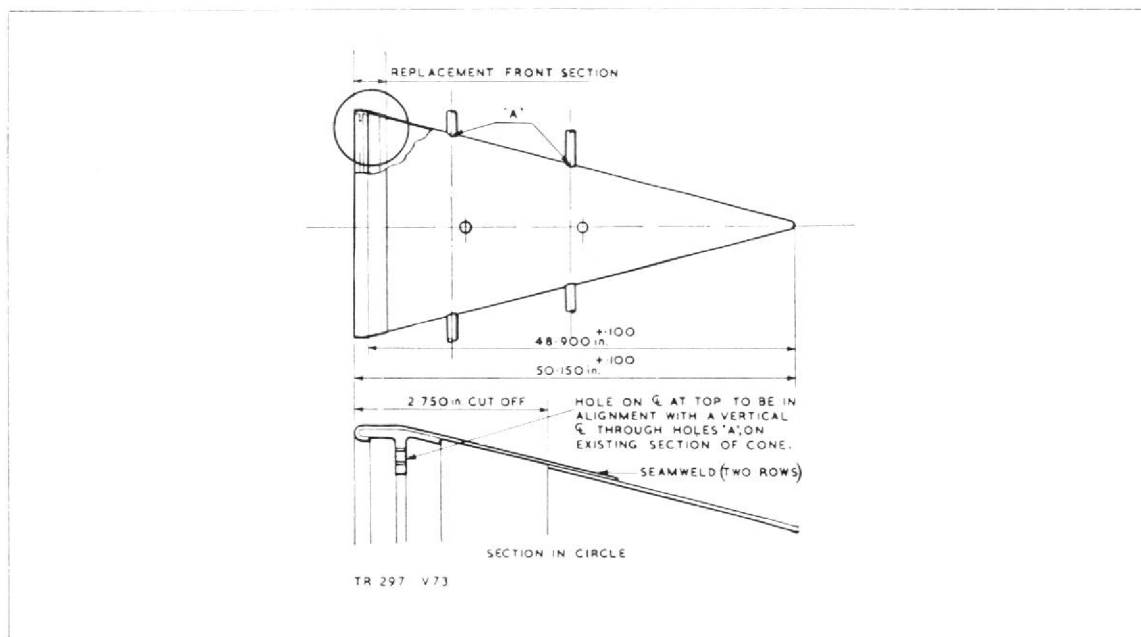
# INNER EXHAUST CONE, FRONT FLANGE T.R. 297 issue 5—Mod. 751

Inner exhaust cones which are excessively cracked, or damaged at the stiffening ring or threaded holes, may be rectified by fitting a replacement front flange section in accordance with these instructions. It should be noted that single cracks running inwards from any holes (up to a maximum of four) on the existing stiffening ring may be repaired by cleaning out and welding the cracks by the argon-arc process, re-threading the hole and machining the flange faces clean.

5. Seamweld the replacement front section to the inner cone as shown. Using a suitable tool, remove any welding flash.
6. Mark off and form the parallel section at the front end of the inner cone.

7. Trim the edge of the inner cone and clean the argon-arc welded joints in preparation for welding the butt joints of the replacement front section. (This, and operation 8, is only necessary when the replacement front section has been supplied in two parts.)

11. Seamweld the stiffening ring to the inner cone. Stitchweld the seam where missed by the seamwelding machine, on both the replacement front section and stiffening ring. Using a suitable tool, remove any welding flash from all seamweld joints.

12. Dress the skin of the replacement front section over the stiffening ring, as shown, using rollers T.78693.
13. Etch T.R.297 adjacent to the existing part number and make an entry in the appropriate record book of the engine.
