Chapter Forty-eight

## THE LODGE SURFACE DISCHARGE IGNITER PLUGS

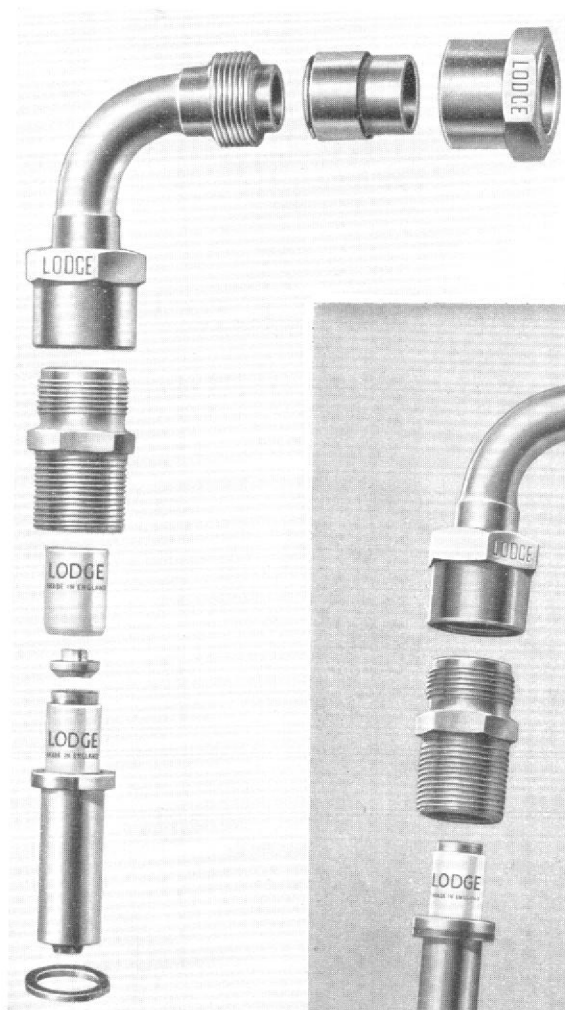
Fig. 1.

The general arrangement of these surface discharge plugs will be obvious from an inspection of the photographs on this page. Each high energy, surface discharge, igniter assembly is made up of a high energy igniter, and a screen tube; the elbow is, normally, part of the ignition cable assembly. These igniters can be operated only with B.T.H. or Rotax high energy units.

WHEN INSTALLING it is important to ensure that the seating washer is in position in the mount-

ing adapter, which is a component part of the engine combustion chamber, and that the screen tube is fitted as shown in these photographs—that is with the longer threaded portion screwing into the mounting adapter. The screen tube should be tightened down to a torque of 240 to 300 lb./in. and the nut on the elbow fitting to a torque of 50 to 60 lb./in.
