SI/HUNTER/137

From: CENTRAL DEFECT AUTHORITY

MAINPLANE: UNDERCARRIAGE PIVOT FITTINGS: CRACKING:

B. 1 Hunter all marks.

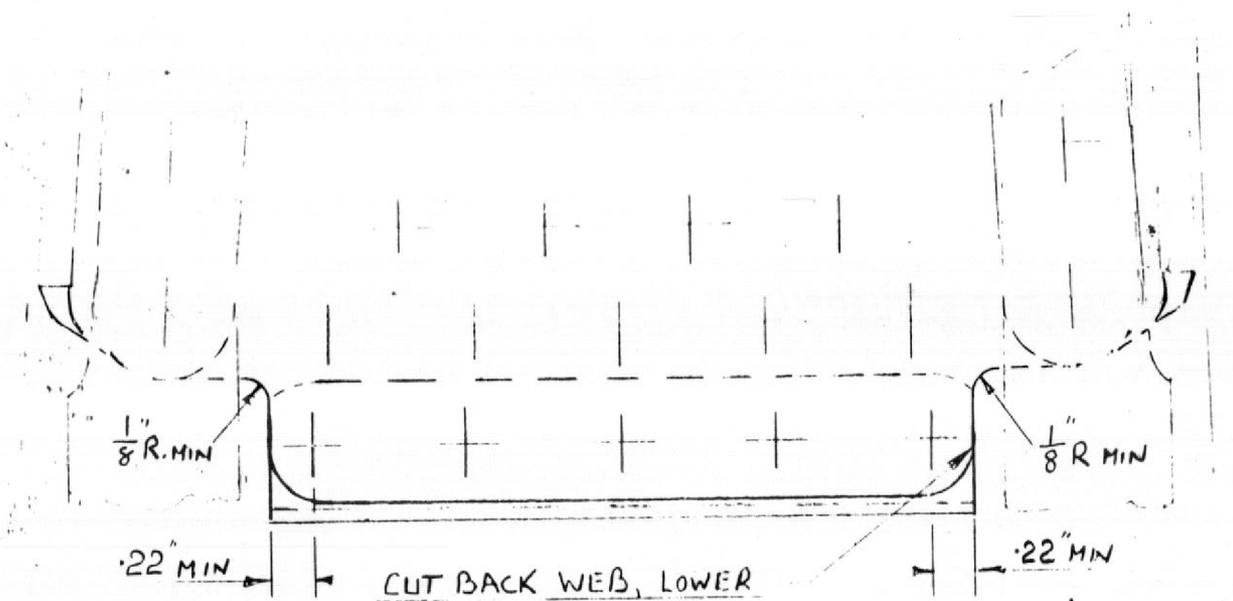
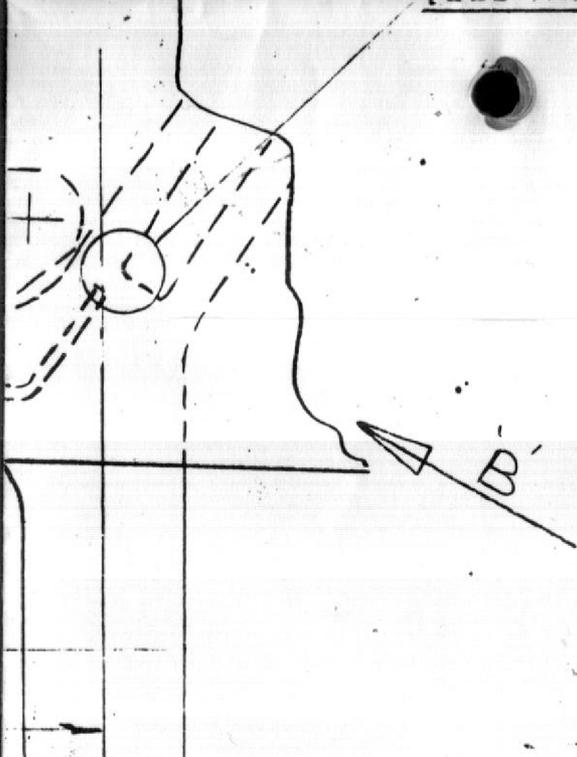
SCRAP VIEW ON ARROW B
MAY BE INCORPORATED FOR N.D.T. PURPOSES

CORNER OF RIB ATTACHMENT FITTING
TO BE INSPECTED. PORT & STBD.

CUT BACK WEB, LOWER RIB FLANGE AND REINFS PLATE TO DIMS SHOWN
