## Chapter 6 PROCEDURES FOLLOWING HAZARDOUS INCIDENTS

### Introduction

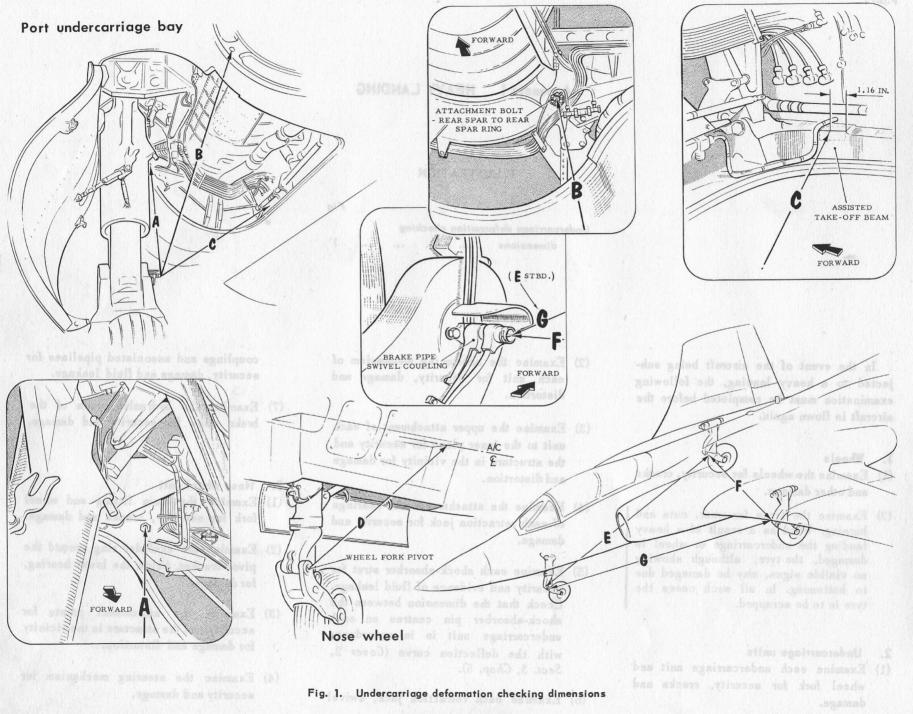
- (1) Examine the main fitting and wheel fork for security, cracks and damage.
- (2) Examine the excluder ring around the pivot bracket, below the lower bearing, for damage.
- (3) Examine the attachment points for security and the structure in the vicinity for damage and distortion.
- (4) Examine the steering mechanism for security and damage.

- (5) Examine the shock-absorber strut for security and evidence of fluid leakage. Check that the dimension between the shock-absorber pin centres is in accordance with the deflection curve (*Cover* 2, *Sect.* 3, *Chap.* 5).
- (6) Examine the telescopic lock strut for security and damage.
- (7) Examine all associated hydraulic pipe connections, swivel couplings and assemblies for security, damage and leakage.
