**Chapter 3 TAIL UNIT
ILLUSTRATION**

Fin structure and skin plating 1 **Fig**

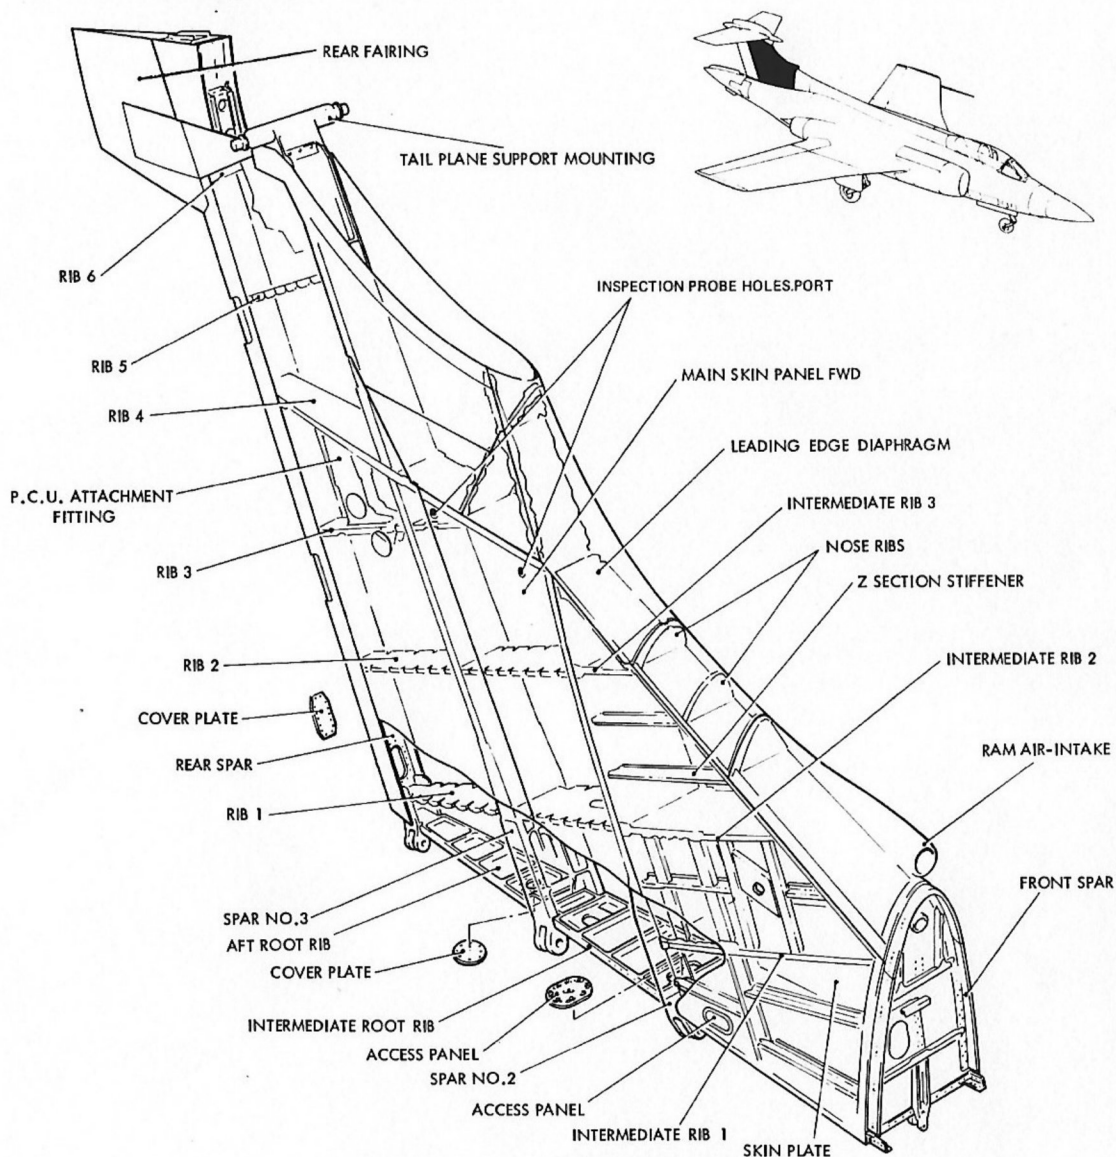
**Fig.1 Fin structure and skin plating
(STI/Buccaneer 428 satisfied)**

1. Prior to embodiment of Mod 1785, the fin is identical to that described in AP 101B-1202-1A, Cover 2, Sect 3, Chap 3. On embodiment of Mod 1785 a refurbished fin is fitted; fin spars 2, 3 and 4 and the aft and intermediate root ribs are replaced by modified items and oversize skin panel fasteners are introduced. Access panels are incorporated in the aft and intermediate root ribs, the rear spar and the starboard forward skin panel. Removal and installation of the fin constitutes a major repair and detailed procedures are in AP 101B-1200-6, Cover 2, Part 2, Repair Leaflet D1/1.

2. Two inspection probe holes introduced by STI/Buccaneer/428, are located through the port side of fin skin at spars 2 and 3 below rib 4 datum. The holes are covered by patches of pressure sensitive tape Ref No. 9535-00-94-6812 or 100PH/12042.
