A.P.4505, Vol. 6, Part 1

CHAPTER 2

FUSELAGE

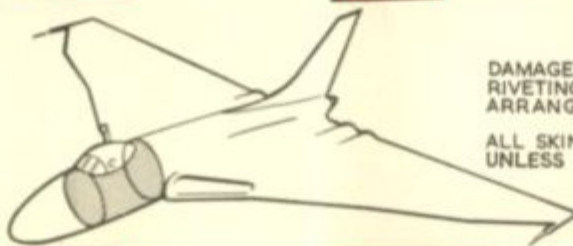
Fig.213 Front fuselage skins

SIDE SKINS-PORT

NEGLIGIBLE DAMAGE -

FOR REPAIRS SEE FIG. 222-A-B-C

SIDE SKINS-STBD.

DAMAGE IN AREAS OF CONCENTRATED RIVETING MUST BE REPAIRED WITH JOINTS ARRANGED OUTSIDE THE AREA.

ALL SKINS ARE MADE FROM 18 S.W.G. SPEC. L.72. UNLESS OTHERWISE STATED.

BOTTOM SKINS

REFER TO FIG. 211 FOR ENTRANCE DOOR SKINNING.

TOP SKINS

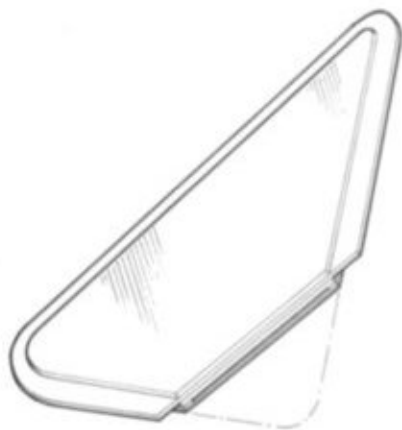
Fig. 231. D.V. window, windscreen - dry air sandwich

Post Mod. 165

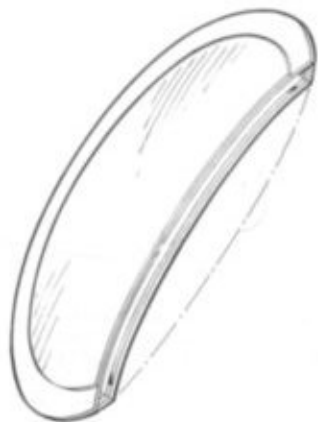
Fig. 232. Canopy window - dry air sandwich

Post Mod. 271
