## Chapter 1

## PROPELLER

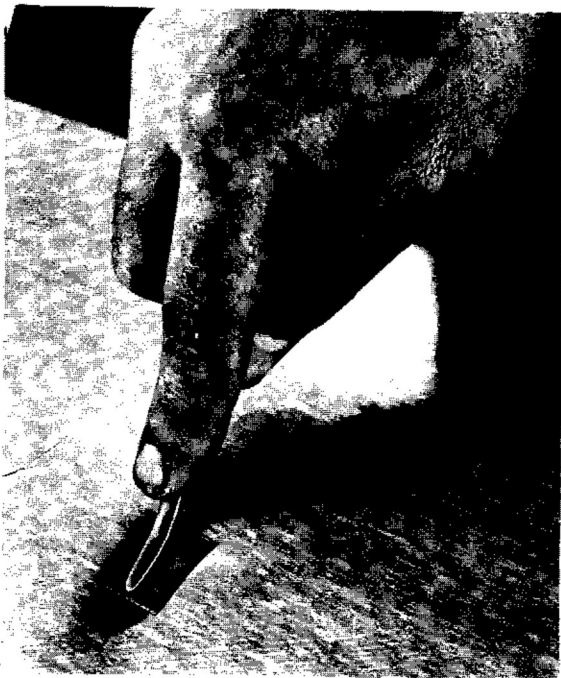
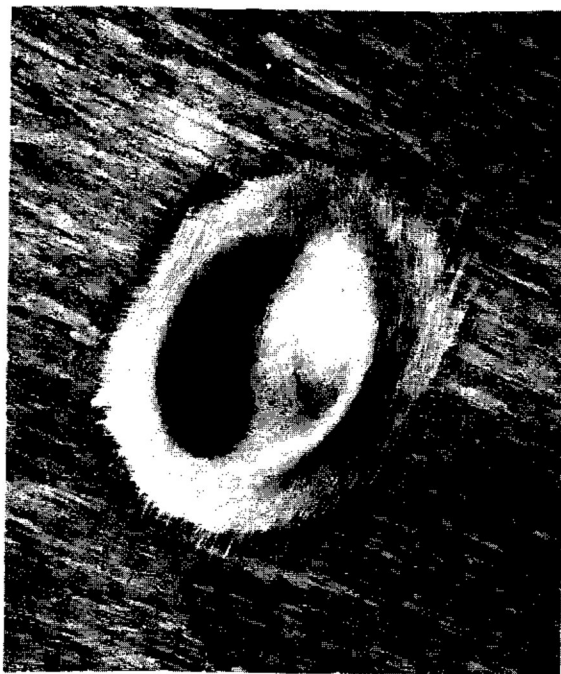
Fig. 3. Sequence of blade re-work

**A** ENLARGED VIEW OF DAMAGE TO BLADE SURFACE-  
BEFORE TREATMENT

**B** FIRST STAGE OF REPAIR-RIFFLER FILE

**C** SECOND STAGE OF REPAIR-EMERY CLOTH

**D** ENLARGED VIEW OF DAMAGE TO BLADE SURFACE-  
AFTER TREATMENT  
PP1995

(5) After performing the foregoing instructions, which are illustrated in figs. 3 and 4, examine the re-worked area with a 5X to 10X magnifying glass; if no damage remains remove a further 0.002 inch minimum of stock by polishing.
