CHAP 2 AIRFRAME SP 156 AL 6 SHEET 1 OF 4	SERVICING PROCEDURE F53 T55	BAC F53 & T55 (SA) 5A3A Section 1 2nd Edition
No.2 Engine Bay Firefloor Overseal - Water Leak Check		AFSC 53450 53470 43151 43171
Safety and Servicing Notes are to be complied with throughout the work detailed on this card.		TIME EST
SPECIAL TOOLS AND EQUIPMENT Nil		ASSOCIATED PROCEDURES
<p>NOTE 1: This servicing procedure must be carried out with No.1 and No.2 engines, No.1 intermediate and reheat pipe removed, and the aircraft in the jacked and trestle position in accordance with local instructions.</p> <p>NOTE 2: No.2 engine hatch jury strut must be fitted at all times during this servicing procedure.</p> <p>NOTE 3: Single leaks of 10 drops per minute are acceptable providing there is no other leak within a radius of 12 in.</p> <p>NOTE 4: More than 2 leaks in any compartment is not acceptable. If 2 leaks occur they must not exceed 3 drops per min. or be within 3 in. of one another. A total of 60 drops per min. is the maximum permissible leakage. i.e. 2 leaks at 3 drops per min. in 10 compartments.</p> <p>NOTE 5: Stains which do not degenerate into leaks over a period of 10 min. are acceptable.</p>

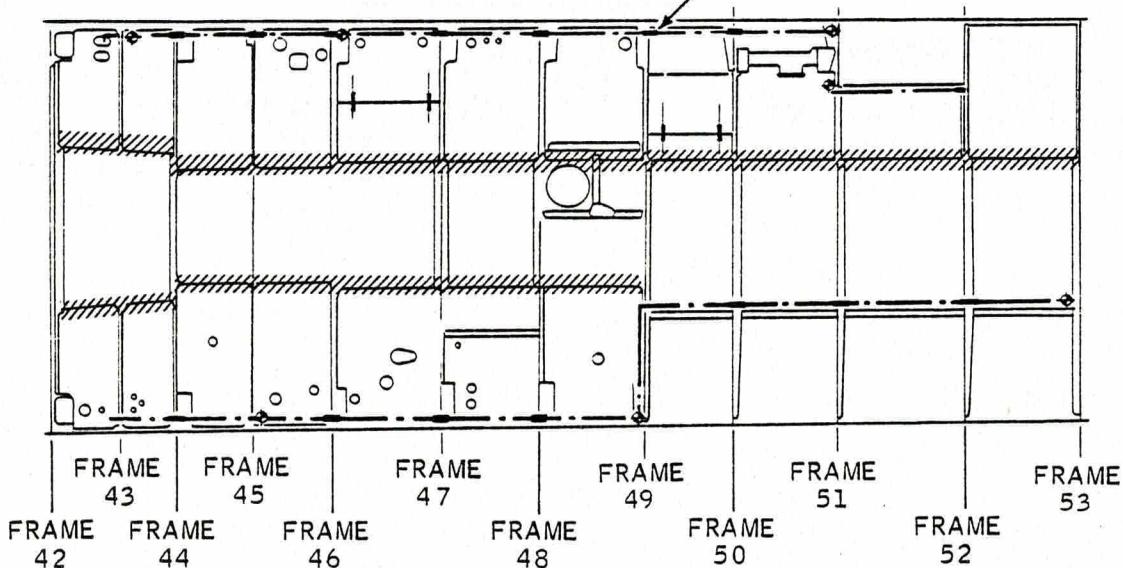
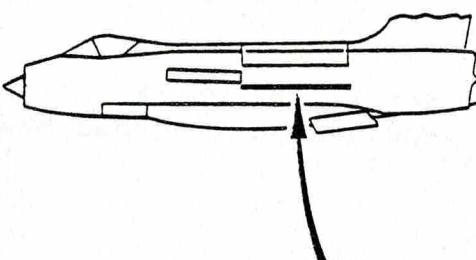
FIREFLOOR SEALING
FIGURE 1

THIS HOLE MUST BE
SEALED WHERE
THE PALOUSTE SYSTEM
IS FITTED

1. EXISTING FIREFLOOR OVERBOARD DRAINS SHOWN THUS
2. DRAINAGE PATHS AND STRUCTURE DRAIN HOLES ARE SHOWN THUS
3. THE DRAINAGE PATHS AND DRAIN HOLES ARE ON ALL MARKS OF AIRCRAFT IN THE POSITIONS SHOWN AND MUST NOT BE OBSTRUCTED WITH SEALANT
4. THE FIREFLOOR MUST BE OVER-SEALED WHERE SHOWN THUS
5. IF ACCESS IS DIFFICULT, SEALING MAY BE UNDERTAKEN FROM NO.1 ENGINE BAY OR JET PIPE TUNNEL
6. DETERIORATED ARALDITE AT POSITIONS FRAMES 44-45, 49-53 LEFT HAND SIDE FRAMES 51-53 RIGHT HAND SIDE MUST BE REPAIRED AND OVERCOATED WITH BOSTIK VITON NO.2221

53450 / 43151		
<p>1. PREPARATION</p> <p>1.1 Overboard drains. (See Fig.1). Fit locally manufactured blanks.</p> <p>2. TESTING</p> <p>2.1 Compartments between Frames 42 and 53. Apply approximately 2 pints of water in each compartment.</p> <p>2.2 Firefloor undersurface. Check for leaks.</p> <p>NOTE: Item 3 is applicable only if leaks are in excess of limits defined in notes 3 to 5 inclusive. If resealing from within No.2 engine compartment proves to be difficult i.e. inaccessible corners further sealing can be carried out from No.1 engine compartment or jet pipe tunnel.</p>		
Continued Overleaf
