A
ROLLS - ROYCE

Instructional Strip-Film

MAINTENANCE OF THE
AVON 1
TURBO JET AERO-ENGINE

PREPARED UNDER THE TECHNICAL DIRECTION OF THE ROLLS-ROYCE AERO-ENGINE SCHOOL, DERBY, ENGLAND.

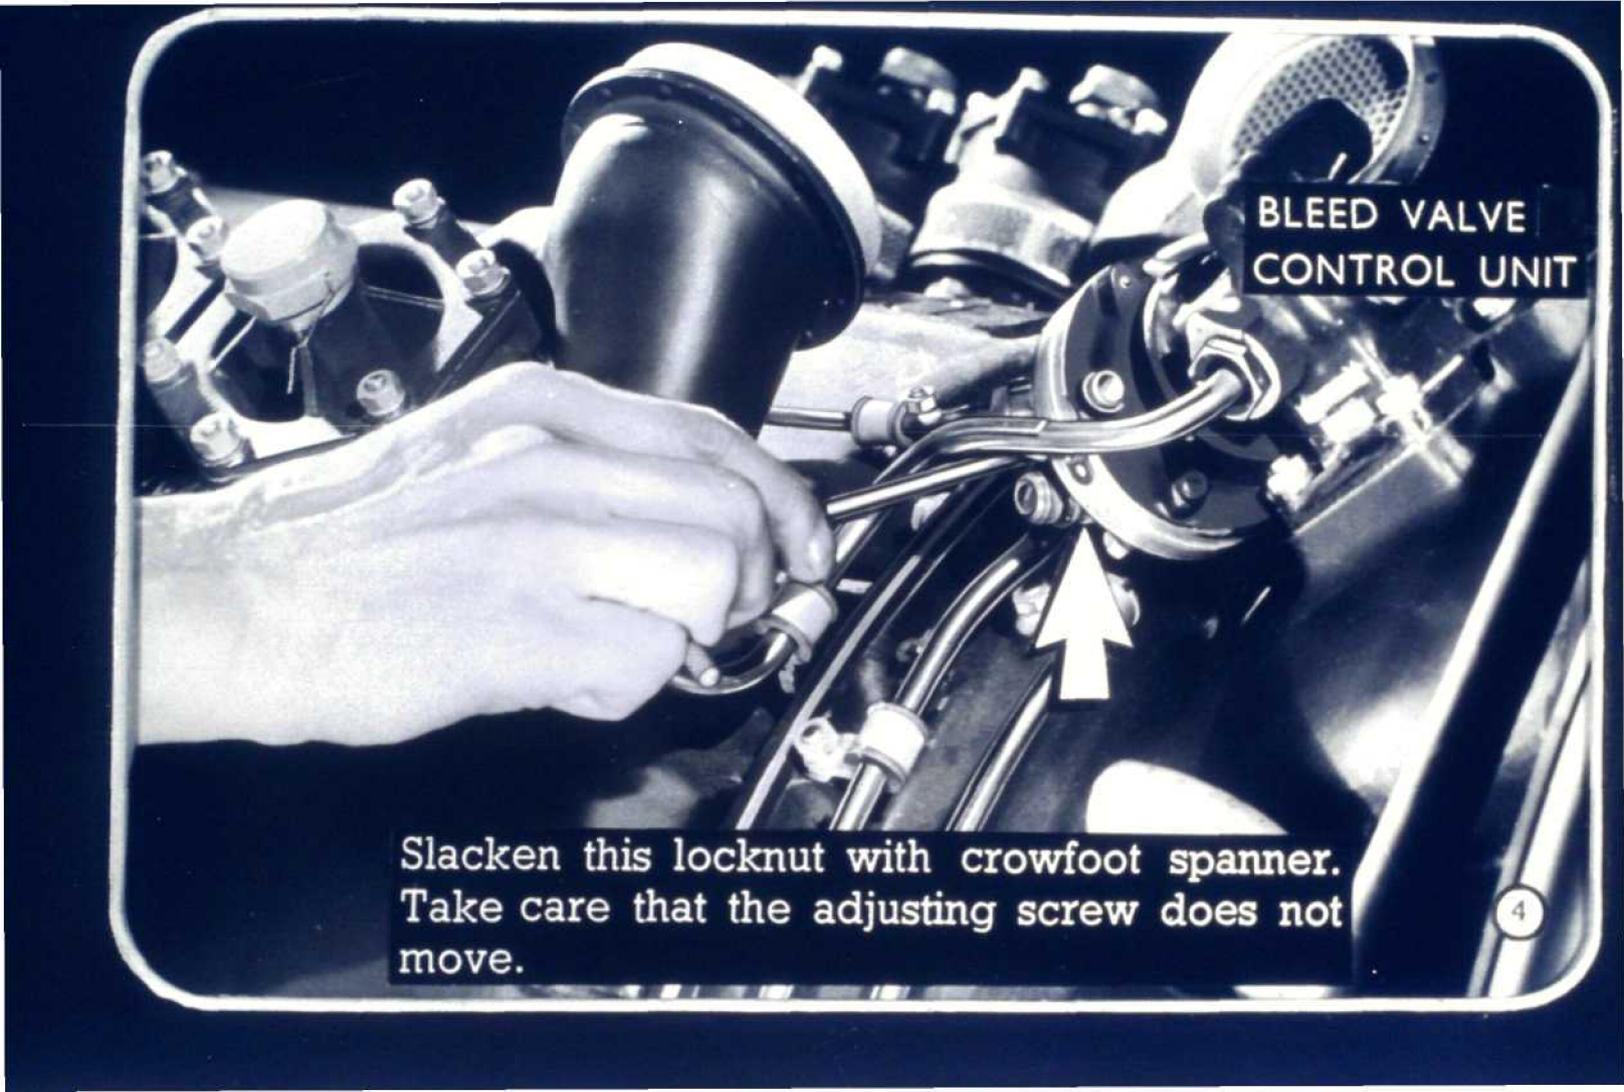
**BLEED VALVE
CONTROL UNIT**

**Slacken this locknut with crowfoot spanner.
Take care that the adjusting screw does not
move.**

BLEED VALVE AND SWIRL CHANGE R.P.M. ADJUSTMENT.

The bleed valves should close at 6400—6650 on accelerating and open at 6000—6200 on deceleration, if incorrect proceed as follows :-

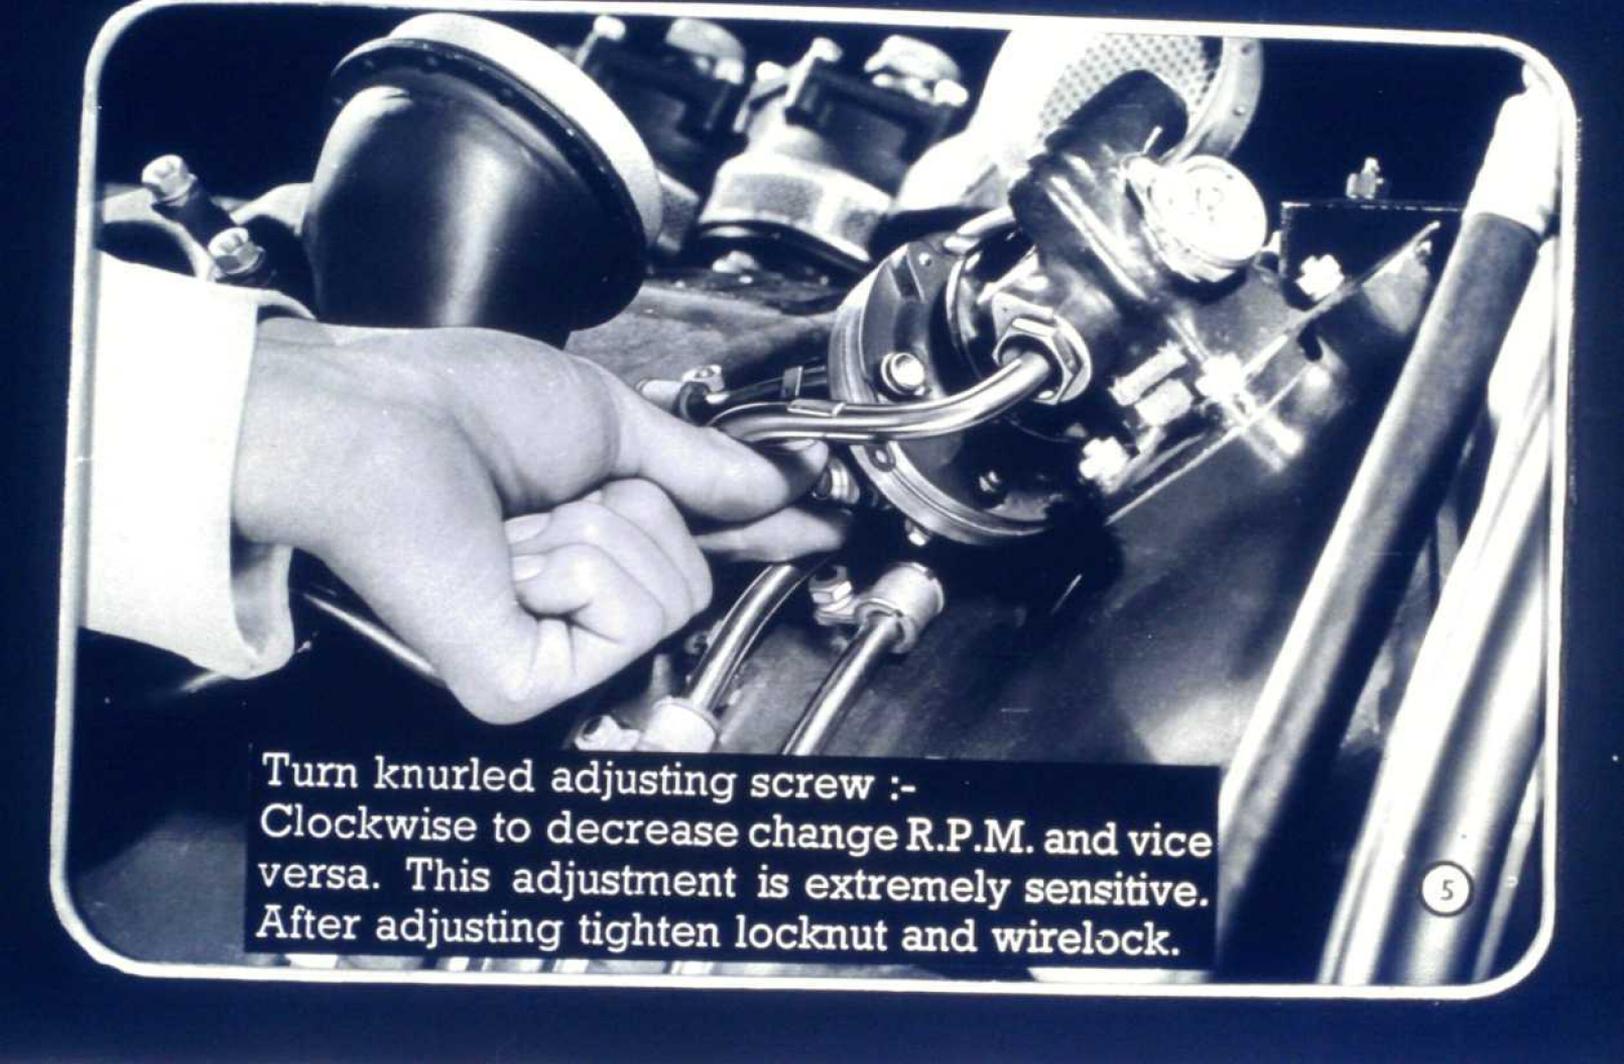
Turn knurled adjusting screw :-
Clockwise to decrease change R.P.M. and vice
versa. This adjustment is extremely sensitive.
After adjusting tighten locknut and wirelock.

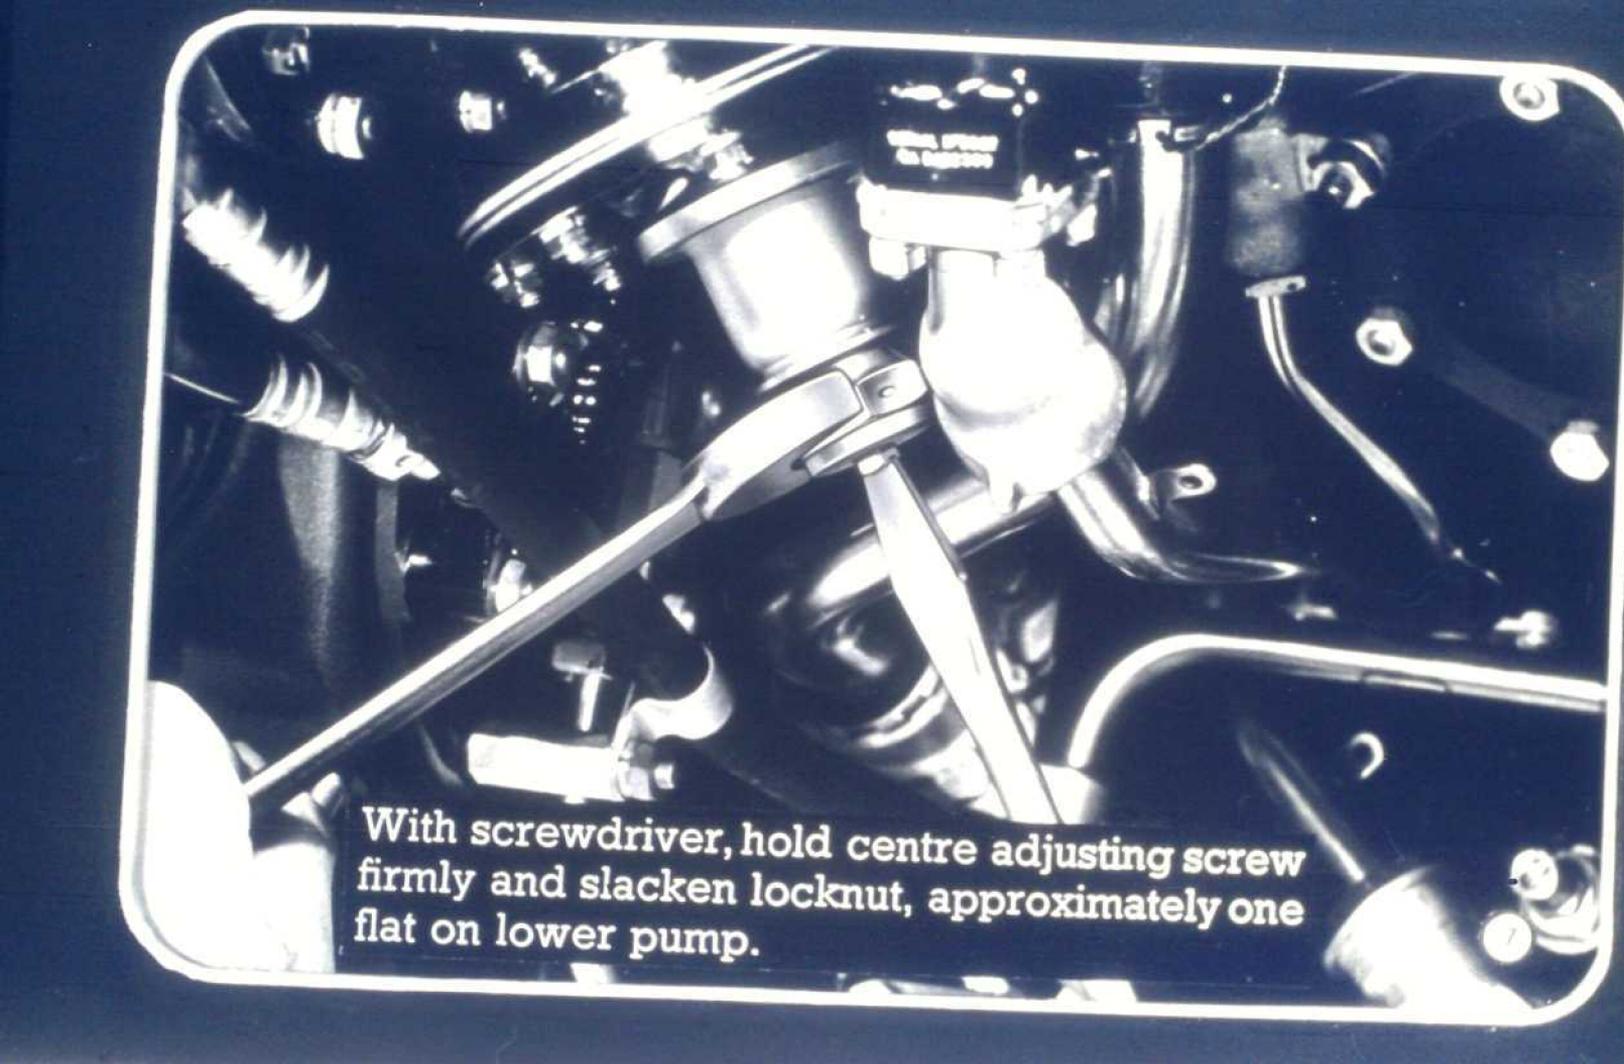
With screwdriver, hold centre adjusting screw firmly and slacken locknut, approximately one flat on lower pump.

Small adjustments are carried out on lower pump. If fuel pumps are replaced proceed as follows :-

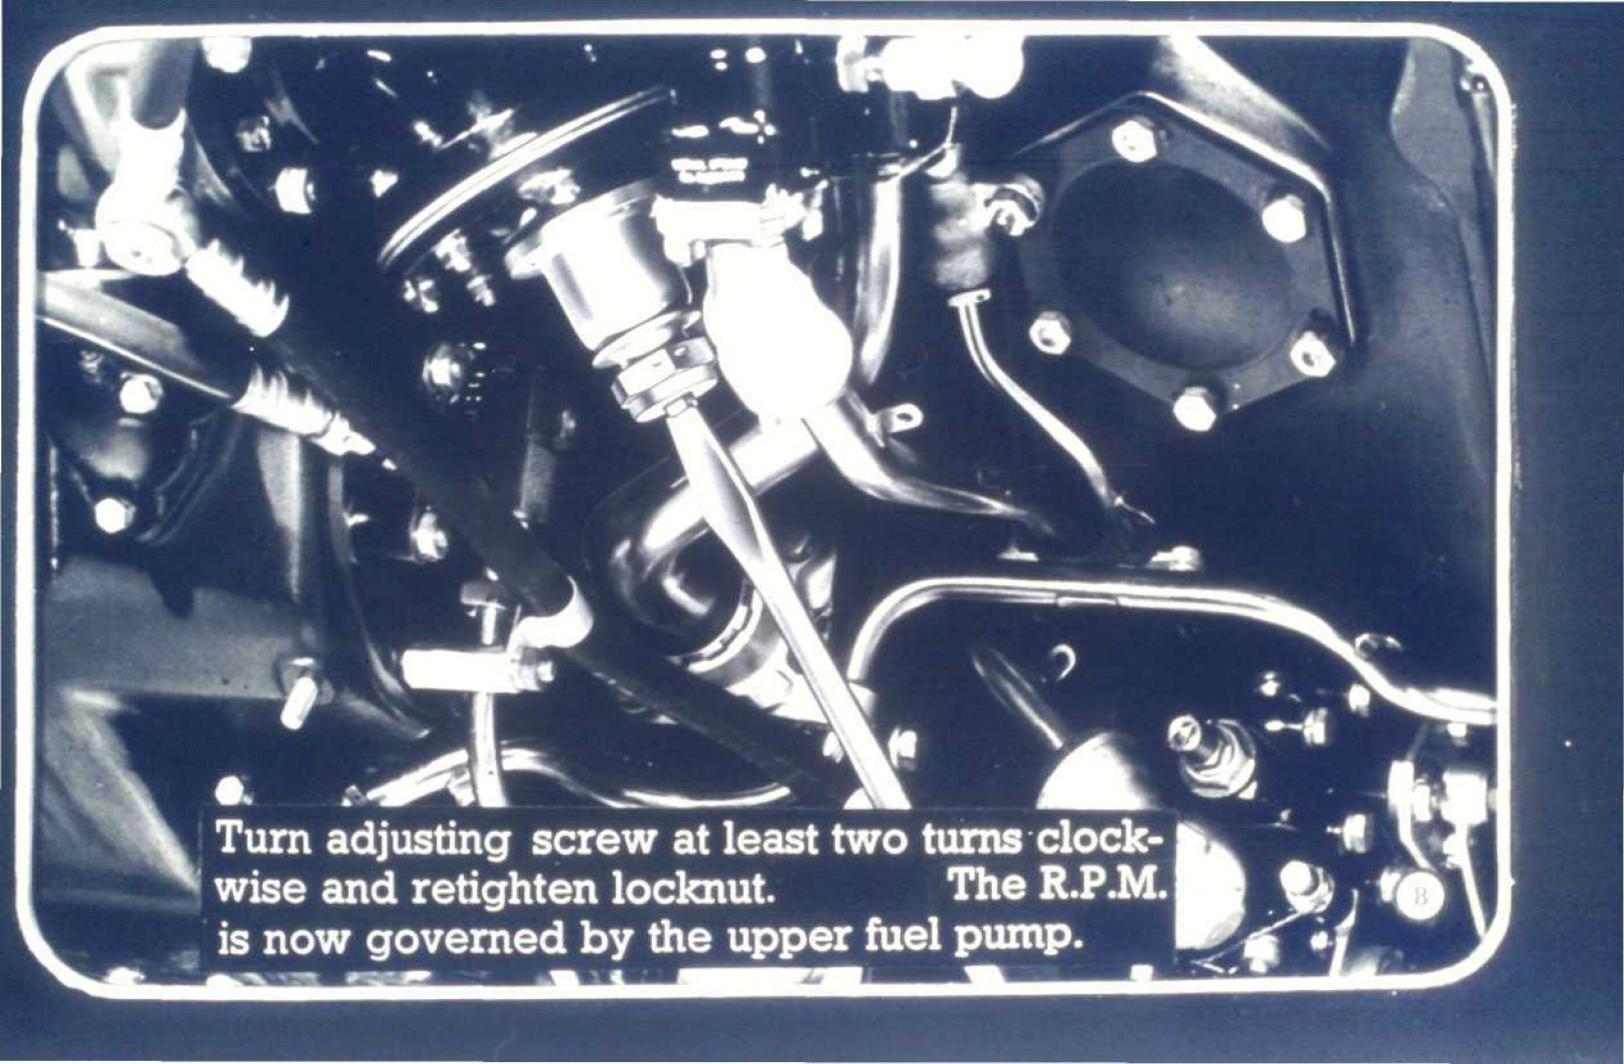
Turn adjusting screw at least two turns clockwise and retighten locknut. The R.P.M. is now governed by the upper fuel pump.

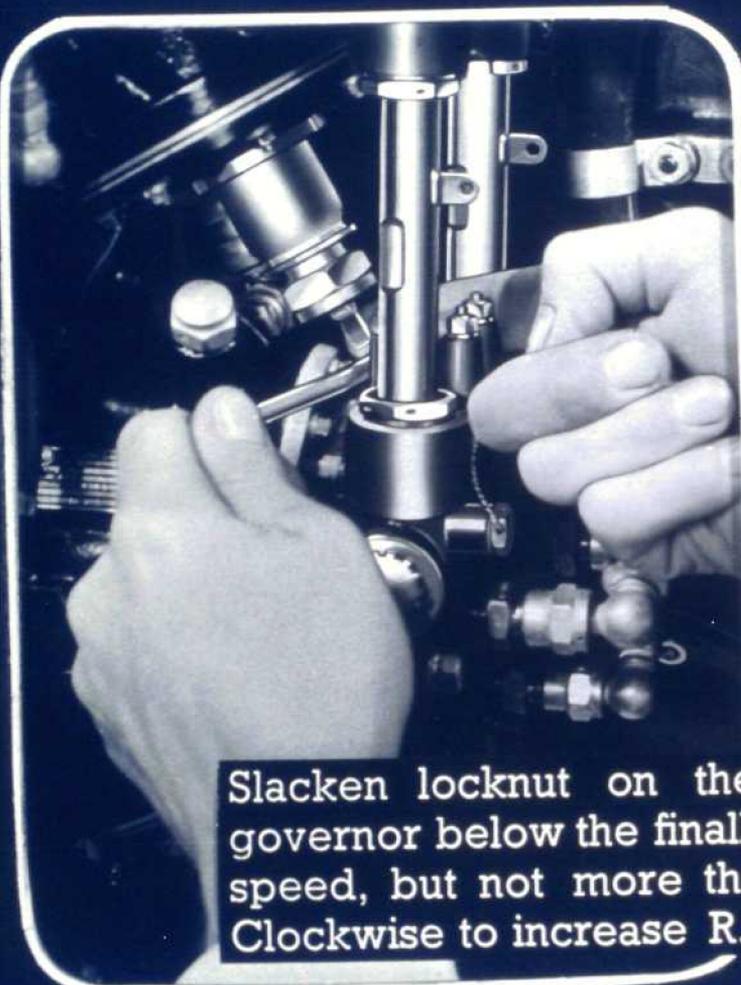
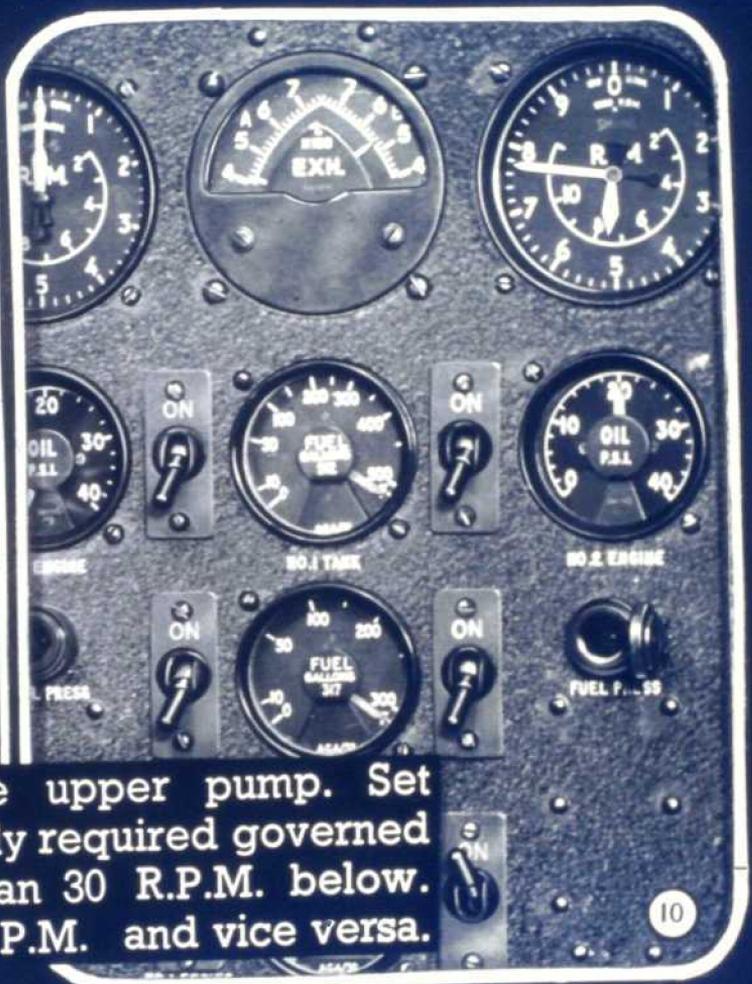
Slacken locknut on the upper pump. Set governor below the finally required governed speed, but not more than 30 R.P.M. below. Clockwise to increase R.P.M. and vice versa.

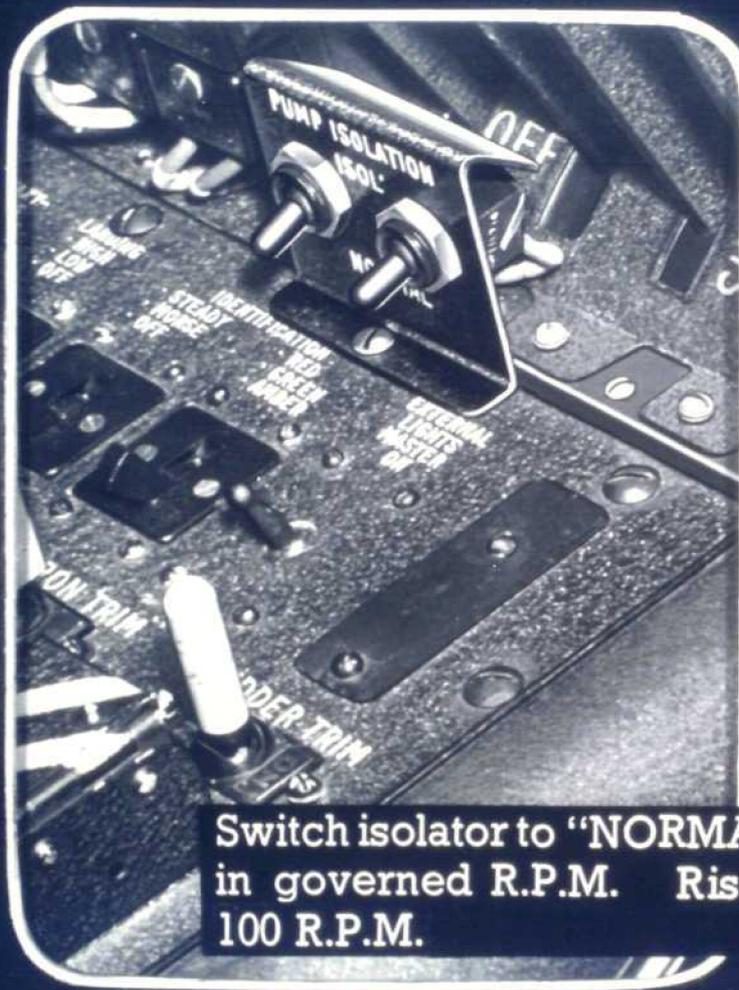
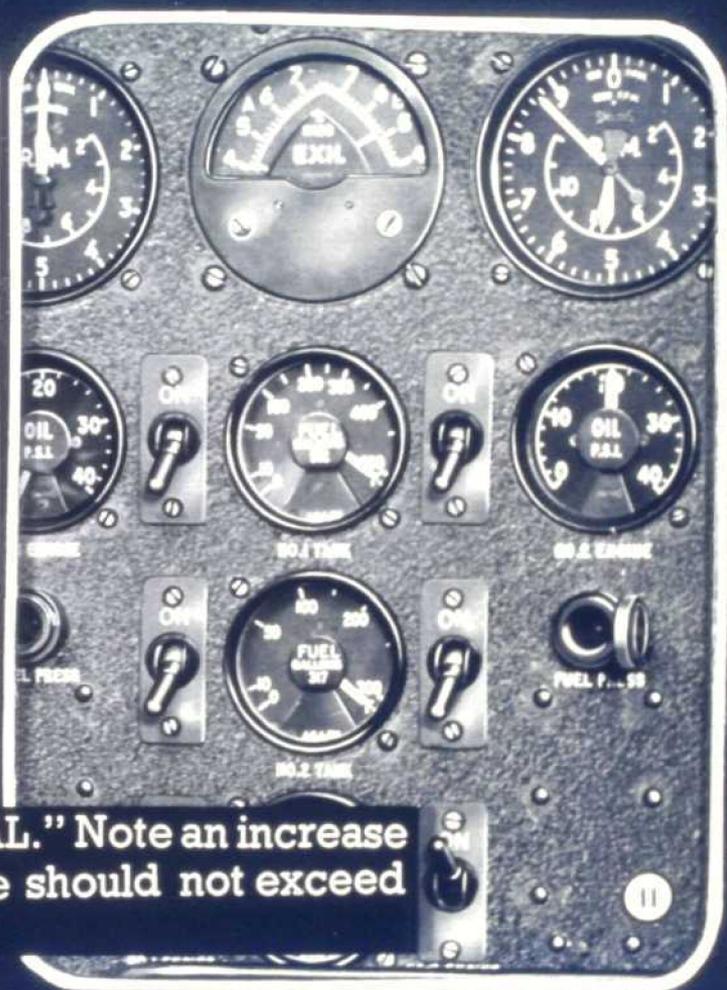
Switch isolator to "NORMAL." Note an increase in governed R.P.M. Rise should not exceed 100 R.P.M.

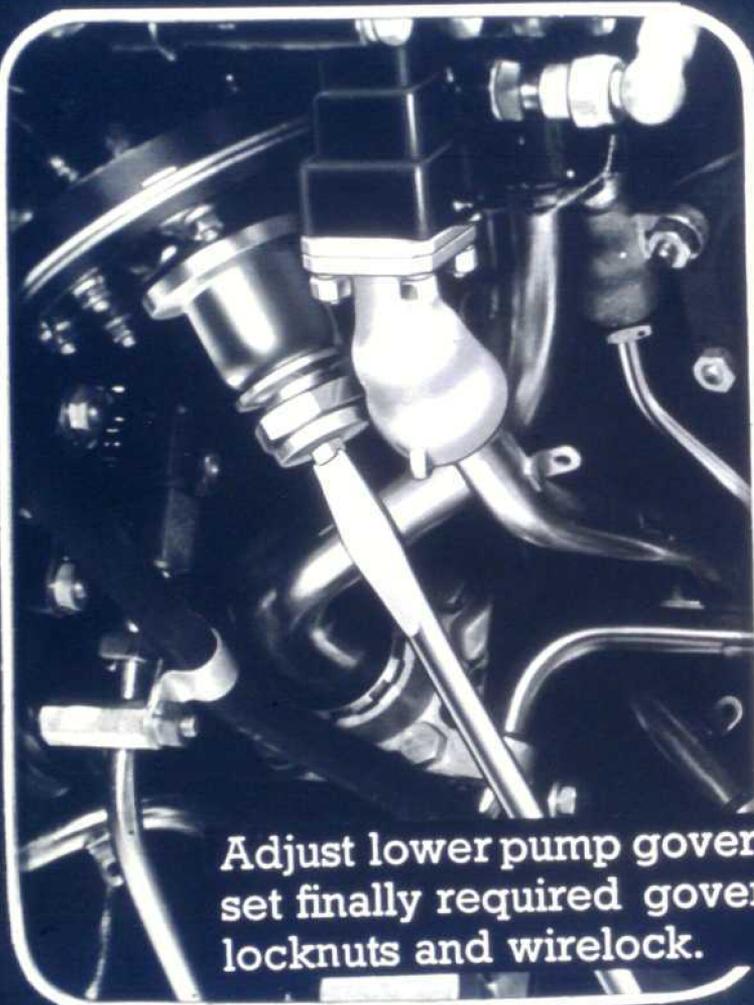
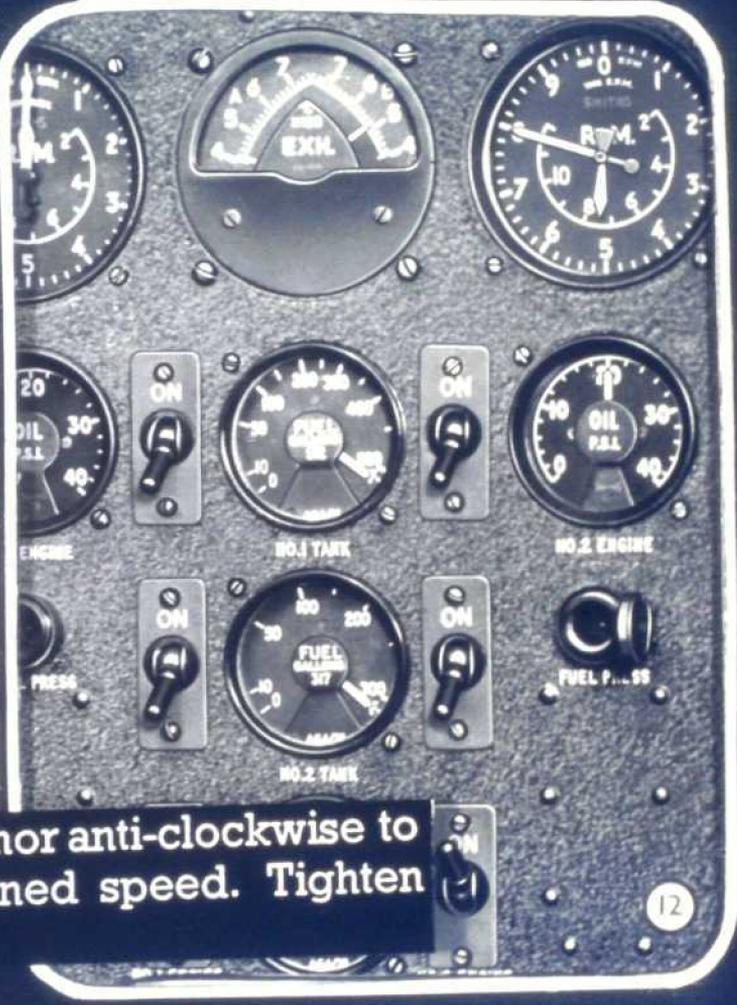
Adjust lower pump governor anti-clockwise to set finally required governed speed. Tighten locknuts and wirelock.

**NOTE ; The R.P.M. drop at governed
speed when isolated should not be
more than 75 R.P.M.**

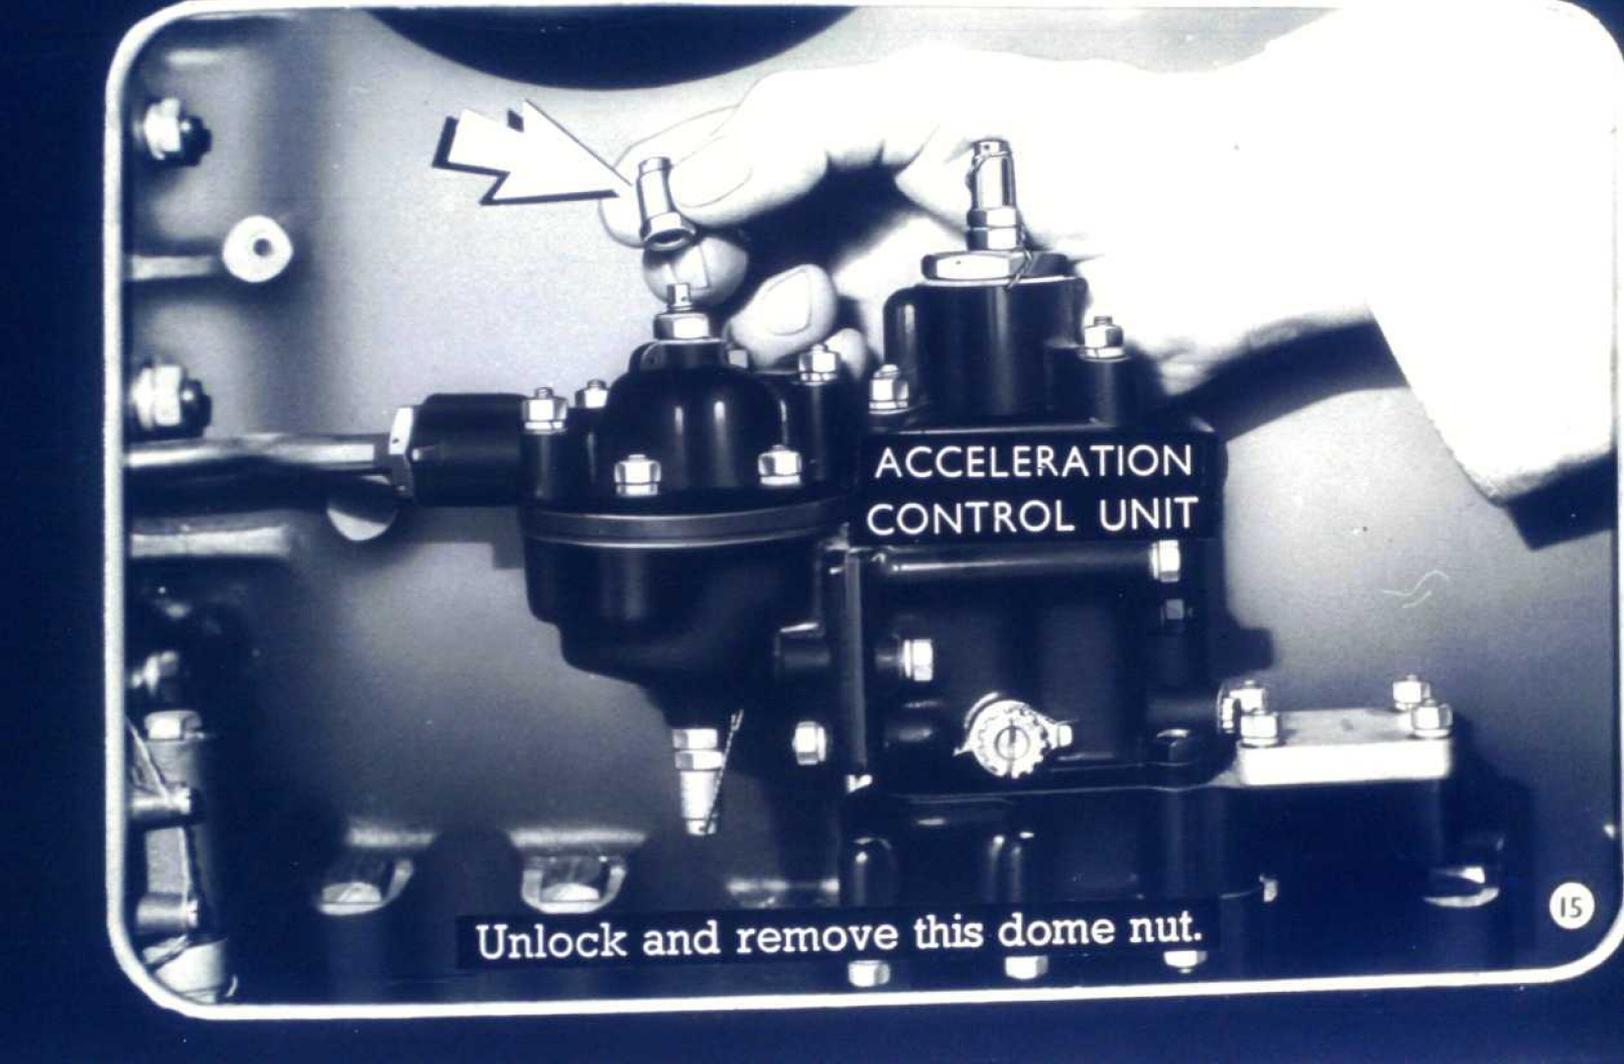
ACCELERATION
CONTROL UNIT

A black and white photograph showing a hand in a white glove removing a dome nut from a mechanical assembly. The assembly is labeled "ACCELERATION CONTROL UNIT". A lightning bolt symbol is drawn next to the dome nut being removed. The unit is mounted on a metal plate with various bolts and a circular dial. The background is dark and shows other parts of the machinery.

Unlock and remove this dome nut.

**The average acceleration time from
2750 R.P.M. to 7800 R.P.M. is 12-14 secs,
but consult log book for verification,
and then proceed as follows :-**

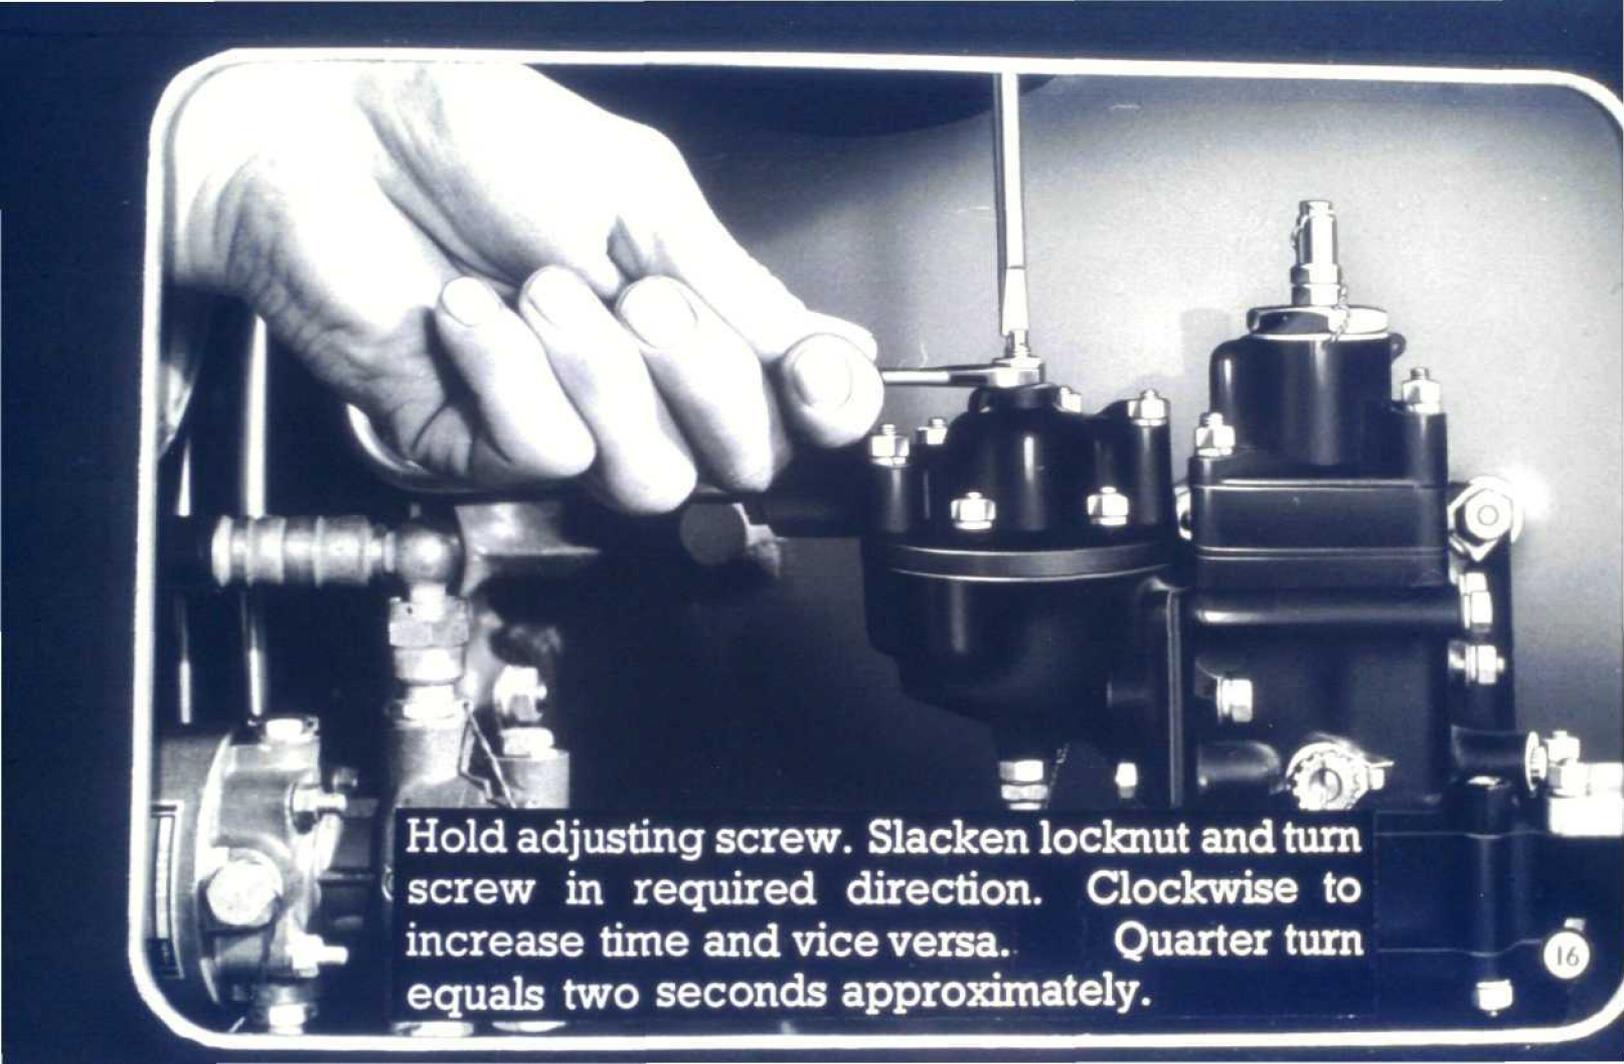
A black and white photograph showing a hand adjusting a screw on a mechanical device. The hand is positioned on the left, with fingers gripping a horizontal screw. The device is complex, with various components, including a large cylindrical part on the right. The background is dark, and the lighting highlights the hand and the mechanical parts. The text is overlaid at the bottom of the image.

Hold adjusting screw. Slacken locknut and turn screw in required direction. Clockwise to increase time and vice versa. Quarter turn equals two seconds approximately.

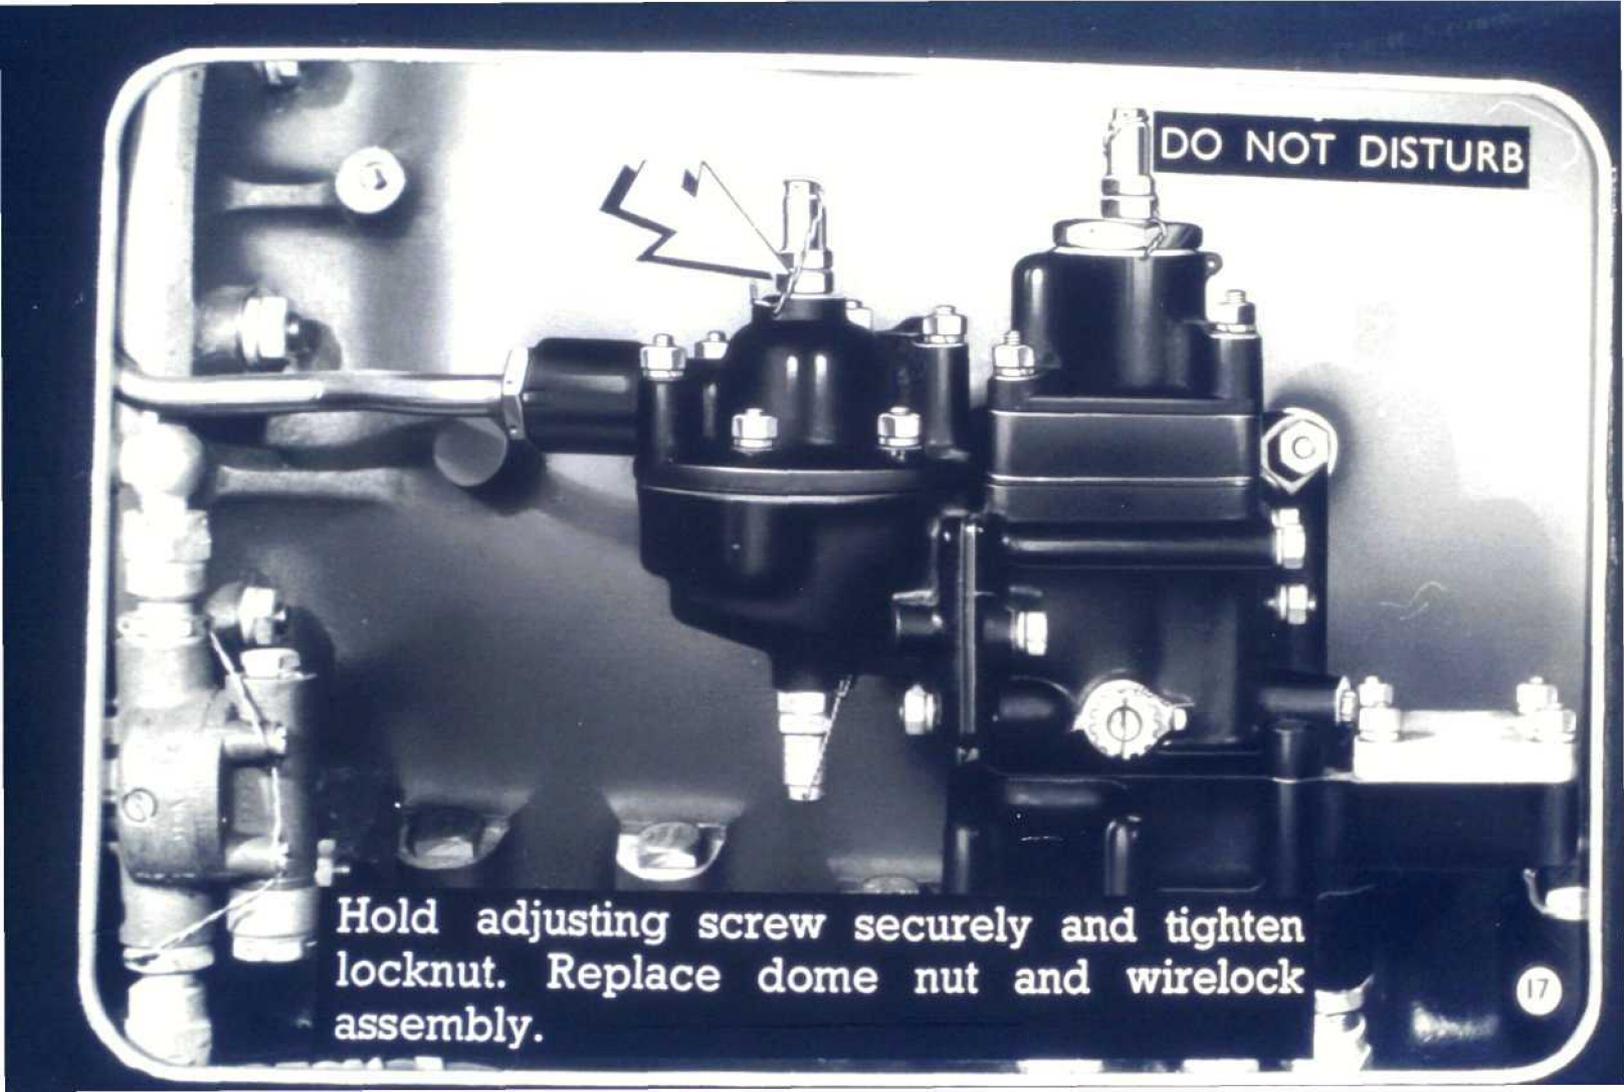
DO NOT DISTURB

Hold adjusting screw securely and tighten locknut. Replace dome nut and wirelock assembly.

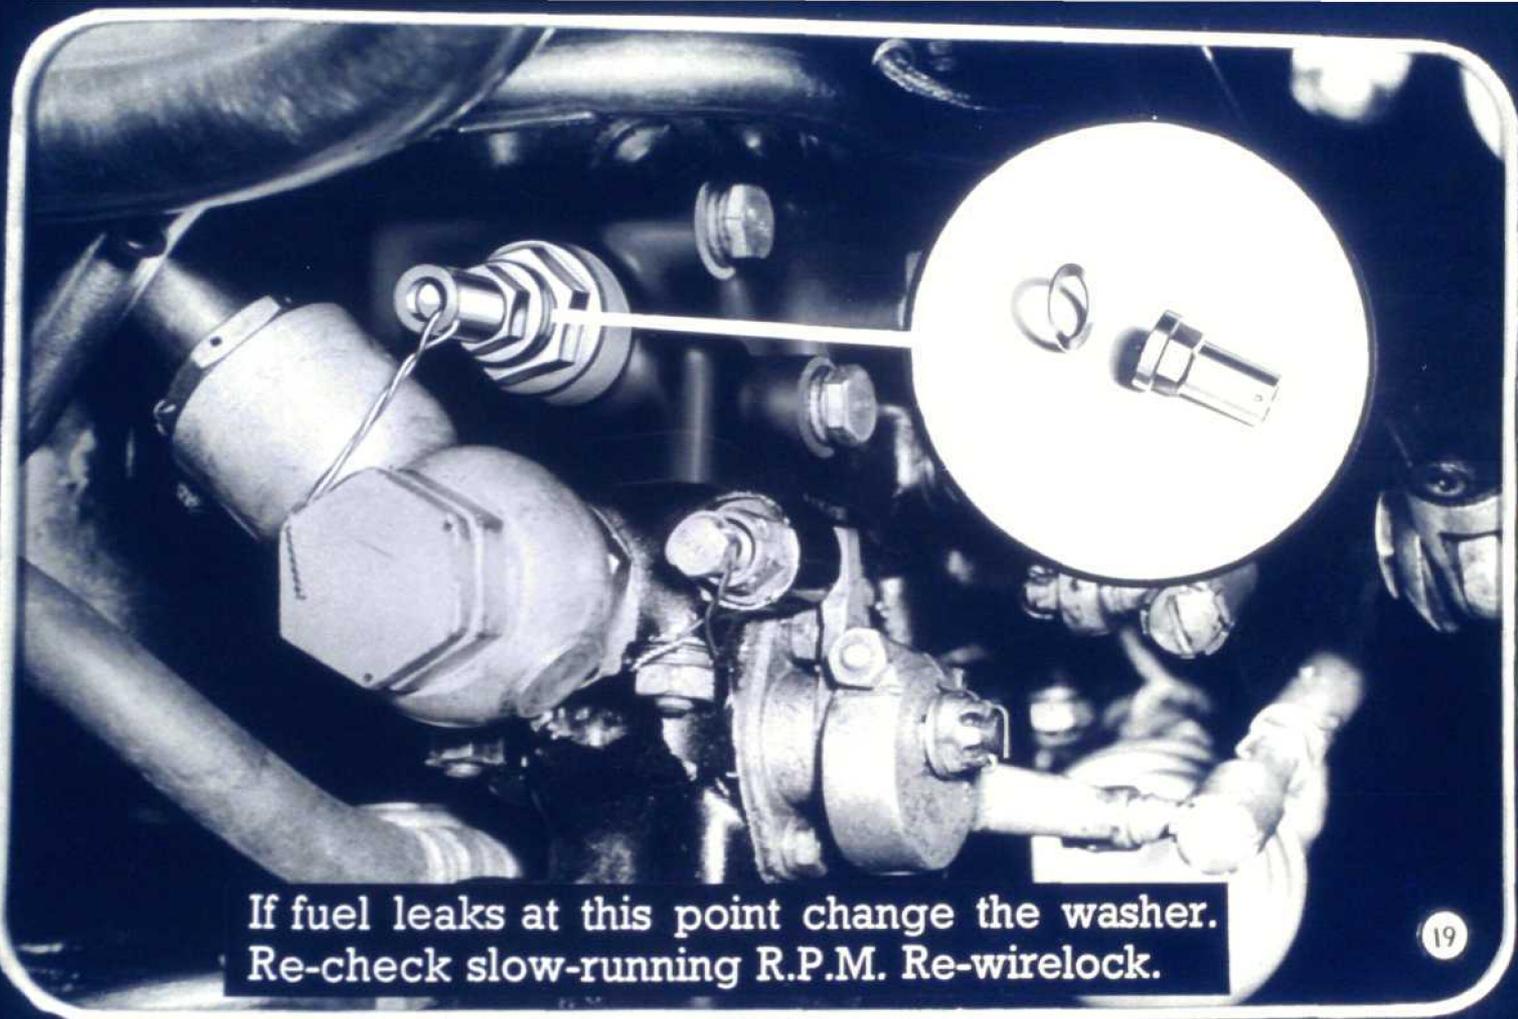
FUEL CONTROL UNIT

With special spanner unlock and turn adjusting nut. Clockwise to decrease and anti-clockwise to increase R.P.M. One turn equals 300 R.P.M. Hold adjustment nut steady, tighten dome nut.

If fuel leaks at this point change the washer.
Re-check slow-running R.P.M. Re-wirelock.
