CHAPTER 4

TAIL UNIT

Chapter 4 TAIL UNIT

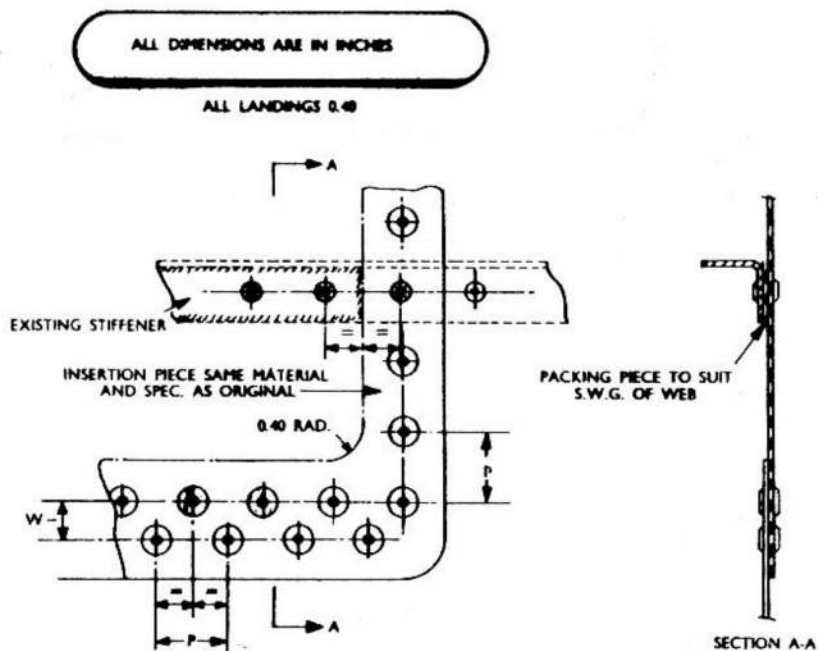
Fig. 30. Non-flush patch to fit main spar web

ITEM	S.W.G.	RIVET SPEC.
1	16	TLP/D/BS429
2	18	TLP/D/BS424
3	20	TLP/D/BS419

EXISTING RIVET DATA

— DENOTES EXTENT OF CLEANED-OUT DAMAGE
