**ENGINE NACELLE**

## Chapter 6 ENGINE NACELLE - AVON MK.1

1. A method of pictorial indexing is employed in this chapter to locate and categorize damage and to illustrate repair schemes by step-to-step progression from the main component key diagram, through detailed structural illustrations and negligible damage charts, to repair schemes designed for particular structural items. Figure 1 - Key diagram, illustrates the cowling assembly and gives the figure numbers of the individual cowling structure illustrations. The structure illustrations simplify the identification of structural items and, in the key, give details of these items together with negligible damage definitions and repair figure numbers.

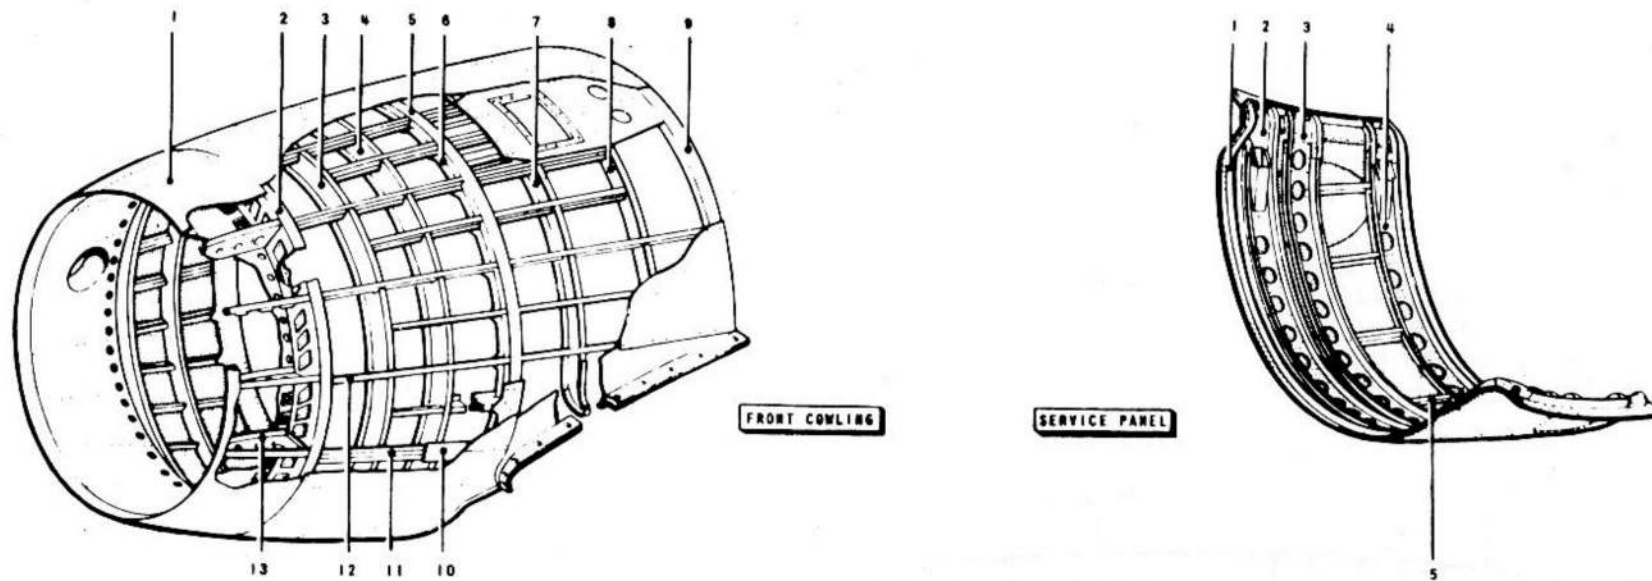
Fig. 2. Front cowling and service panel structure

KEY TO FIG. 2 (FRONT COWLING AND SERVICE PANEL STRUCTURE)

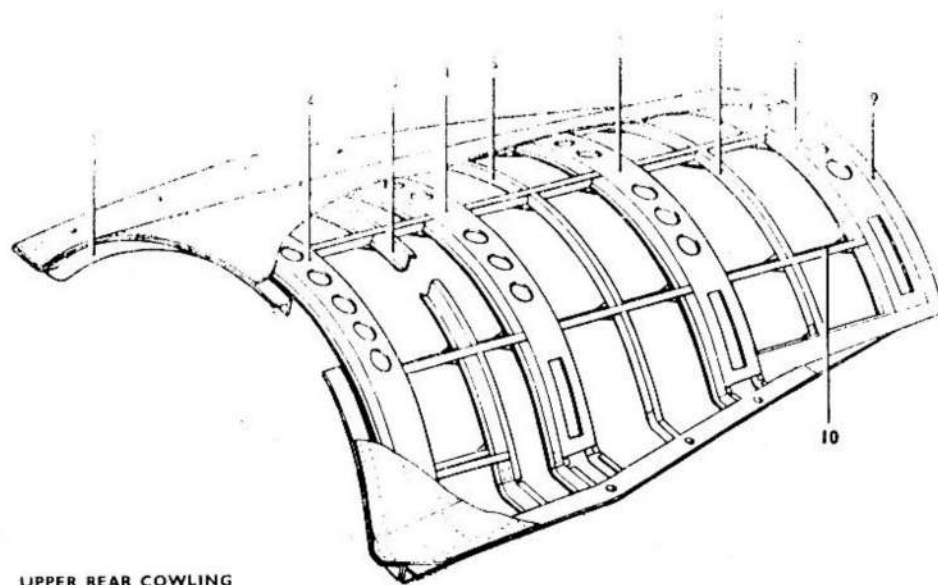
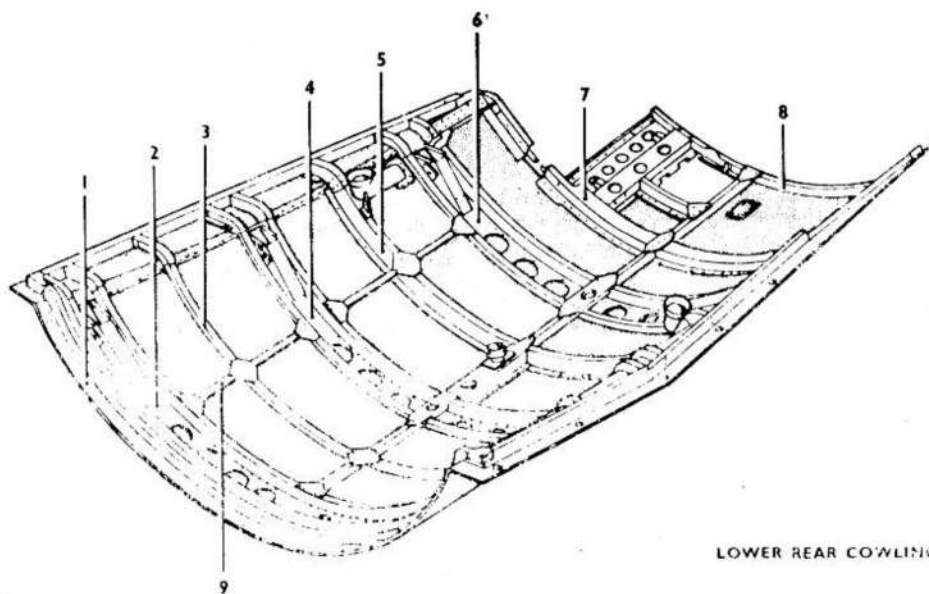
Fig. 4 Upper and lower rear cowling structure

UPPER REAR COWLING

LOWER REAR COWLING

## KEY TO FIG. 4 (UPPER AND LOWER REAR COWLING STRUCTURE)

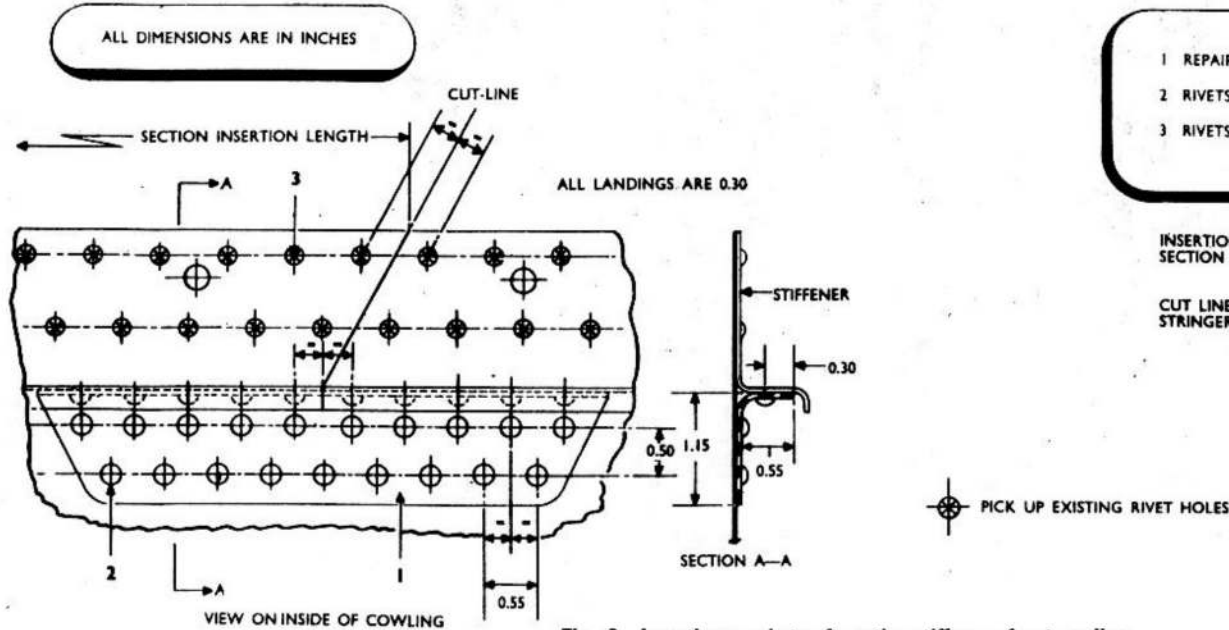
Fig. 9. Insertion repair to aft seating stiffener—front cowling

INSERTION REPLACEMENT TO BE CUT FROM APPROPRIATE SECTION AND MADE ON EITHER SIDE OF SECTION CUT-LINE

CUT LINES MUST BE MADE MIDWAY BETWEEN EXISTING STRINGERS

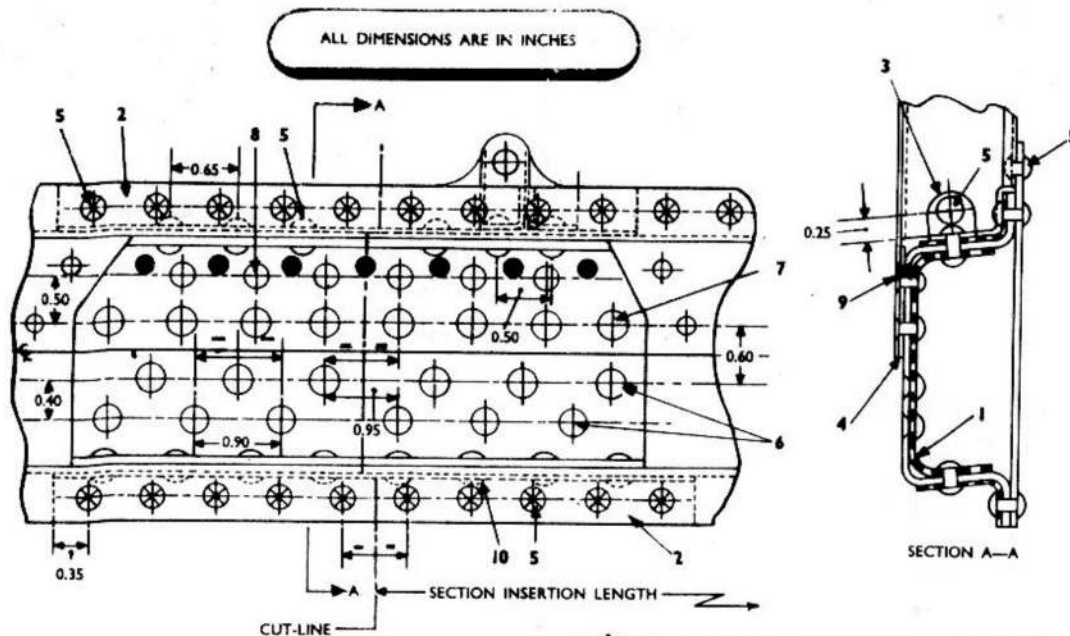
Fig. 11. Insertion repair to support hoop, frame 2, lower half

REPLACEMENT FRAME INSERT TO BE MADE FROM APPROPRIATE FRAME, CUT TO LENGTH AND MADE ON EITHER SIDE OF FRAME CUT-LINE

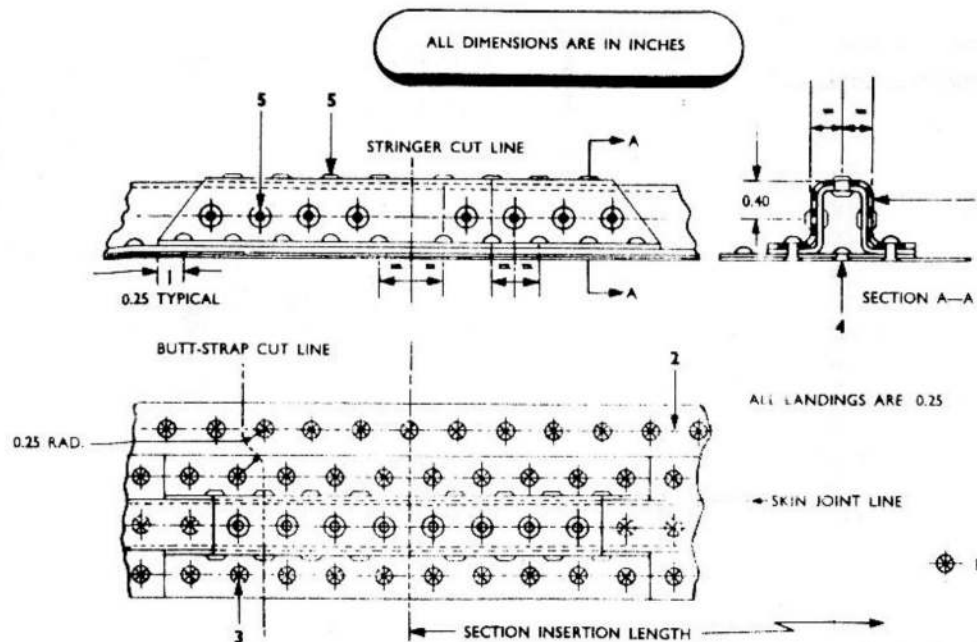
Fig. 12. Insertion repair to skin joint butt-strap and channel-section stringer—front cowling

INSERTION REPLACEMENT TO BE MADE FROM APPROPRIATE SECTION, CUT TO LENGTH AND MADE ON EITHER SIDE OF SECTION CUT-LINE

BUTT-STRAP CUT-LINE NEED NOT NECESSARILY LIE UNDER THE TOP-HAT REPAIR MATERIAL

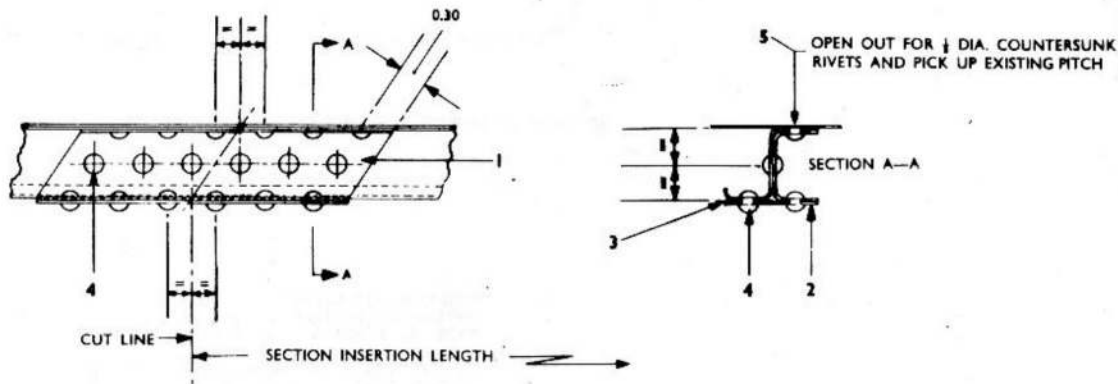
Fig. 13. Insertion repair to typical stringer—front cowling

INSERTION REPAIR TO BE MADE FROM APPROPRIATE SECTION, CUT TO LENGTH AS REQUIRED AND MADE ON EITHER SIDE OF SECTION CUT-LINE

NOTE.—THIS REPAIR IS ONLY APPLICABLE TO THE CONSTANT-DEPTH PORTION OF THE STRINGER

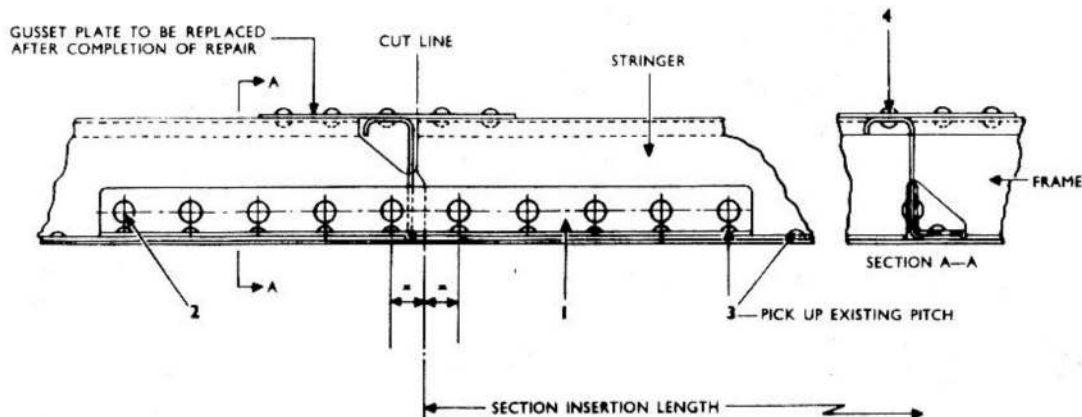
Fig. 14. Insertion repair to E.E.J.71 section

INSERTION REPAIR TO BE MADE FROM APPROPRIATE SECTION, CUT TO LENGTH AS REQUIRED AND MADE ON EITHER SIDE OF SECTION CUT-LINE

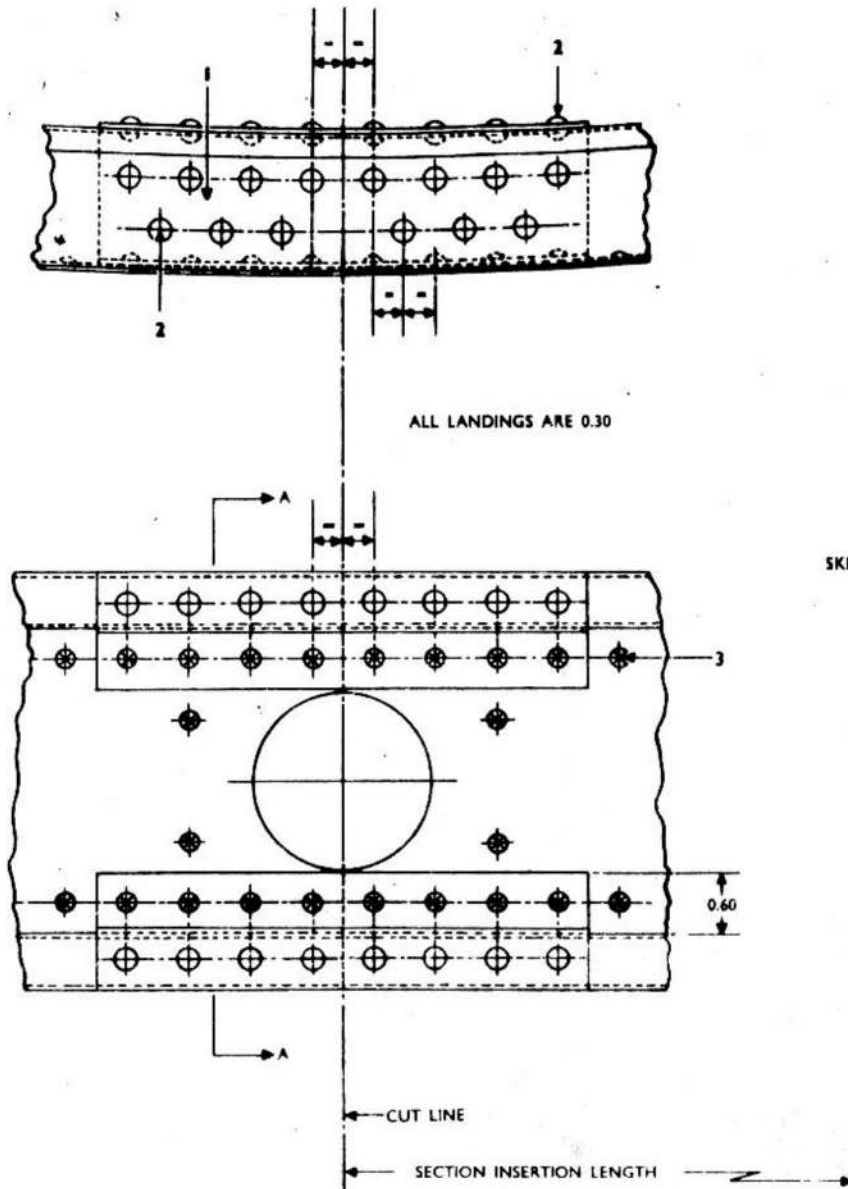
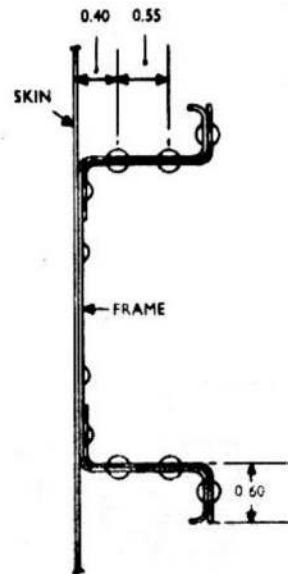
Fig. 15. Insertion repair to frames 1, 2, 3 and 4—upper and lower rear cowlings

INSERTION REPLACEMENT TO BE MADE FROM APPROPRIATE SECTION, CUT TO LENGTH AND MADE ON EITHER SIDE OF SECTION CUT-LINE

ALL CUT LINES TO BE TAKEN MIDWAY BETWEEN EXISTING RIVET HOLES AND, WHERE POSSIBLE, THROUGH THE CENTRE OF LIGHTENING HOLES

THIS REPAIR IS NOT APPLICABLE TO FRAME 2, UPPER COWLING

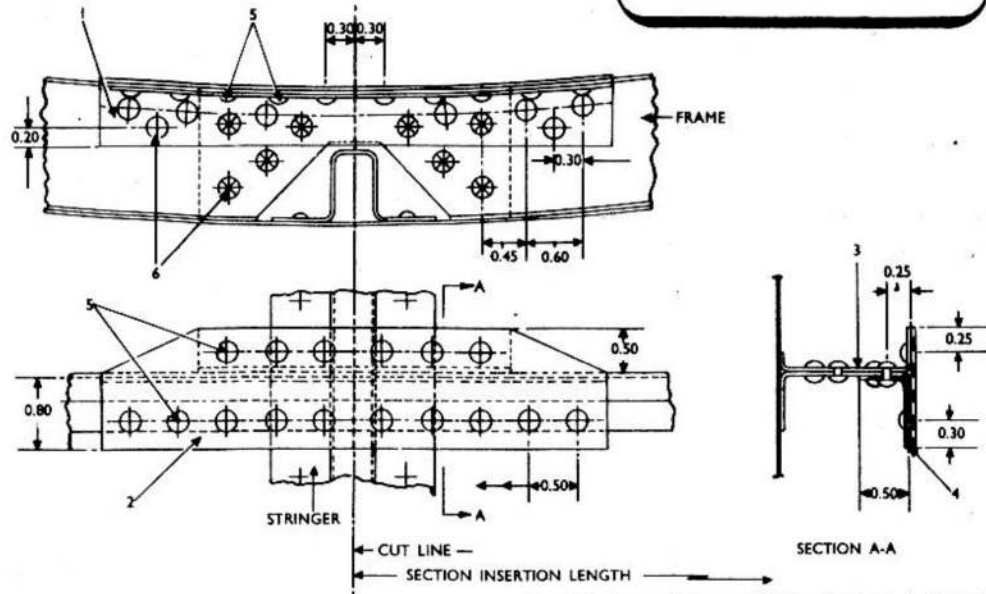
Fig. 16. Insertion repair to frames 1, 2 and 3-jet pipe cowling

SECTION REPLACEMENT TO BE MADE FROM APPROPRIATE SECTION, CUT TO LENGTH AND MADE ON EITHER SIDE OF SECTION CUT-LINE

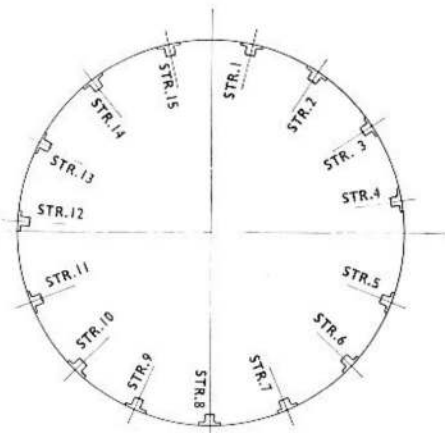
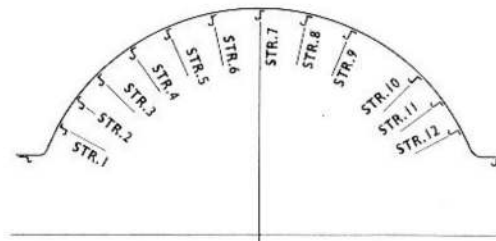
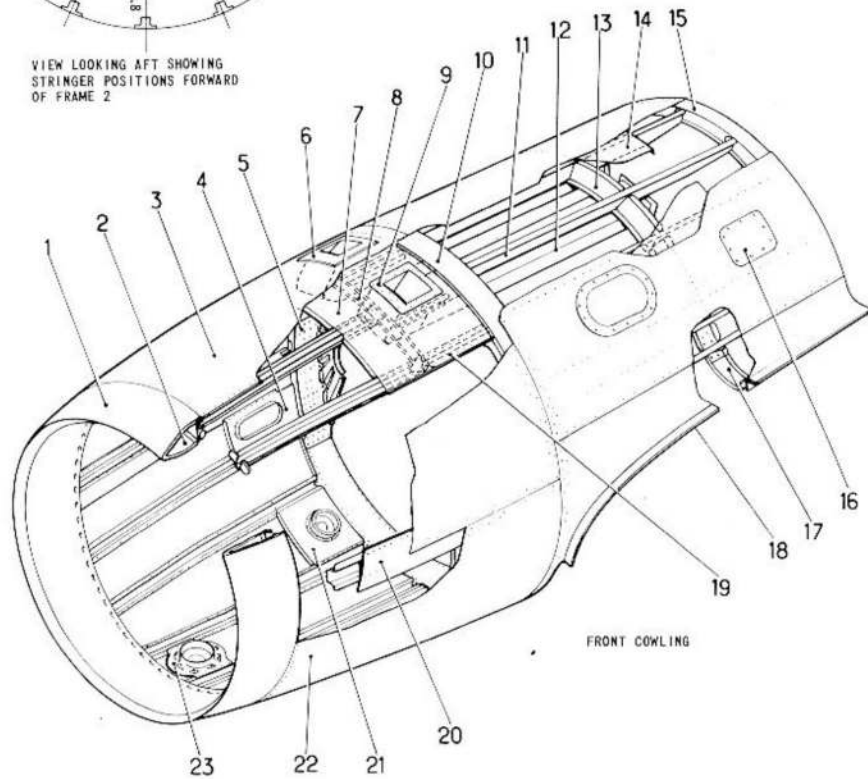
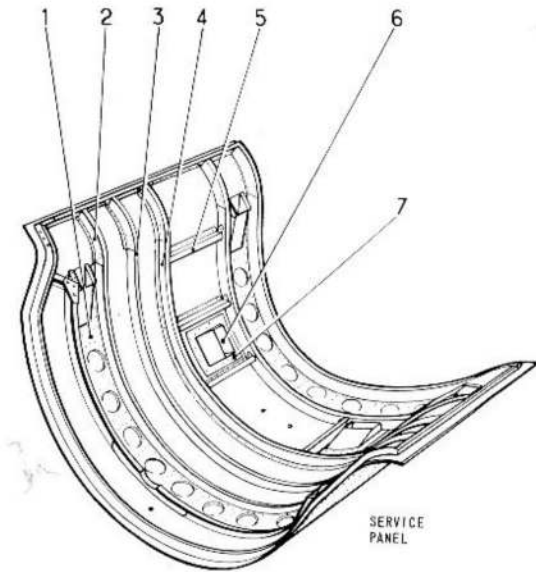
FIG.602 FRONT COWLING AND SERVICE PANEL STRUCTURE

VIEW LOOKING AFT SHOWING  
STRINGER POSITIONS FORWARD  
OF FRAME 2

VIEW LOOKING AFT SHOWING STRINGER POSITIONS  
AFT OF FRAME 2

FRONT COWLING

SERVICE  
PANEL

KEY TO FIG.602 (FRONT COWLING AND SERVICE PANEL STRUCTURE)

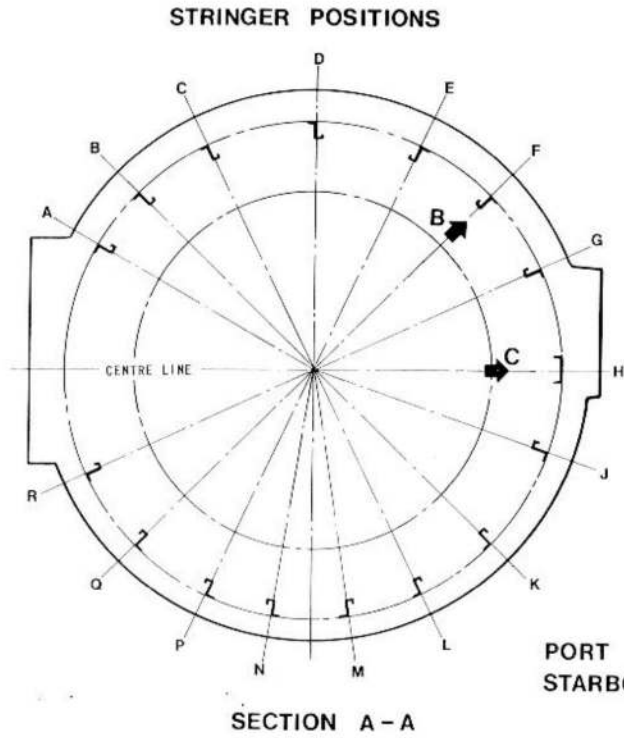
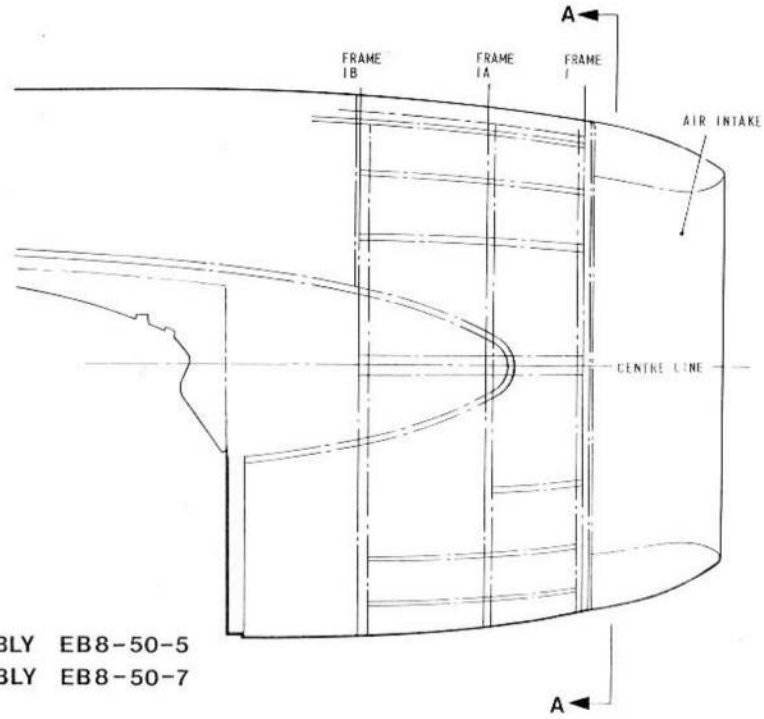
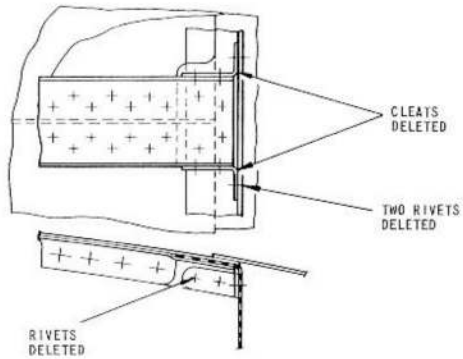
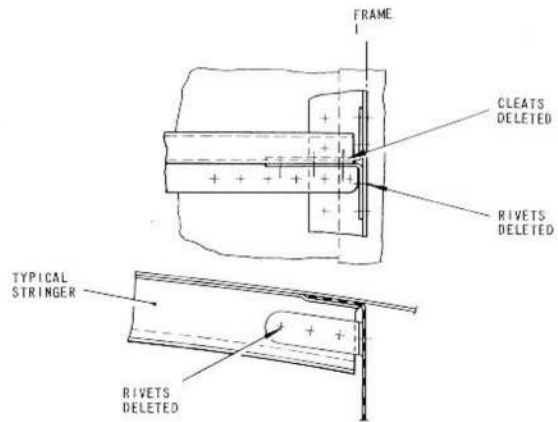
**FIG. 906 DELETION OF AIR INTAKE SECURING CLEATS FROM FRAME 1 OF THE ENGINE COWL**

**VIEW ON ARROW C**  
DETAIL AT STRINGER H

**VIEW ON ARROW B**  
TYPICAL DETAIL OF LOCATIONS  
AFFECTED EXCEPTING STRINGER H

**Deletion of air intake securing cleats from frame 1 of the engine cowl (fig.906)**

3. Whenever an engine cowl assembly air intake assembly is replaced, the cleats securing frame 1 to the stringers at the positions indicated in the illustration must be removed by carefully drilling out the securing rivets and filling the redundant rivet holes with
