PROPULSION MP 105(1) (1 to 10)	MAINTENANCE PROCEDURES COMPONENT REPLACEMENTS CANBERRA PR9	AP101B-0409A-5A3A 2nd Edition Sect 1 Chap 4	Maintenance Record  Aircraft or Equipment Serial No: _____		MOD Form 707MS (Revised Jan 01)  Date: _____		
ECU AVON 20601 - REMOVAL							
INFORMATION IN THE TOPIC 5A2 IS TO BE CONSULTED THROUGHOUT THE WORK DETAILED ON THIS CARD			Tradesman		Brief Details of suspected fault(s) and SNOW(s)	Supervisor	
Associated Procedures			Code	Man Hrs		Certification and TDM	Man Hrs
<u>Special Tools and Equipment:</u> Wing Bridge Piece, 26FZ/0095522. Avon Engine Universal Sling Mk2, 4G/4232188.							
<b>WARNING</b>  AVTUR IS A HAZARDOUS SUBSTANCE.  OIL OX-38 IS A HAZARDOUS SUBSTANCE.							
BLOCK 1	ELECTRICAL

MAINTENANCE PROCEDURES  
COMPONENT REPLACEMENTS  
CANBERRA PR9

AP101B-0409A-5A3A  
2nd Edition  
Sect 1  
Chap 4

ECU AVON 20601 - REMOVAL

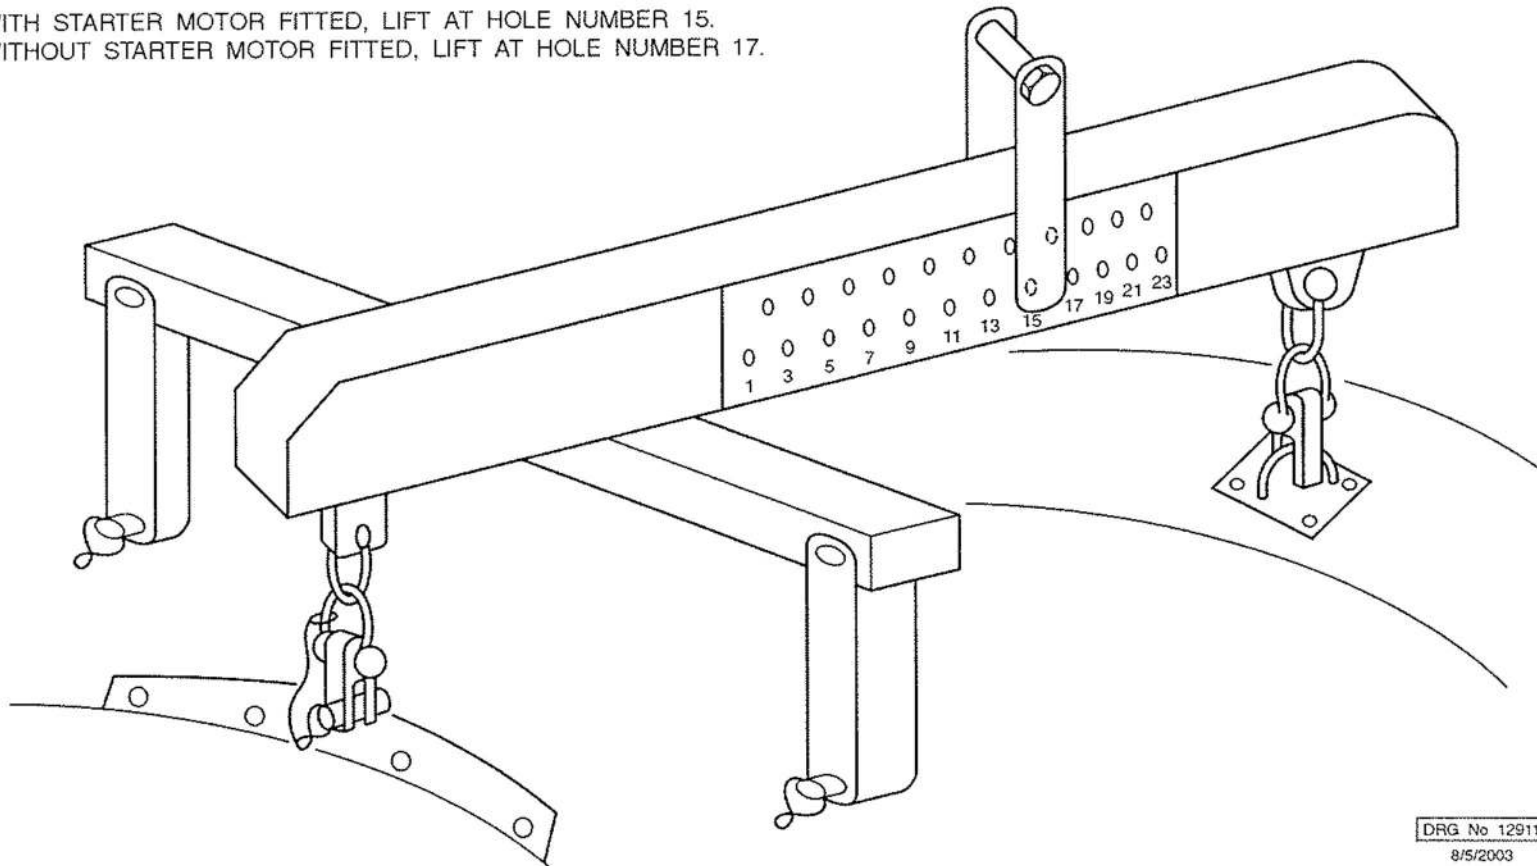
Fig 1 Engine Lifting Beam Balance Points

1. WITH STARTER MOTOR FITTED, LIFT AT HOLE NUMBER 15.
2. WITHOUT STARTER MOTOR FITTED, LIFT AT HOLE NUMBER 17.

DRG No 12911  
8/5/2003

INFORMATION IN THE TOPIC 5A2 IS TO BE CONSULTED THROUGHOUT THE WORK DETAILED ON THIS CARD			Tradesman		Brief Details of	Supervisor	
BLOCK 1	PROPULSION SNCO	Code	Man Hrs	Certification and TDM	suspected fault(s) and SNOW(s)	Man Hrs	Certification and TDM
8.	<u>Removal</u>						
8.1	Engine sling.	(i) Fit (Fig 1). (ii) Take weight of ECU.					
8.2	Rear trunnion mounting cap (2 off).	Remove.					
8.3	Front support strut (2 off).	Disconnect.					
8.4	ECU.	(i) Lift clear of rear mounting studs. (ii) Lift forward and upward. (iii) Ensure inner cone does not foul transition piece.					
8.5	Trunnion mounting spherical bearing (2 off).	Remove.					
8.6	ECU.	Fit to transportation stand.					
8.7	Wing bridge piece.	Fit to engine compartment mounting.
