**ENGINE MOUNTING  
AND COWLING**

## ENGINE MOUNTING AND COWLING

(Completely revised)

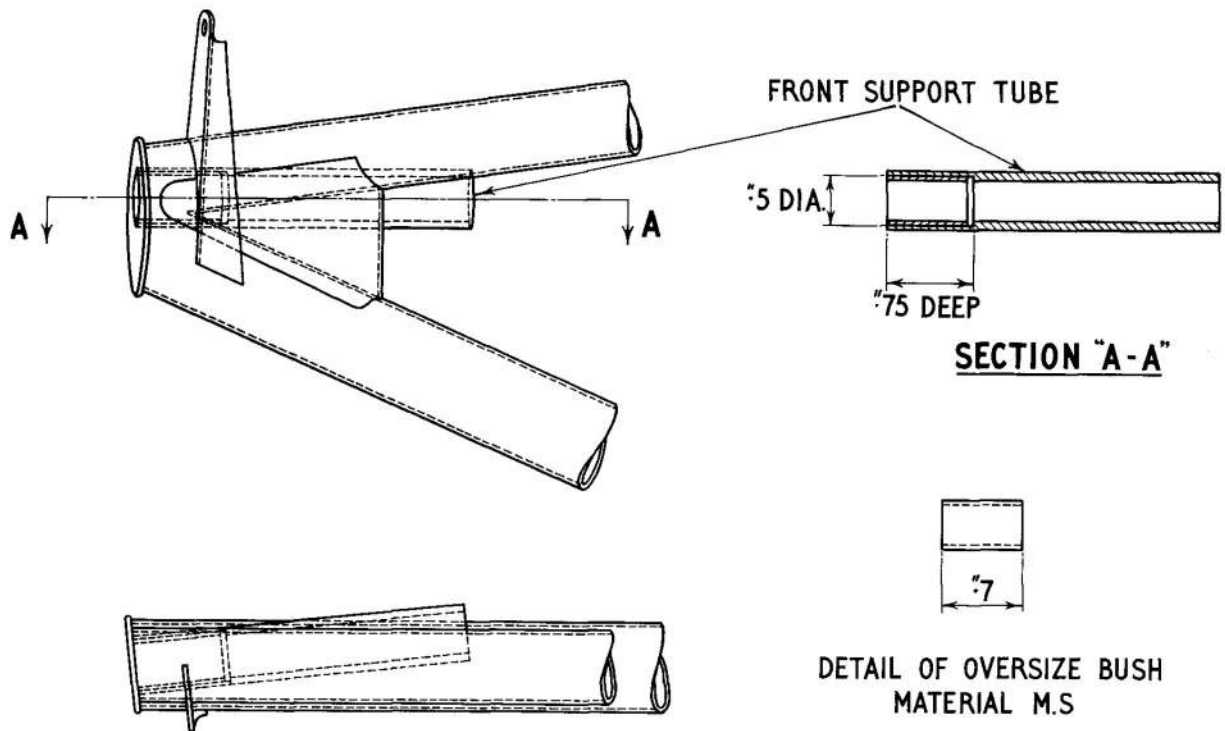
Fig. 2/3. Repair to front foot

### JOINT "B" ENGINE MOUNT

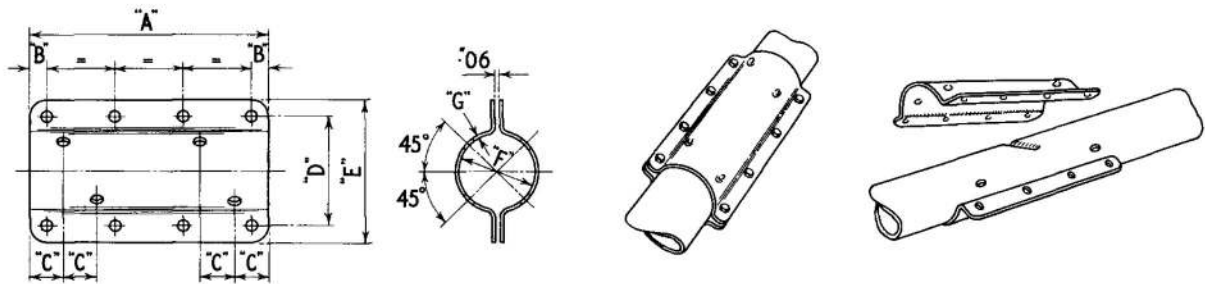
Fig. 2/4. Repair to engine mounting tubes

REPAIR TO	"A"	"B"	"C"	"D"	"E"	"F"	"G"	MATL	ACCESSORIES
$1\frac{1}{8}$ " O/D. TUBE 17 SW.G	4"50	0"25	0"65	1"60	2"10	$1\frac{1}{8}$ " O/D	16	D.T.D 124	8 FERRULES $\frac{5}{16}$ in. DIA. AGS. 934/GS 4 SCREWED RODS AGS. 935/G, 1.6in. LONG 8 FLANGE BOLTS A.25/1C 8 NUTS A.27/CP
$\frac{3}{8}$ " O/D. TUBE 20 SW.G	2"50	0"25	0"50	1"10	1"60	$\frac{5}{8}$ " O/D	18	D.T.D 124	8 PINS $\frac{3}{16}$ in. DIA. DHS. 94/6/90 8 FLANGE BOLTS A.25/1C 8 NUTS A.27/CP

4. The following method should be used in repair :-

(1) The tube should be carefully restored to shape and the dent reduced as much as possible, to permit the snug bedding of the sleeve patch.

(2) Two half sleeve patches should be prepared as detailed above and clamped down symmetrically over the damage by fitting bolts through the holes in the flanges.

(3) The tube should be drilled through the pilot holes in the sleeves and then reamed to suit the size of the ferrules or pins specified in the table. Insert ferrules or pins.

(4) Secure ferrules with screwed rods and lock by peening over rod ends trimmed  $1\frac{1}{2}$  threads proud of ferrules. Secure pins by peening ends to spread them to approx.  $7/32$  in. dia.

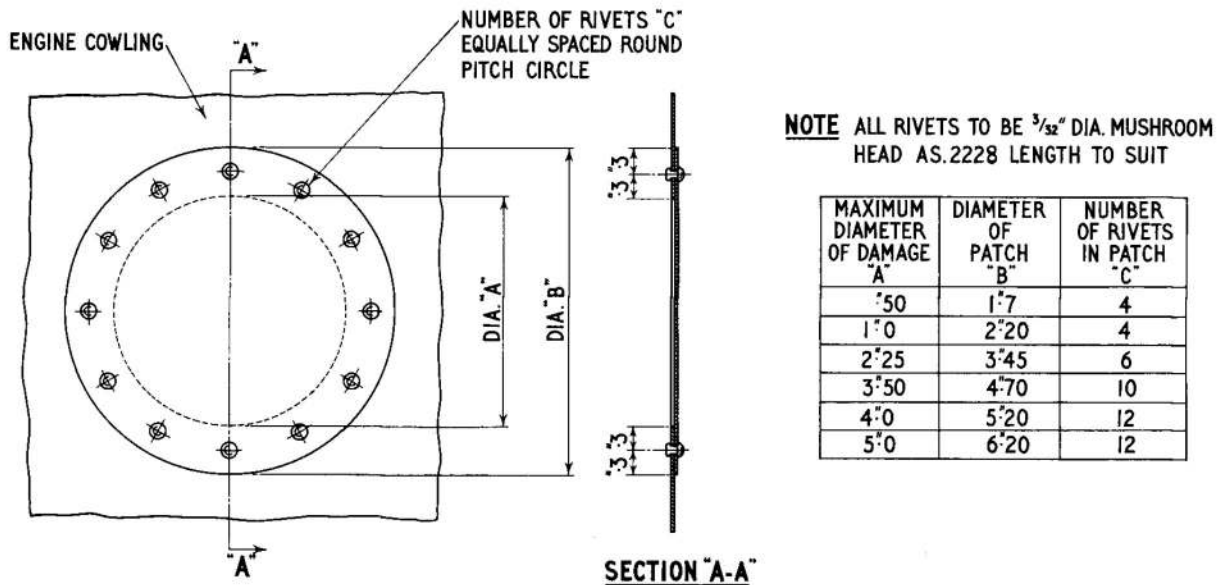
Fig.2/5. Repair to engine cowling

5. Dress out local buckles and cut damage out to a shape as near a circle as possible. Fit appropriate sized patch as shown above. It will be found that any damage exceeding 5.0 in. in diameter is more economically repaired by renewing the cowling.
