CHAPTER 7

TAIL UNIT

TAIL UNIT
(Completely revised)

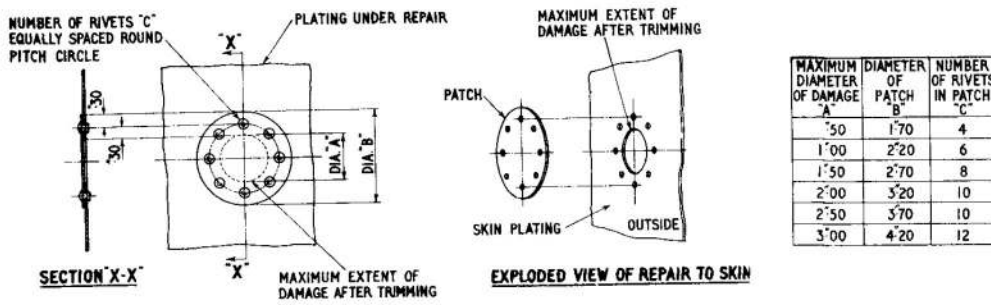
Fig. 7/9. Patch repairs

4. All patch material must be similar in gauge and specification to the material under repair. 3/32 in. dia. mushroom head solid rivets should be used where possible otherwise 1/8 in. dia. blind rivets (Chap. 1, para. 11) should be used.

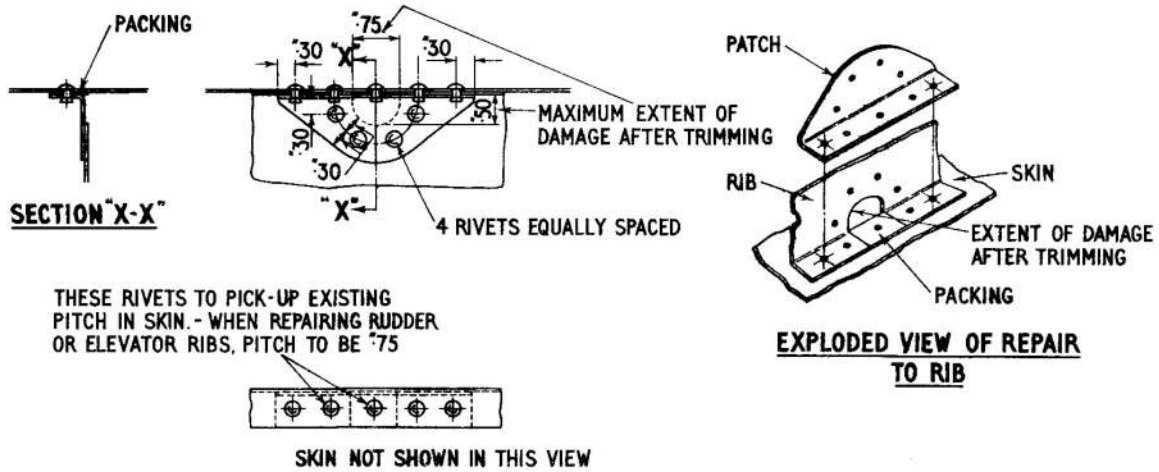
Fig. 7/11. Flange repair

6. Damage which may be repaired in accordance with fig. 7/11 includes penetration into the web to a depth of 0.5 in. Mushroom head rivets to AS.2228/303 should be used generally, picking up existing rivet holes, and 1/8 in. monel dome head pop rivets to A.G.S.2050 (Chap. 1, para. 11) in positions where solid riveting is not possible. Patch to be same gauge and specification as flange being repaired.

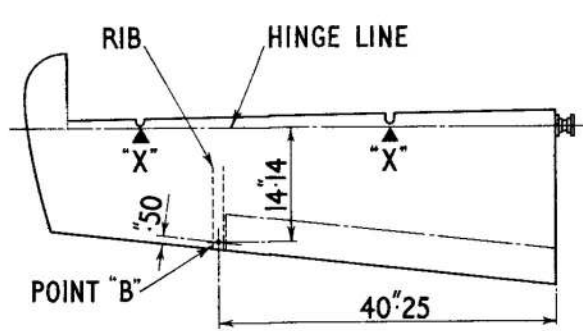
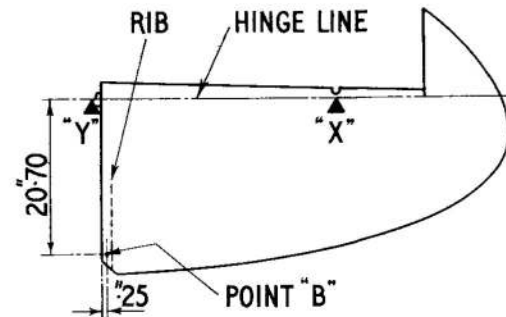
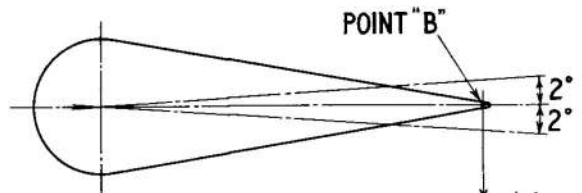
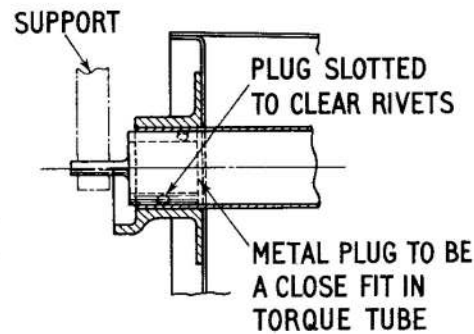
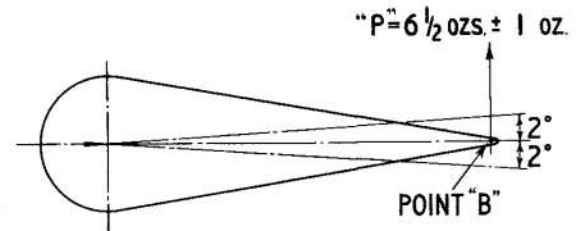
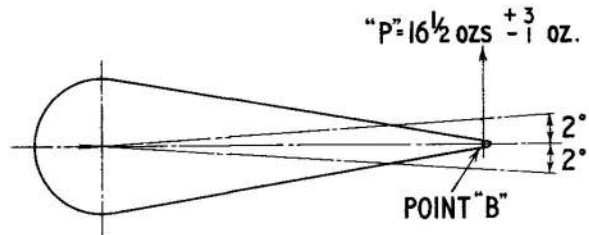
Fig. 7/13. Rebalancing of rudder and elevator

ELEVATOR

TYPICAL METHOD OF SUPPORTING AEROFOILS AT POINTS "X"

RUDDER

PORT ELEVATOR

"P" = $6\frac{1}{2}$ ozs \pm 1 oz.

TYPICAL METHOD OF SUPPORTING RUDDER AT POINT "Y"

STARBOARD ELEVATOR

"P" = $16\frac{1}{2}$ ozs \pm 3 oz.

ALL REPAIRS TO THESE COMPONENTS NECESSITATE REBALANCING CHECKS

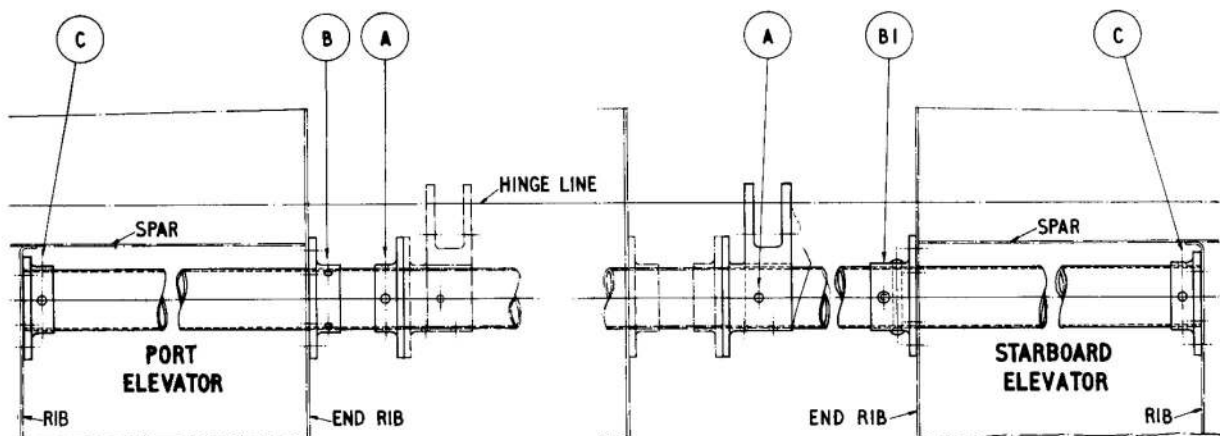
Fig.7/15. Elevator torque tube repairs

Check for loose rivets and pins :

(1) Through lever and torque tube and through flange fitting and torque tube, locations A.

(2) Through flange fitting and torque tube, location B. Through flange fitting and torque tube, location B1. Through flanges of fittings and ribs.

(3) (Only if loose rivets are evident at check 2 - obtain access by cutting fabric open). Through flange fitting and torque tube, location C, also through flange of fitting and rib.

Repair where loose rivets are suspected : locations A, B and C.

Remove loose rivets, open out holes with 7/32 in. diameter drill (fitting to tube) or No.21 drill (fitting flange to rib) and fit snap head rivets AS.2227/707 or AS.2227/506 respectively.

To rivet fitting to tube at location C it is necessary to detach fittings from both ribs and move tube assembly clear of rib. Re-attach fittings to rib as above. Finally repair fabric.

Repair where loose pins are suspected : location B1.

Remove pins, ream out holes $\frac{1}{4}$ in. diameter for light drive fit. Insert pins and spread ends to 0.3 in. diameter approximately.
