Chapter 31

SWITCH, MAGNETIC, TYPE 14A, No. 3, (ROTAX D 9241/1)

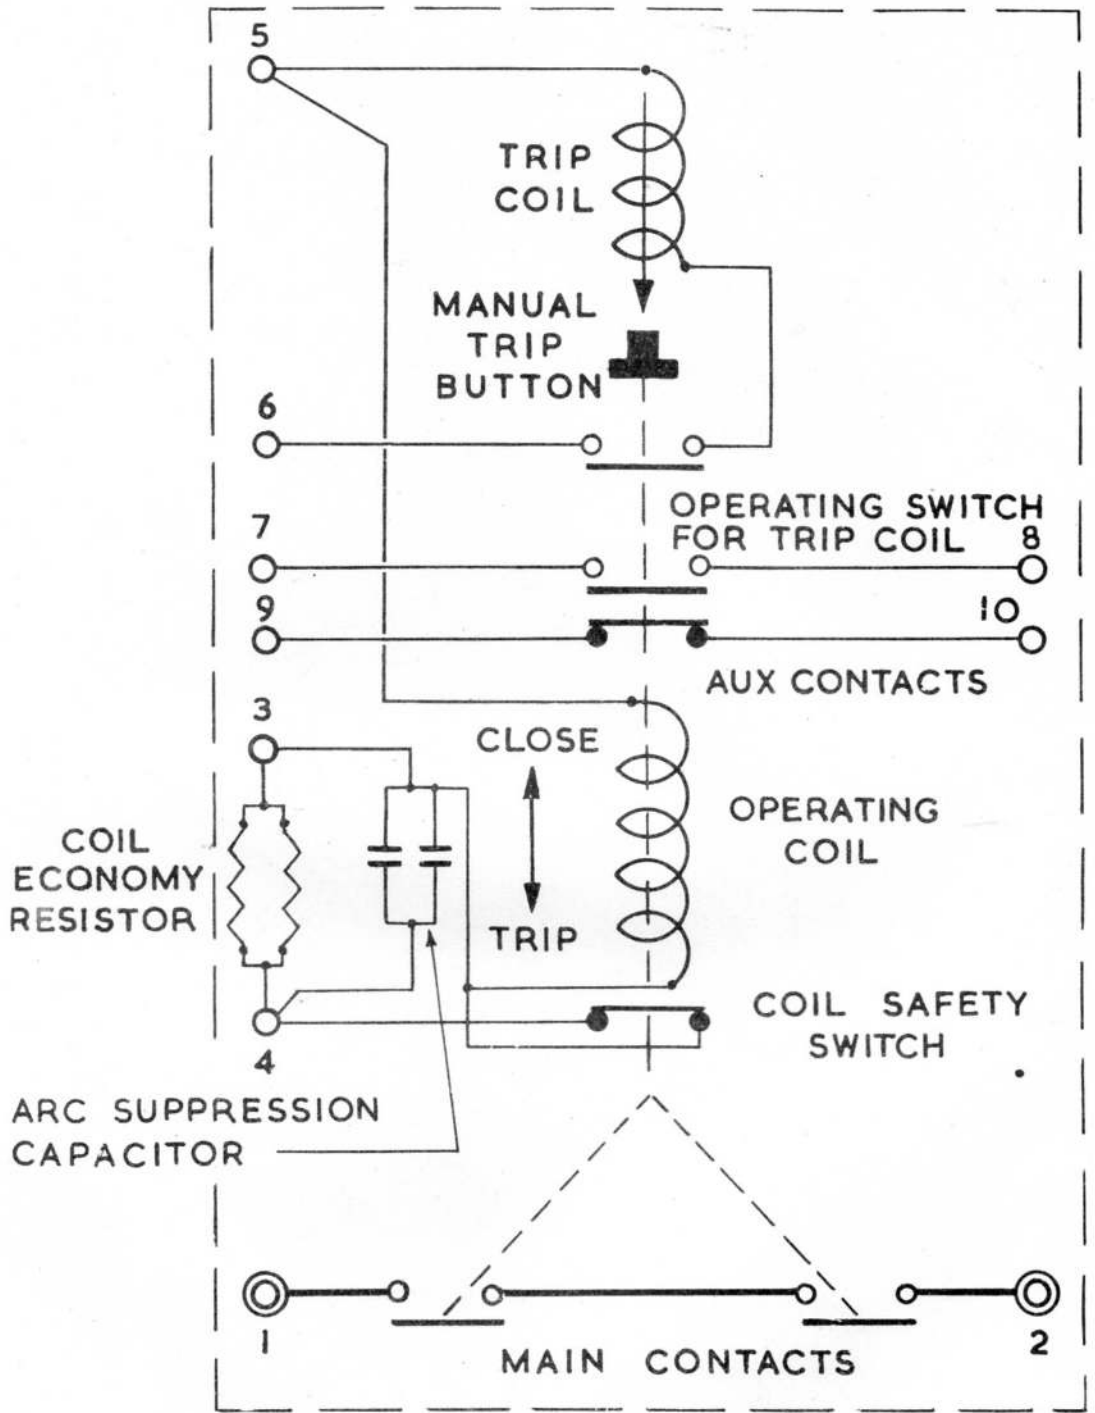
Fig. 2. Diagram of internal connections

6. Using a 250 volt insulation resistance tester, the insulation resistance must be at least 2 megohms between the following points:—

- (1) Terminal 1 and terminal 2 with contacts in the normal position (*fig. 2*).
- (2) Terminal 1 and terminals 5, 7, 9 and 10 with the contacts in the operated position.
- (3) Terminal 1 and the frame with the contacts in the operated position.

(4) Terminal 5 and the frame of the unit with the contacts in the operated position.

(5) Terminal 9 and terminal 10 with contacts in the operated position.

(6) Terminal 5 and terminals 6, 7, 8 and 9 with the contact in the normal position (*fig. 2*).

(7) Terminal 6 and terminals 7, 8 and 9 with the contacts in the normal position (*fig. 2*).

(8) Terminal 7 and terminal 8 and 9 with the contacts in the normal position (*fig. 2*).

(9) Terminal 8 and terminal 9 with the contacts in the normal position (*fig. 2*).

(10) The frame of the unit and terminal 5 with the contacts in the normal position (*fig. 2*).
