Chapter 14

COCKPIT WARNING LAMP, ROTAX, TYPE H4401

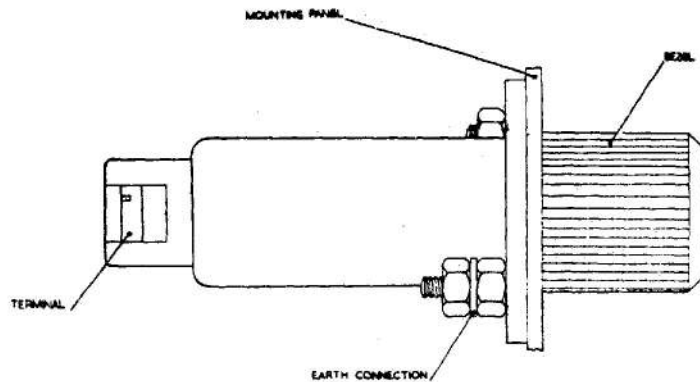
Fig. 1. Type H4401 warning lamp

2. The lamp is housed by a cylindrical brass body having a moulded insert at one end. A single terminal (6 B.A.) for connection to positive is set axially in the moulded insert and is protected by a shroud integral with the insert. The terminal stud projects through to the interior of the lamp, and the inner end is hollow where it receives a plunger loaded by a helical spring. The bulb holder, which is retained in the body by the insert, is of a miniature "bayonet" type and the bulb (Interservice Ref. 5LX.951271) has a single end contact which makes with the plunger. Connection to "earth" is made via the frame of the lamp. Full illumination of the bulb is obtained when a 28V d.c. signal is applied to the 6 B.A. terminal.

3. A mounting flange, having two mounting holes, is threaded to the body. One of the screws which secure the unit to the mounting panel is used for bonding the lamp to aircraft "earth." The colourless window is mounted in a bezel which screws onto the open end of the body.
