A.P.4335, Vol. 6, Part 1

CHAPTER 5

ALIGHTING GEAR

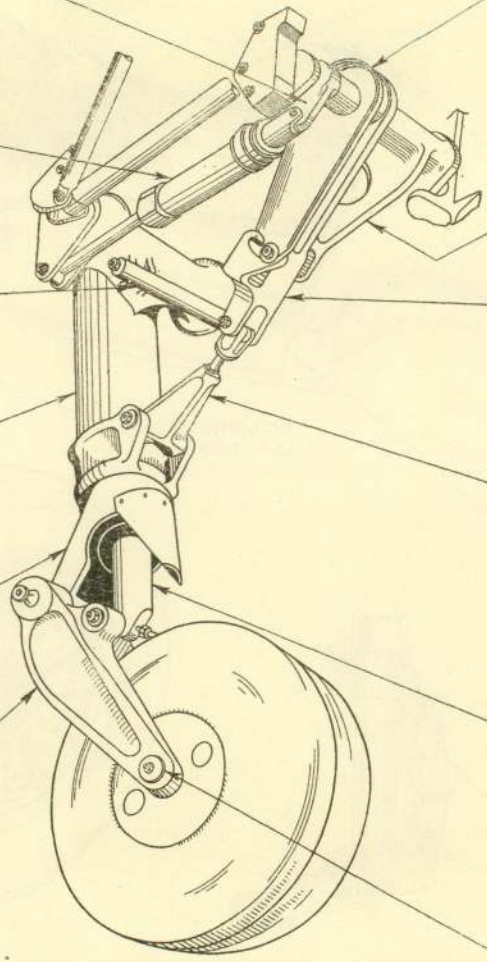
Fig. 5/2. Nose undercarriage, Mk.1 and 4

JACK PICK-UP

LOCK PLATE

JACK

RADIUS ROD FORK

SUPPORT LINK

LOCK LINK

NOSEWHEEL BARREL

RADIUS ROD LINK

SWITCH LUG

SHOCK ABSORBER UNIT

NOSEWHEEL FORK

AXLE TUBE

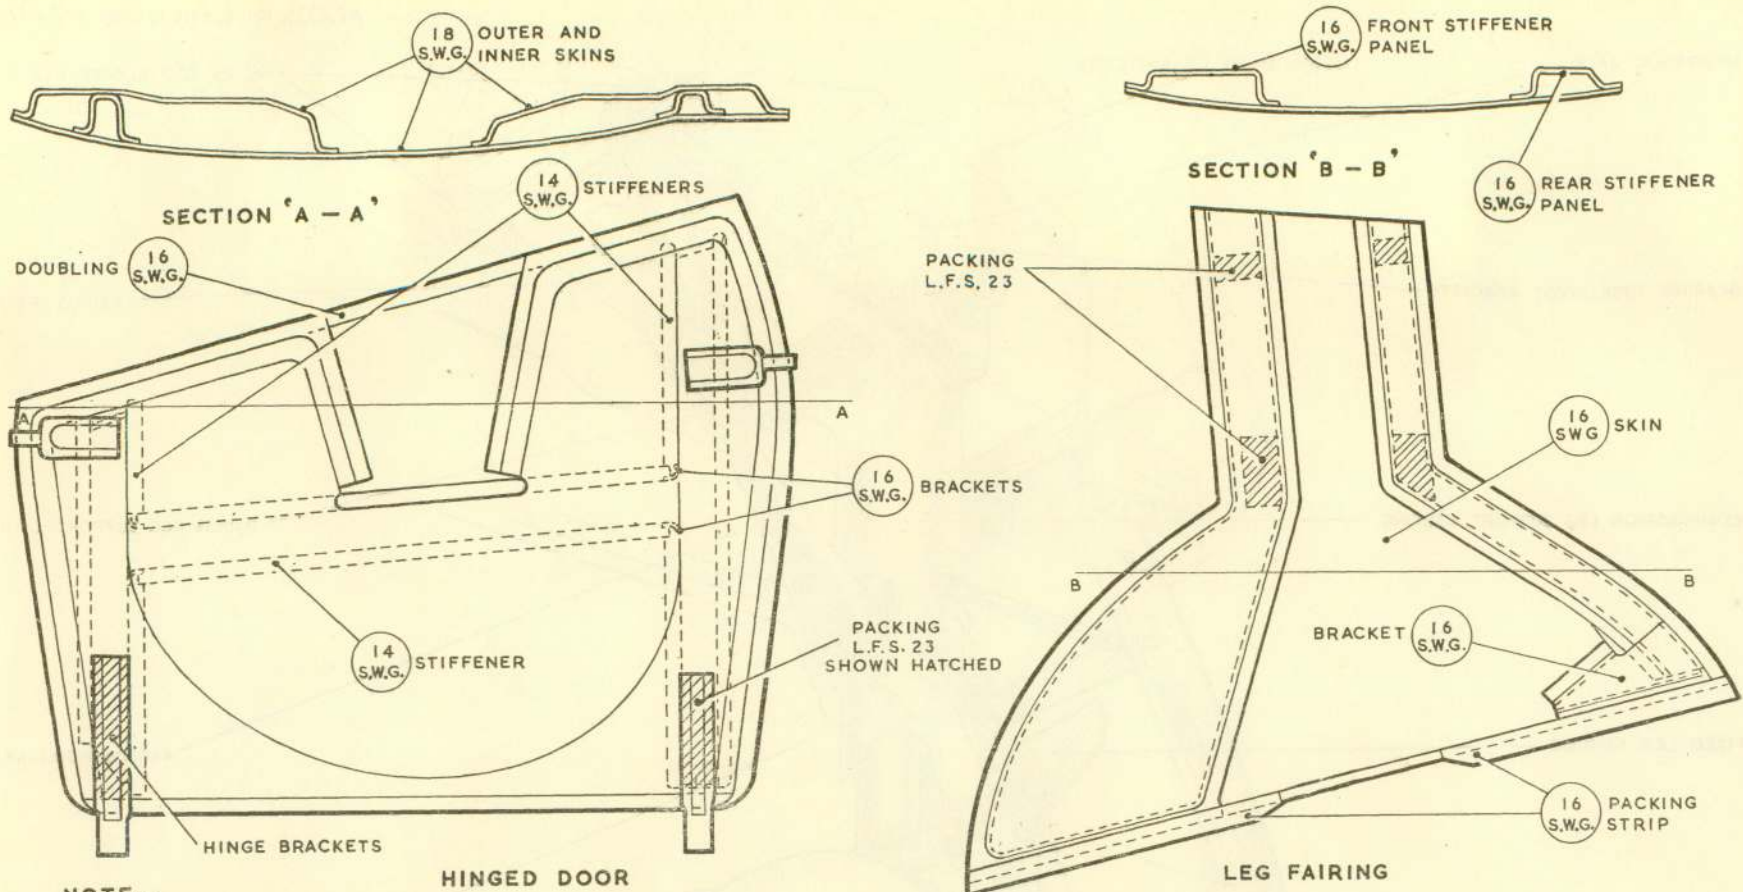
Fig. 5/4. Main-undercarriage doors, all Marks

Definitions of negligible and repairable damage

Item	Negligible damage—dents (inches)			Repairable damage (inches)	Repair fig.
	Max. depth	Min. dia.	Min. spacing		
SKINS	0.05	1.0	12.0	{ 0.5 and 1.0 dia., 12.0 spacing 2.0 dia., 18.0 spacing Repair at edges, one per side }	5/5
STIFFENERS	0.05	0.75	12.0	{ Flanges—Up to 3.0 long and 0.45 wide, one per flange }	5/5. Repair as for edges, using reinforcing angle only

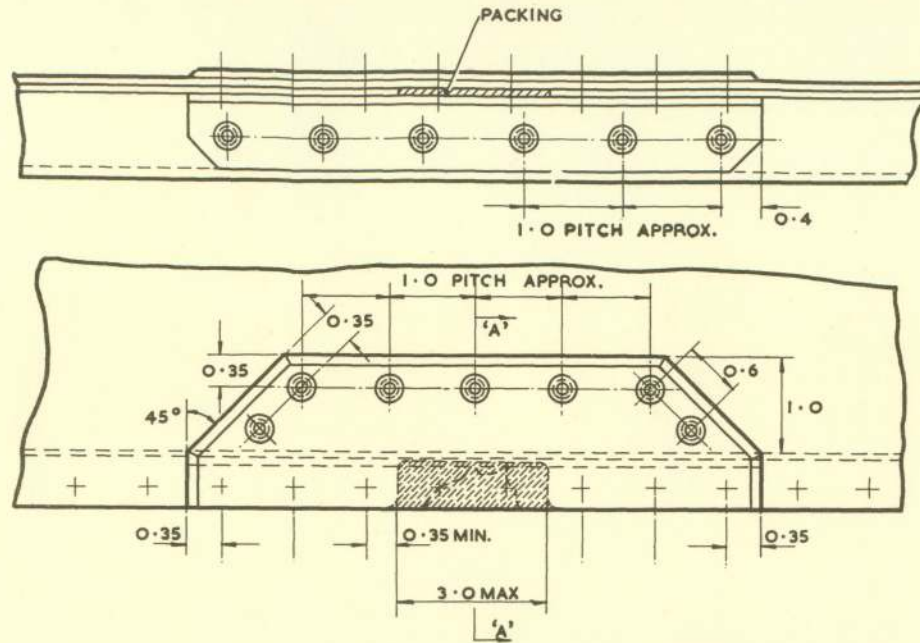
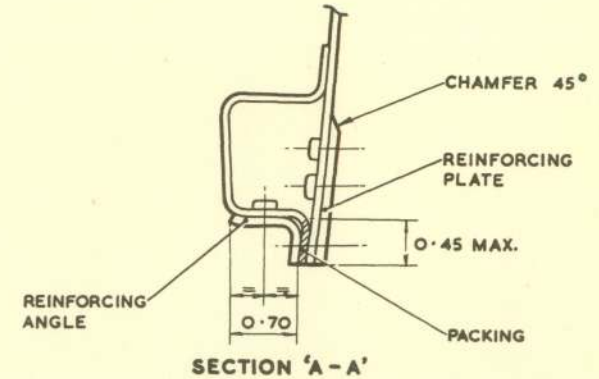
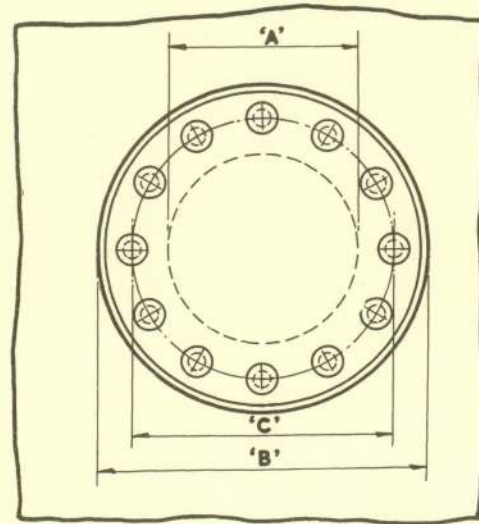
Fig. 5/5. Repairs to undercarriage doors

TYPICAL REPAIR AT EDGES

REINFORCING PLATE AND ANGLE TO BE OF SAME THICKNESS AND MATERIAL AS THE DAMAGED PART. RIVETS IN THE FLANGE MARKED THUS + UTILIZE EXISTING RIVET HOLES; AT LEAST THREE RIVETS MUST BE USED EITHER SIDE OF THE CUT-OUT. USE 5/32 DIA. RIVETS TO AS.2229 IN THE FLANGE AND 5/32 DIA. STEEL PINNED CHOBERT RIVETS IN INACCESSIBLE AREAS.

DIA. OF DAMAGE 'A'	DIA. OF PATCH 'B'	P.C.DIA. 'C'	Nº OF RIVETS IN PATCH
0.5	1.9	1.2	6
1.0	2.4	1.7	8
2.0	3.4	2.7	12

PATCHES TO BE OF SAME THICKNESS AND MATERIAL AS THE DAMAGED PART. EDGES TO CHAMFERED 45° WHEN APPLIED TO OUTER SURFACES. USE 5/32 DIA. 120° C'SK. HEAD RIVETS TO A.S.2230 WHERE ACCESSIBLE OR 5/32 DIA. STEEL PINNED CHOBERT RIVETS WHERE INACCESSIBLE EQUALLY SPACED AROUND THE P.C. DIA.

REPAIR TO SKINS
