A.P.4335, Vol. 6, Part 1

CHAPTER 6

ENGINE BAY

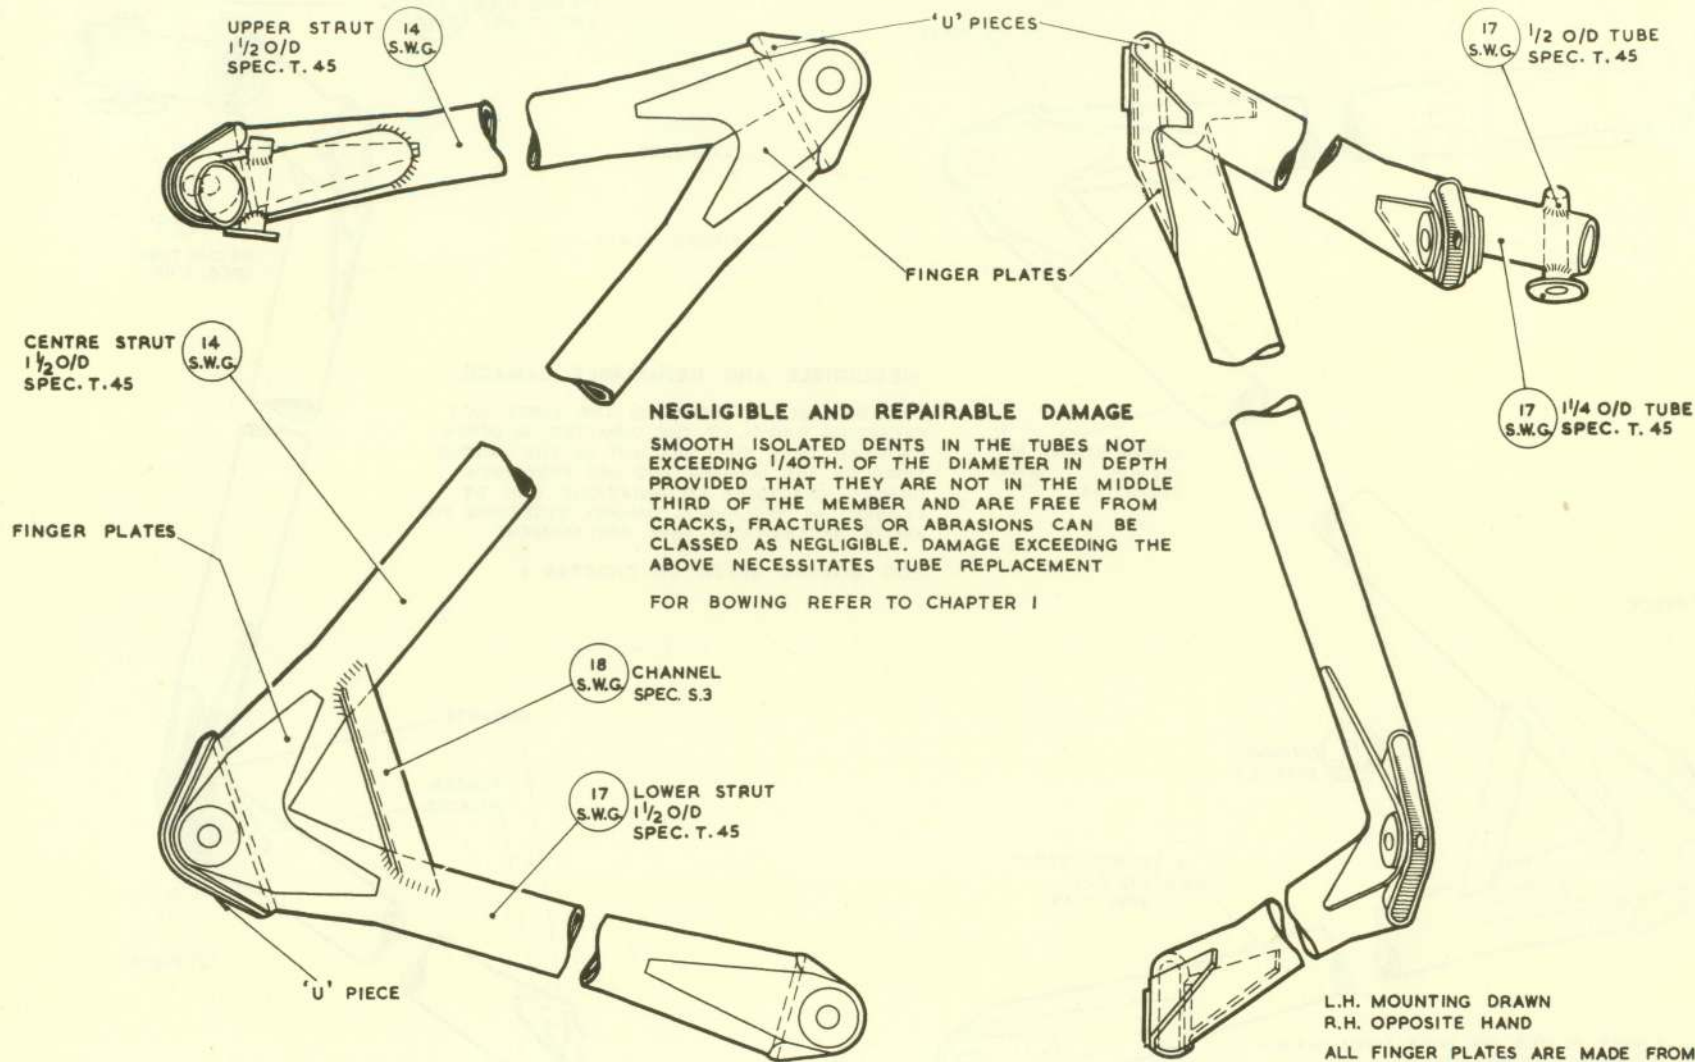
Fig. 6/1. Engine mounting, Mk.1,2 and 4

NEGLIGIBLE AND REPAIRABLE DAMAGE

SMOOTH ISOLATED DENTS IN THE TUBES NOT EXCEEDING 1/40TH. OF THE DIAMETER IN DEPTH PROVIDED THAT THEY ARE NOT IN THE MIDDLE THIRD OF THE MEMBER AND ARE FREE FROM CRACKS, FRACTURES OR ABRASIONS CAN BE CLASSED AS NEGLIGIBLE. DAMAGE EXCEEDING THE ABOVE NECESSITATES TUBE REPLACEMENT

FOR BOWING REFER TO CHAPTER I

LEFT HAND MOUNTING ILLUSTRATED

L.H. MOUNTING DRAWN
 R.H. OPPOSITE HAND
 ALL FINGER PLATES ARE MADE FROM 12 S.W.G. SPEC. D.T.D. 124A (ANNEALED)
 ALL 'U' PIECES ARE MADE FROM 10 S.W.G. SPEC. D.T.D. 124A (ANNEALED)
 ALL DIMENSIONS ARE IN INCHES

1. The engine mounting, situated at the rear of the fuselage, consists of two welded tubular steel Z-frames. The frames are attached to eye-bolts located in the two cross-tubes. Two eye-bolts, one at the centre of each cross-tube, provide additional direct engine pick-up points. For power plant repairs, refer to A.P.4320, Vol. 6.

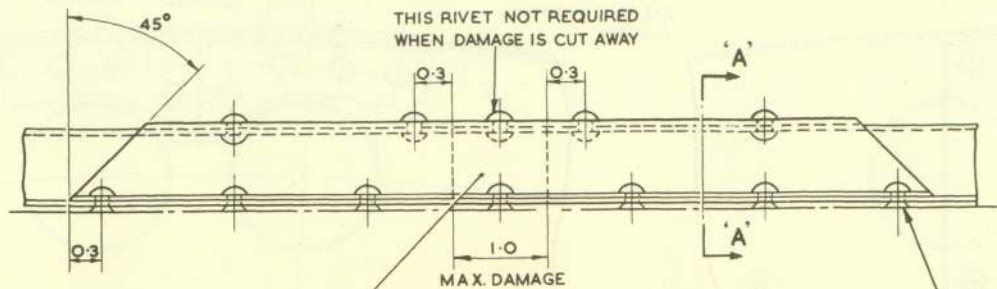
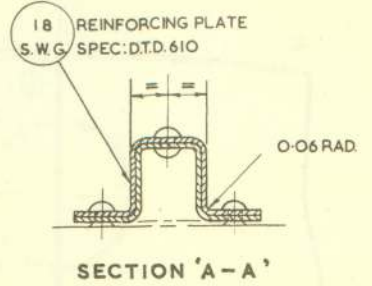
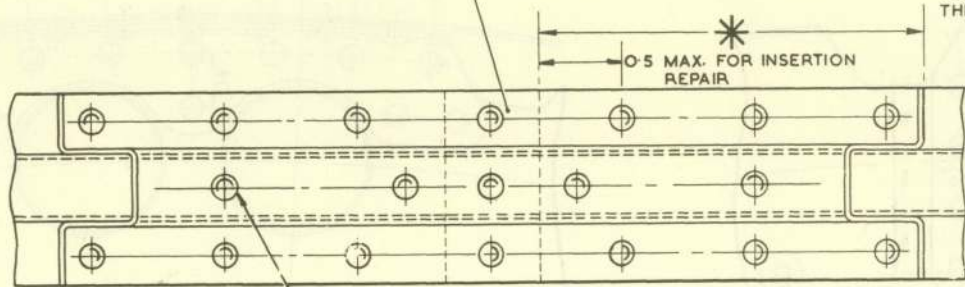
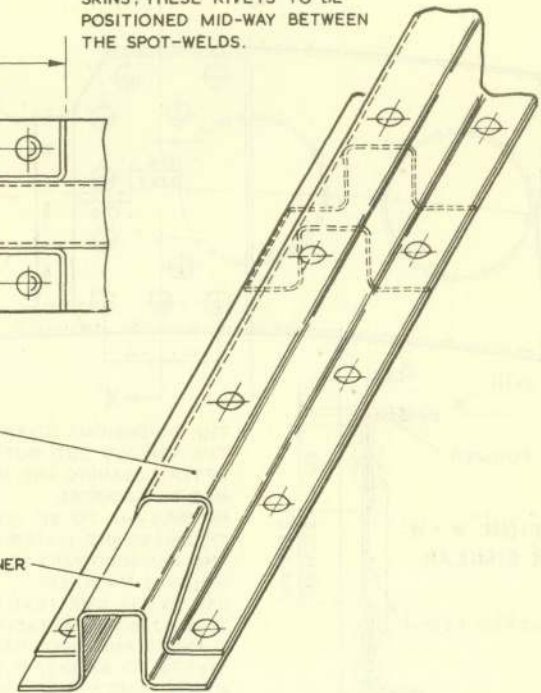
Fig.6/9. Stiffener repair, engine cowling

THIS RIVET NOT REQUIRED WHEN DAMAGE IS CUT AWAY

DAMAGED PORTION OF STIFFENER TO BE DRESSED OUT OR CUT AWAY AS REQUIRED. IF CUT AWAY PACKING MUST BE INSERTED UNDER FLANGES.

5/32 DIA. C'SK HEAD RIVETS A.S.2229 TO PICK UP EXISTING HOLES NOT LESS THAN THREE RIVETS EACH SIDE OF THE DAMAGE WHERE STIFFENERS ARE SPOT-WELDED TO SKINS, THESE RIVETS TO BE POSITIONED MID-WAY BETWEEN THE SPOT-WELDS.

SNAP HEAD SOLID RIVETS A.S.2227 OR STEEL CHOBERT RIVETS A.G.S.2040 5/32 DIA. WHERE STIFFENER IS 18 SWG. OR GREATER AND 1/8 DIA. WHERE 20 SWG. OR LESS.

REINFORCING PLATE BENT TO FIT OVER STIFFENER

EXISTING STIFFENER

INSERTION REPAIR

A NEW LENGTH OF STIFFENER MAY BE INSERTED BY BUTT-JOINING IT TO THE EXISTING PORTION WITH A STRAP SIMILAR TO THE PATCH ABOVE; EACH HALF BEING AS SHOWN THUS * ABOUT THE BUTT-JOINT. SHOULD ADJACENT STIFFENERS BE SIMILARLY DAMAGED, THE BUTT-JOINTS SHOULD BE STAGGERED.
