Chapter 23

CABIN ROOF LAMP, G.E.C., TYPE F.M.1949

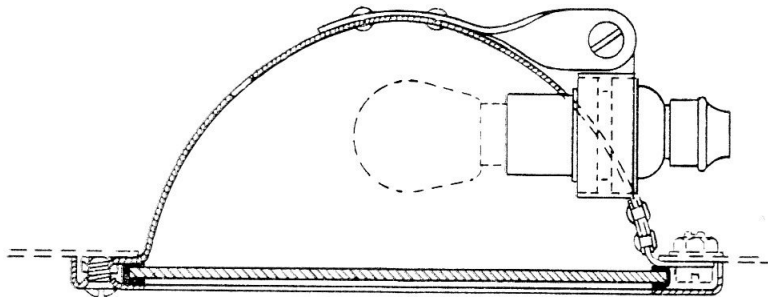
Fig. 1 Sectional view of roof lamp

1. The cabin roof lamp, G.E.C., FM1949 shown in fig. 1, is designed for flush mounting in the cabin roof to provide general illumina-

2. The lamp consists of a polished aluminium reflector which incorporates the mounting flange and accommodates the lamp filament, lamp holder, front glass and retaining ring. The mounting flange has three 2 B.A. clearance holes, to take suitable 2 B.A. screws by which the lamp is secured to the airframe structure, and carries three 2 B.A. tapped bushes to accommodate the retaining ring securing screws. Riveted to the reflector is the lampholder bracket. Provision for cooling is made by $\frac{3}{16}$ in. vent holes in the reflector.

3. Secured to the end of the bracket is the lampholder clamp, the small bayonet cap lampholder is held by the clamp in the aperture in the reflector. The lampholder is

constructed of nickel-plated brass and has a cord grip cable entry. The reflector is closed by a sandblasted front glass which is fitted with a channel section rubber sealing ring and is retained by the retaining ring.
