Chapter 44

FUSELAGE NAVIGATION LAMP, THORN, TYPE FNL/50

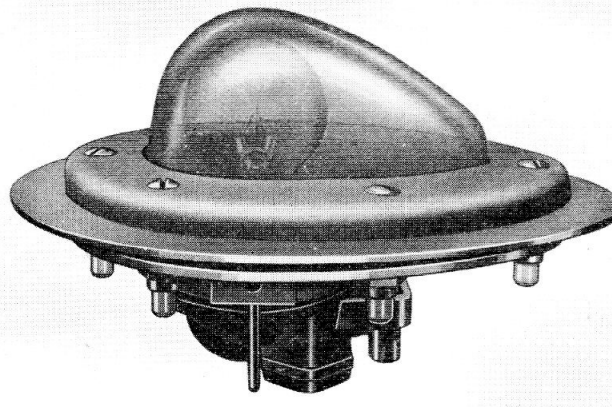
Fig. 1. *Fuselage navigation lamp, Type FNL/50*

2. A general external view of the lamp is shown in fig. 1 while a sectional view is shown in fig. 2. The lamp filament is housed within a clear glass dome which is held in place by an aluminium clamping ring and sealed against air leakage by a double gasket.

1. The fuselage navigation lamp, FNL/50, may be mounted on the top or underneath the fuselage of pressurised aircraft. It can be serviced in the normal manner from the outside when the aircraft is on the ground, or from within the fuselage during flight without risk to pressurisation.

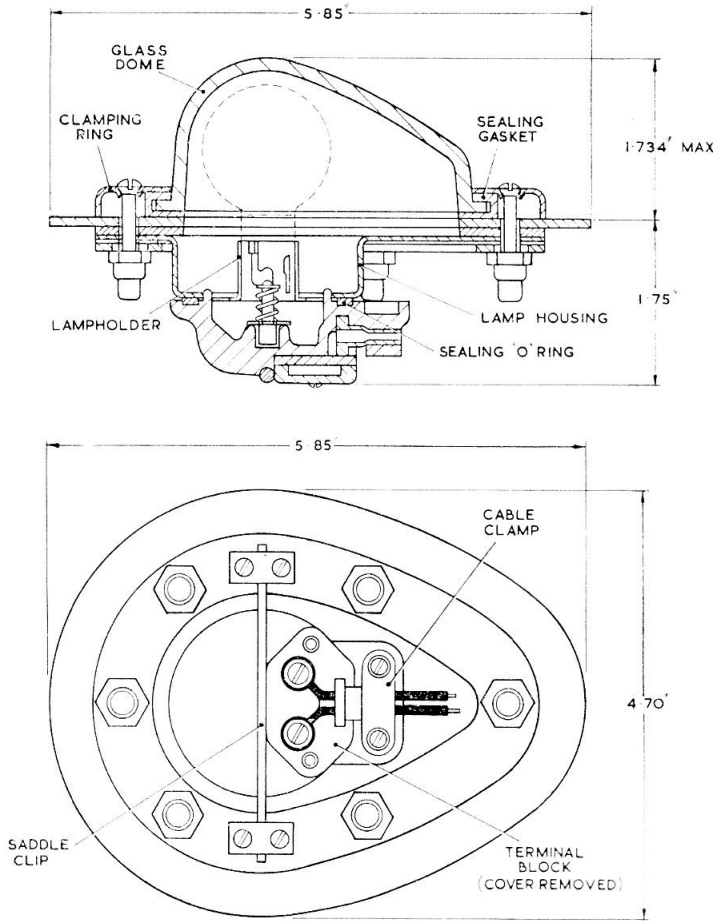
Fig. 2. Sectional view

3. The lampholder is carried on a moulded cap assembly which, when in position abuts a pressed metal housing, being retained in position by a spring saddle clip. The cable entry is made via a moulded rubber sealing grommet held between a moulded terminal cover and the cap assembly; a separate cable clamp is mounted on the cap independent of the terminal cover.

4. Sealing against loss of pressurisation is effected by a sealing gasket between the glass dome and the mounting slate and a rubber 'O' ring between the cap assembly and the lamp housing. The spring saddle clip provides the pressure for sealing in the case of the cap assembly while an alum-

inum alloy clamping ring and six 2 B.A. screws provide the sealing pressure for the glass dome.

5. The glass dome should be examined and cleaned, if necessary, both inside and out; it may be removed by releasing the six 2 B.A. screws retaining the clamping ring. If the filament lamp shows signs of undue blackening, it should be renewed to prevent failure during operational periods. The ends of cables should be examined for signs of damage and connections checked for security and freedom from corrosion.
