Chapter 44 FUSELAGE NAVIGATION LAMP, THORN, TYPE FNL/50

LEADING PARTICULARS

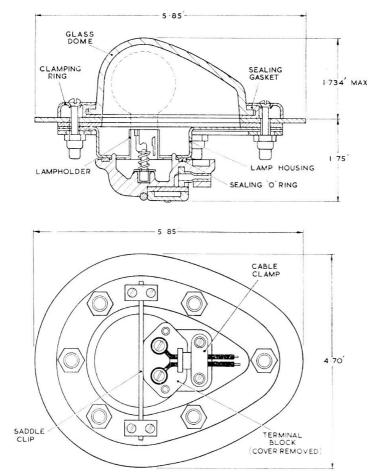
Fig. 2. Sectional view

- 3. The lampholder is carried on a moulded cap assembly which, when in position abuts a pressed metal housing, being retained in position by a spring saddle clip. The cable entry is made via a moulded rubber sealing grommet held between a moulded terminal cover and the cap assembly; a separate cable clamp is mounted on the cap independent of the terminal cover.
- 4. Sealing against loss of pressurisation is effected by a sealing gasket between the glass dome and the mounting slate and a rubber 'O' ring between the cap assembly and the lamp housing. The spring saddle clip provides the pressure for sealing in the case of the cap assembly while an alum-

inium alloy clamping ring and six 2 B.A. screws provide the sealing pressure for the glass dome.

2. A general external view of the lamp is shown in fig. 1 while a sectional view is shown in fig. 2. The lamp filament is housed within a clear glass dome which is held in place by an alluminium clamping ring and sealed against air leakage by a double gasket.
