## Group C CONTROL SURFACES

## AILERON TAB CONTROL (CA)

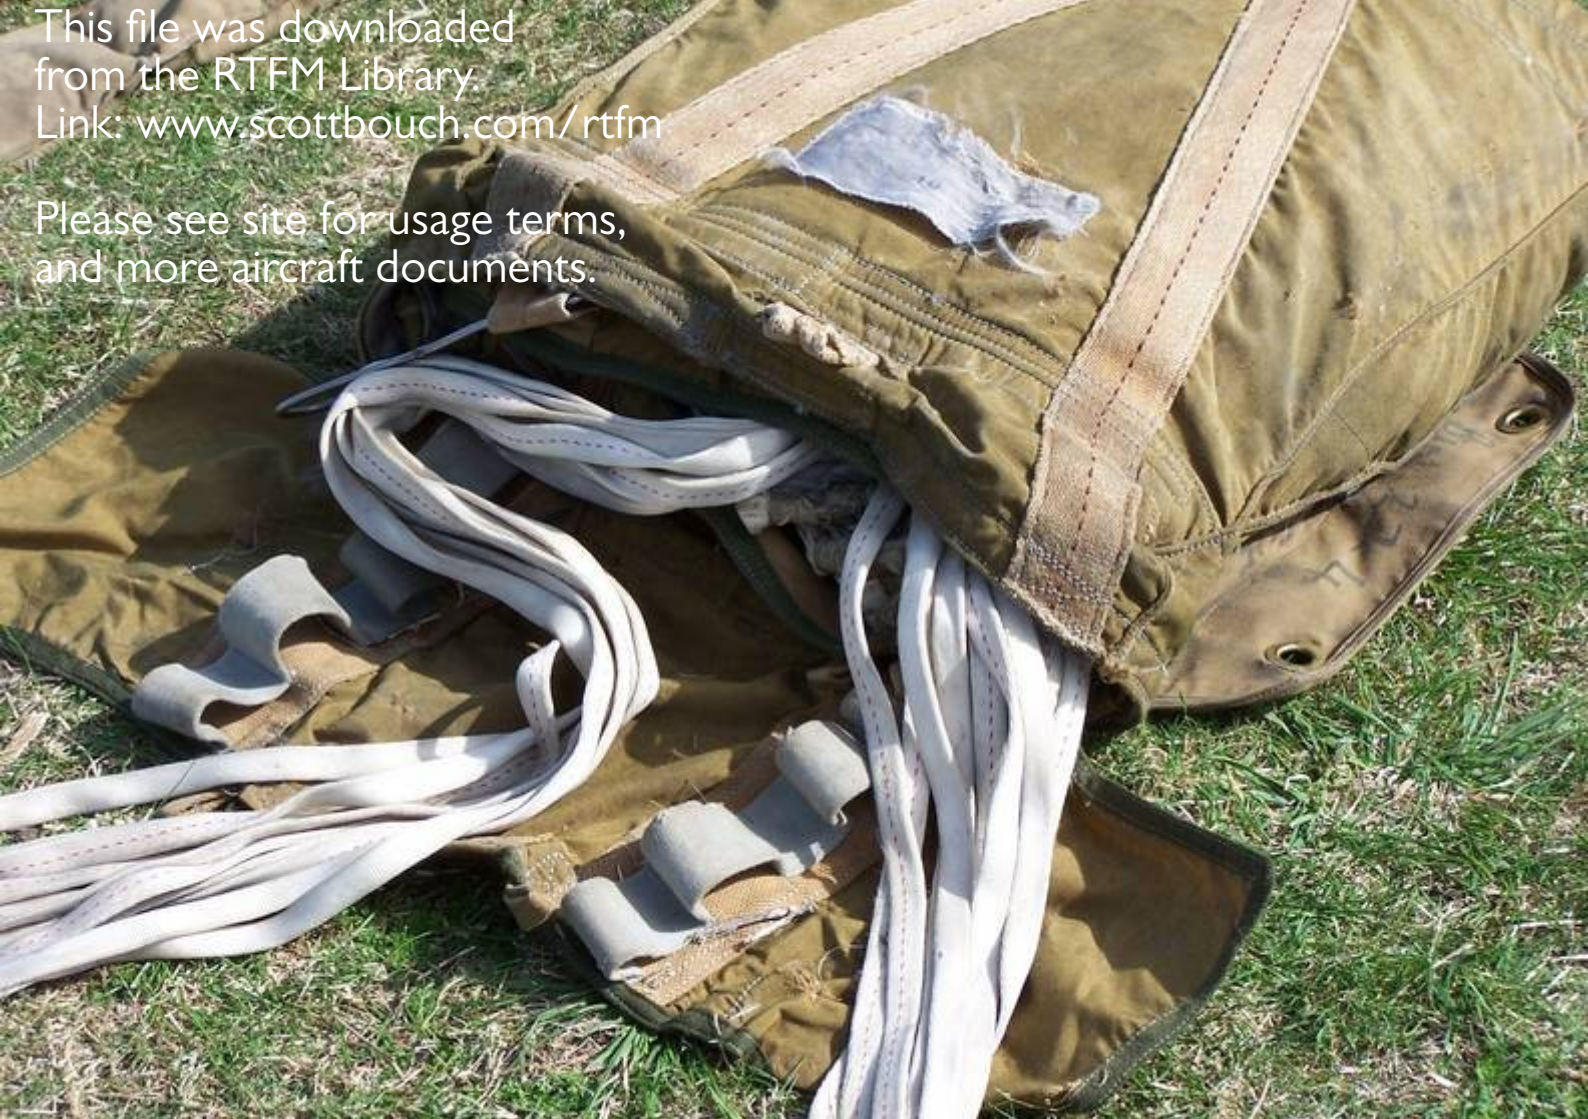
Fig.
Aileron tab control	1

2. Under normal flight conditions the ailerons are operated from the control column via the hydraulically-energized servodyne units, and both aileron balance tabs perform their normal function.

3. In the event of hydraulic pump failure, a pressure closes when the system pressure falls below, 1,400 lb. per sq. in. This action completes the circuit to light the aileron power failure blue warning lamp on panel G and places a supply through the circuit cut-out switch to the selector switch; both switches being located on panel AV on the port side of the cabin. The supply to the pressure switch is through a circuit breaker (AF) mounted on panel A. If the ailerons become difficult to operate at high speed, power-off conditions (the assistance previously derived from the servodyne units no longer being available),

the pilot can operate the two-way selector switch to energize the actuator for the port aileron balance tab. This will move the tab up or down as required, independently of aileron movement.

on a bracket in the port wing. Access is gained through a panel on the wing surface. To remove the bolts securing the actuator to its mounting it is necessary to remove the complete port aileron assembly. Small access panels on the upper and lower wing surfaces give access to the actuator arm linkage. The micro switch controlling the tab neutral position warning lamp is located adjacent to the actuator. The pressure switch in the hydraulic system is located in the front end of the gun bay and it is recommended that the removal of this component, and any others connected with flying controls, should be carried out in conjunction with an airframe specialist tradesman, as certain special checks are necessary after changing components on control surfaces or hydraulic systems.
