Chapter 3

MAIN PLANES

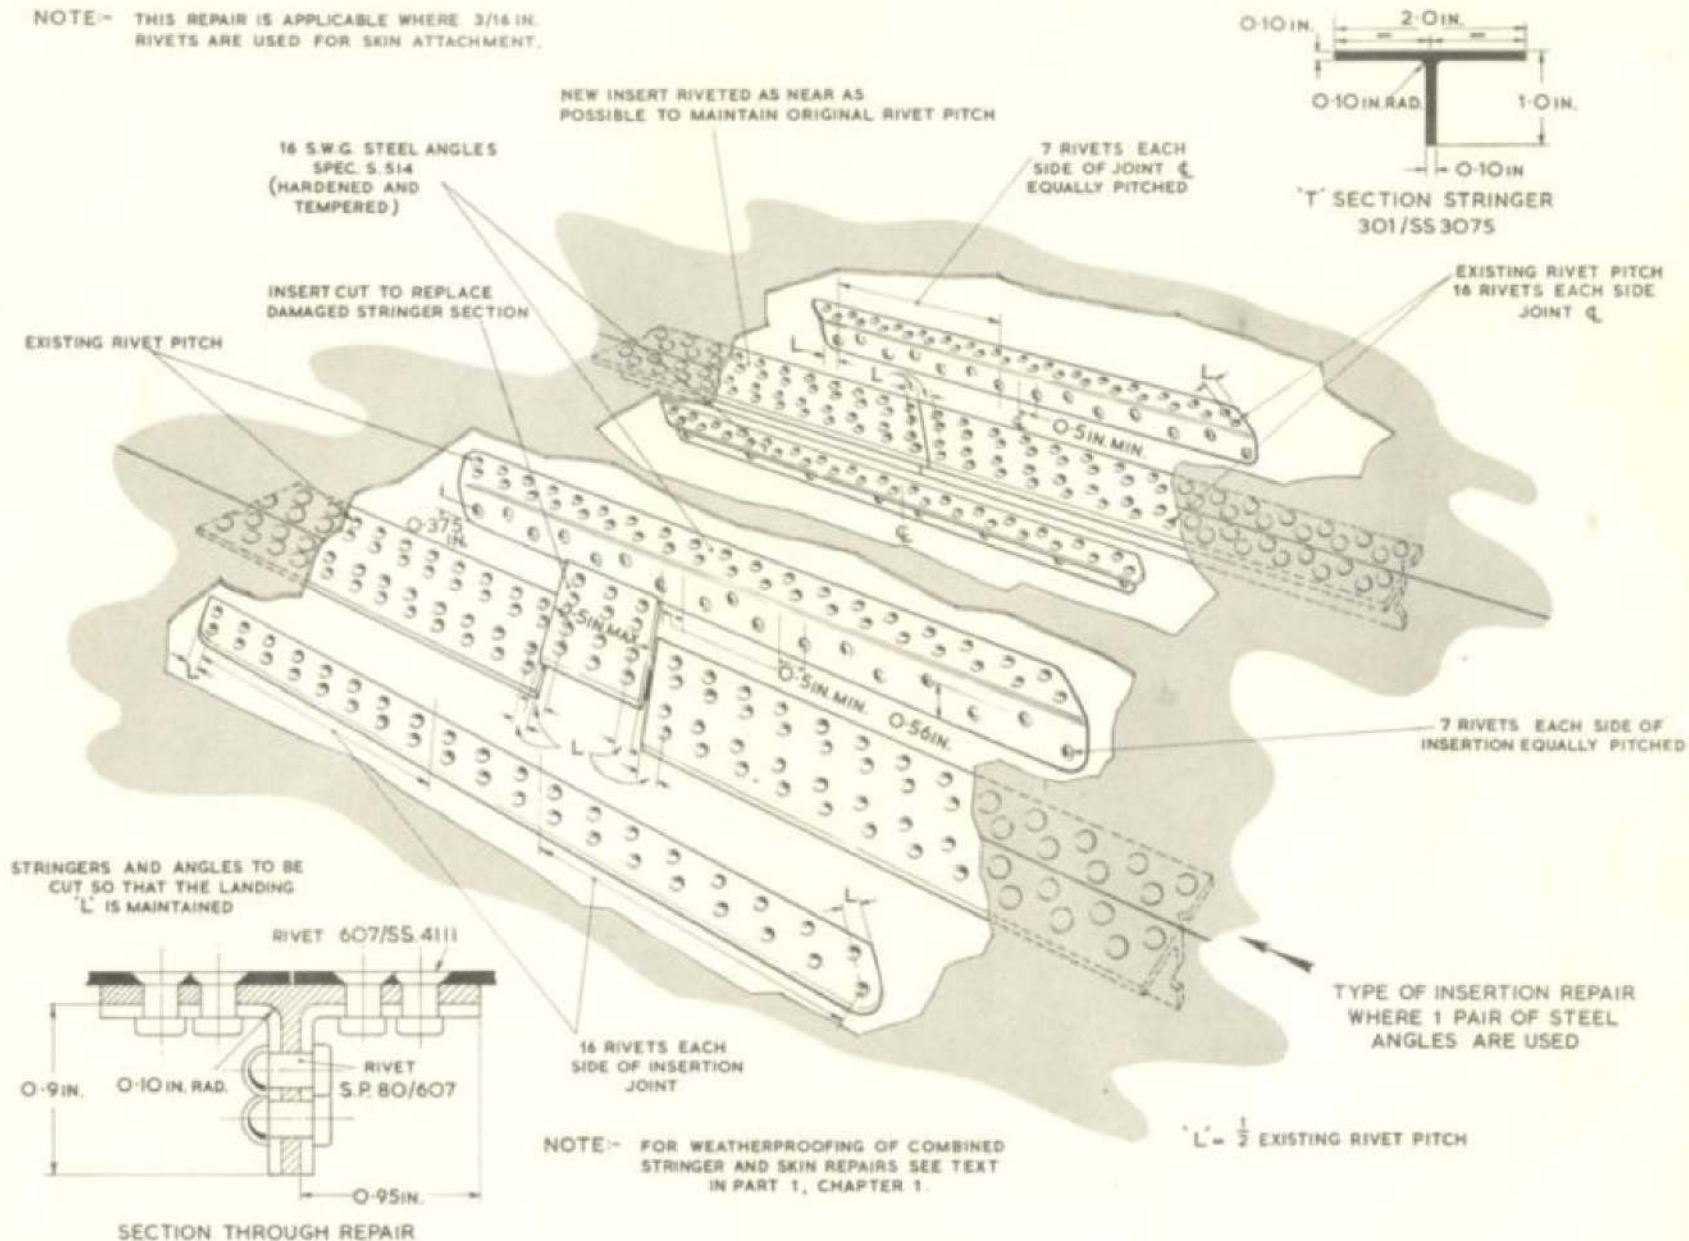
FIG. A 373A. 'T' Section stringers - insertion repairs (301/SS.3075)

NOTE:- THIS REPAIR IS APPLICABLE WHERE 3/16 IN. RIVETS ARE USED FOR SKIN ATTACHMENT.
