A.P.4326, Vol. 6, Part

ENGINE NACELLE

Chapter 6 ENGINE NACELLE - AVON MK.I

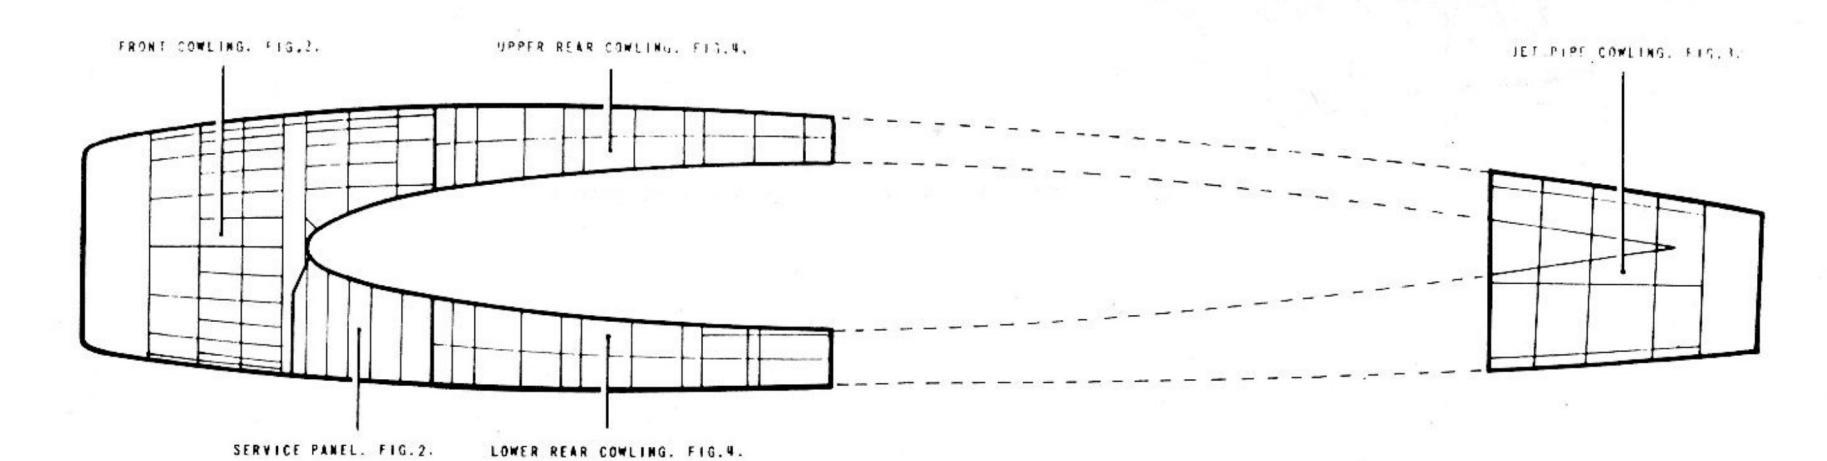
Fig.1 Key diagram

1. A method of pictorial indexing is employed in this chapter to locate and categorize damage and to illustrate repair schemes by step-to-step progression from the main component key diagram, through detailed structural illustrations and negligible damage charts, to repair schemes designed for particular structural items. Figure 1 - Keydiagram, illustrates the cowling assembly and gives the figure numbers of the individual cowling structure illustrations. The structure illustrations simplify the identification of structural items and, in the key, give details of these items together with negligible damage definitions and repair figure numbers.

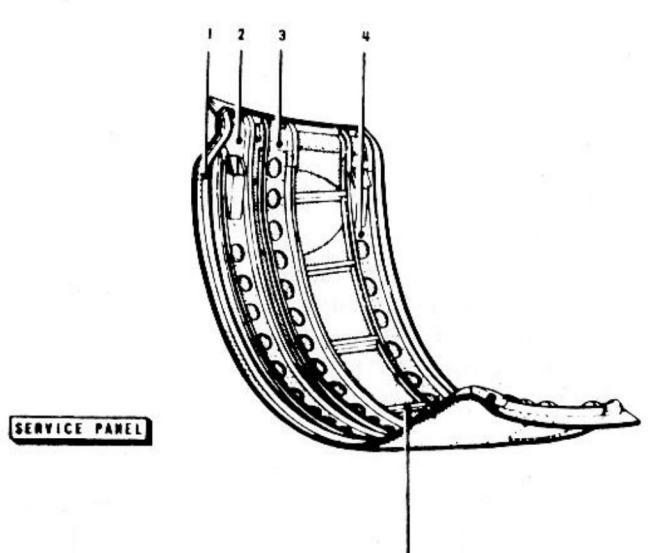
Fig. 2. Front cowling and service panel structure

'	Negligib	le damage				
	Mater	rial		·	D	ents	See	tchee	H	oles		
Item	Spec.	\$.W.G.	Part No.	Description	Max, depth	Min. dia.	Depth	Spacing	Max. dia.	Pitch ratio	ch io Repairable damage	Repair fig. No.
FRONT	COWLING											
1	DTD213	18	F A1 50 843	Airintaka	Eas day	alla of an	-listhin and				(To be added later)	1.00
21		(20	E A1.50 1565	Frame 1	0.05	1.00	a ons	1.00	damage	refer to fig.	. 5	/
3		22	E.A1.50.1231	Intermediate frame 1A	0.05	1.00	0.005	1.00	0.00	45.4		•
4		22	F A1 50 1233	Intermediate frame 1B	0.05	1.00	0.005	1.00	0.20	15:1		8
5		14	E.A1 50.257 (port)	Intermediate frame TD	0.03	1.00	0.003	1.00	0.20	15:1		8
			E A1 50 258 (starb.)									
÷		()	(F.F. 1 147)	Support boon frame 2	0.05	1.50	0.010	2.00	0 125	22.4		
6		14	F A1 50 1273	Capping strip	0.05	1.50	0.010	3.00	0 125	32:1		10
7		22	E A1 50 259 (port)	Capping scrip	0.03	1.30	0.010	3.00	0.172	32:1		10
			E A1 50 260 (starb)	Intermediate frame 74	0.05	1.00	0.005	1.00	0 00	45.4		0

KEY TO FIG. 2 (FRONT COWLING AND SERVICE PANEL STRUCTURE)

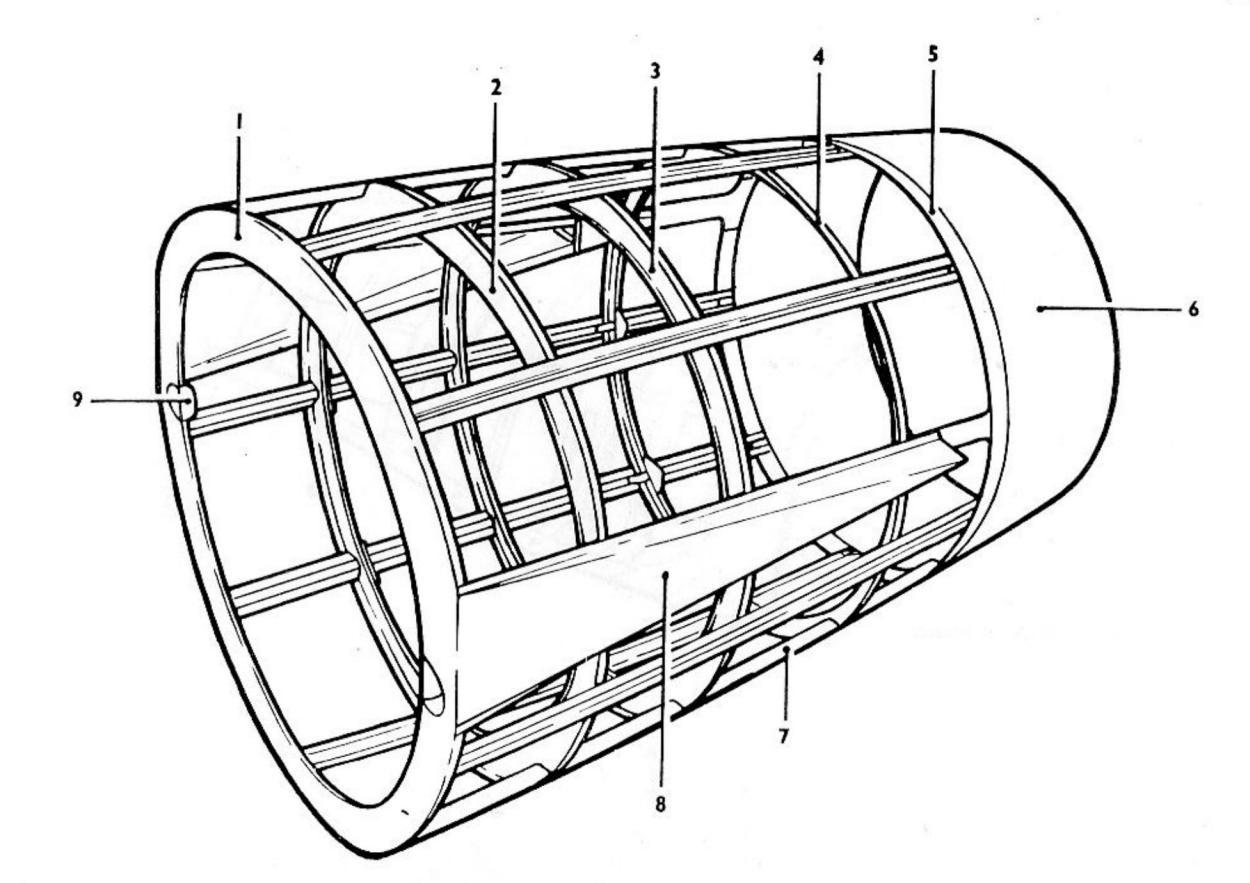
Fig 3. Jet pipe cowling structure

1)			(E.A1.20.10319	Frame 1	0.04	1.00	0.005	1.00	0.20	20.1	(To be added here)	
2			E.A1.20.10321	Frame 2	0.05	0.75	0.010	1.00	0.20	15:1	(To be added later)	16
3 }	D.T.D.610	20	E.A1.20.10323	Frame 3	0.02	0.75	0.010	1.00	0-20	15:1		16
31		18	E A1 20 10337	Frame 4 segment	0.05	0.75	0.010	1.00	0.20	15:1		1/51
6	DTD 171	24	E A1 20 8261	Cone	Eas day	1.00	0.005	1.00	0.125	32:1		
7	D.T.D.610	22	E.A1.20.10349	Colle	FOT Get	ans or neg	singiole and	repairable	damage i	eter to fig.	5	
			(E.E.J.142)	Stringer	0.10	1.00	0.010	1.00	0.125	16.1		
8	D.T.D.213	20	E.A1.20.10335	Side panel	For det	ails of nes	ligible and	renairable	damage :	eler to fir	5	
9	D.T.D.124	22	E.A1.20.1193	Reinforcing cowl	0.03	0.75	0.005	2.00	annage I		-

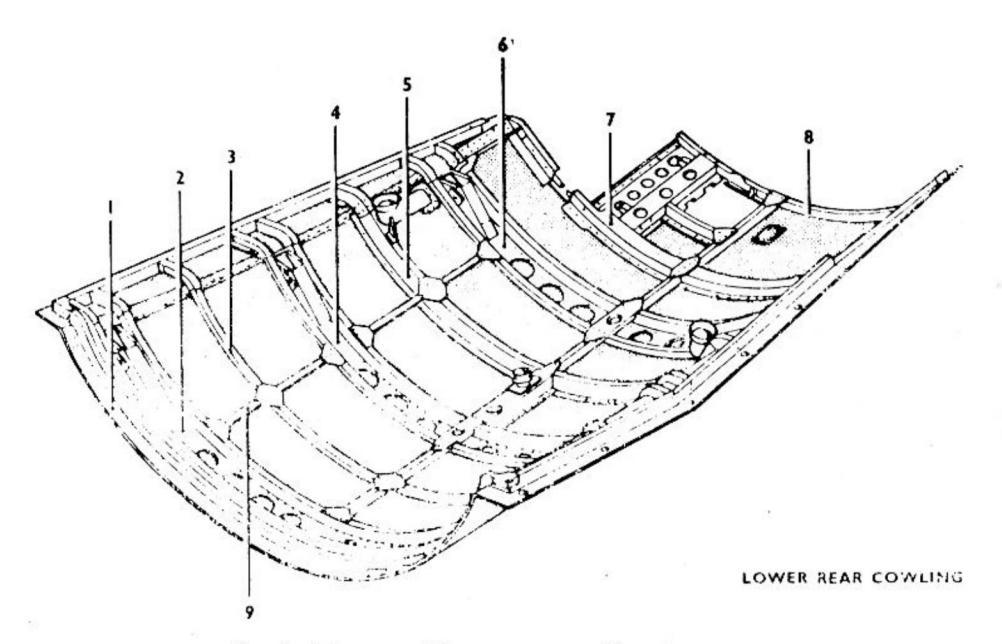
Fig. 4 Upper and lower rear cowling structure

Negligib	le damage				
2	Mater	ial				D	ents	- See		H	oles	a sea a sea a	
ltem	Spec.	S.W.G.	Part No.	Description		Max. depth	Min. dia.	Depth	Spacing	Max. dia.	Pitch ratio	Repairable damage	Repair fig. No.
UPPER	REAR COWLI	NG											
1]		(16	E.A1.50.1293									····	
2		22	(E.E.J.268) F A1 50 785 (port)	Front seating stiffener		0.04	1-00	0.010	1.00	0.125	32:1	(To be added later)	
3		22	E.A1.50.786 (starb.) E.A1.50.755 (port) E.A1.50.755 (port)	Frame 1		0.10	1.00	0.010	1.00	0.20	15:1		15
4		16	(E.E.J.71) E.A1.50.205 (port)	Frame 1A		0-10	1.00	0.005	1.00	0-125	16:1		14
5 }	D.T.D.610	22	(E.E.J.70) E.A1.50.211	Frame 2		0.10	1.00	0.010	1.00	0.20	15:1	· · · · ·	
6		16	(E.E.J.71) E A1 50 203	Frame 2A		0.10	1.00	0.005	1.00	Q-125	16:1		14
7		122	(E.E.J.70)	Frame 3		0-10	1.00	0.010	1.00	0.20	15:1		15
		122	(E.E.J.71)	Frame 3A		0-10	1.00	0.005	1.00	0.125	16.1		14
в		16		Frame 4	÷.	0.10	1.00	0.010	1.00	0.20	15.4		14

KEY TO FIG. 4 (UPPER AND LOWER REAR COWLING STRUCTURE)

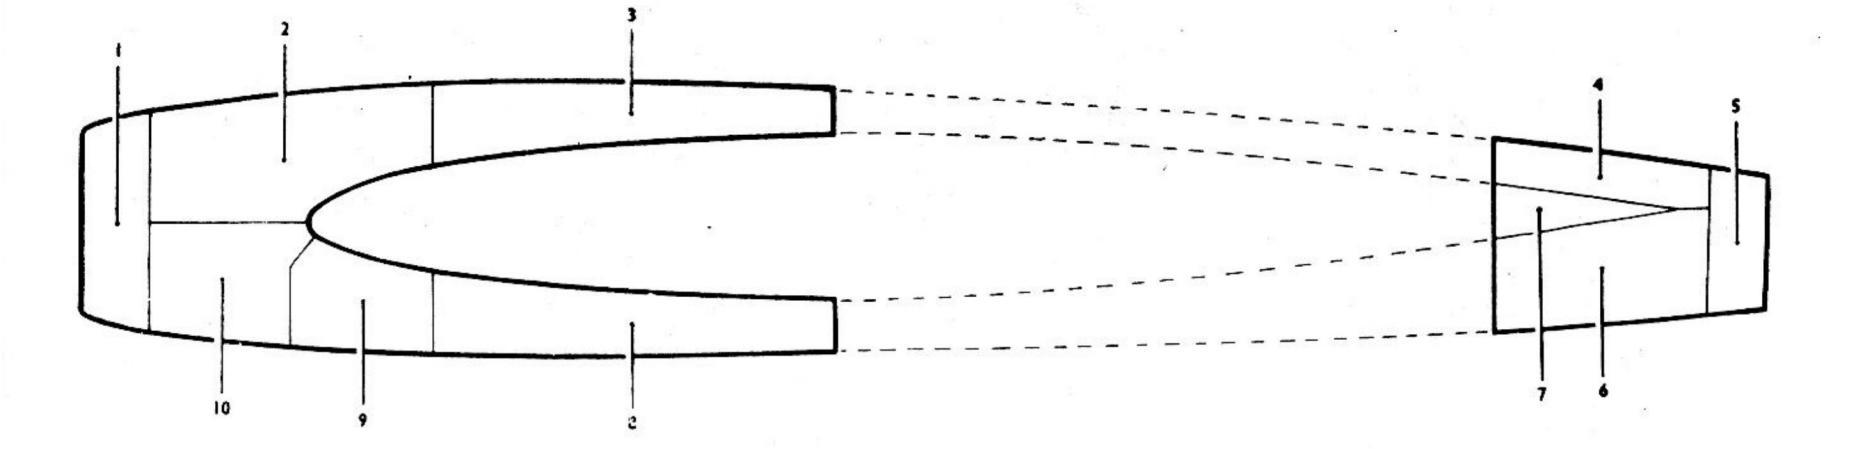
Fig. 5. Engine cowling skinning

1	legligible	damage				
	Marar	ial.			Scratches			Dents				
Item Spec.	Spec.	S.W.G.	Part No.	Description	Depth	Min. spacing	Max. depth	Max. width	Min. width	Min. spacing	Repairable damage	Repair fig. No.

12)	D.T.D.213	18	€.A1.50.843 (E.A1.50.1261 (port)	Air-intake skin	0·005	3	0.05	4	1.00	6W	Holes. Oil canning effect.	7
3	D.T.D.610	22	E.A1.50.1262 (starb) E.A1.50.425 (port) E.A1.50.426 (starb.)	Front cowling upper panel Upper rear cowling panel	0.003	2	0.03	4	0.50	4₩	Panting and damage in excess of negligible.	6

3. Cracking of the front inner cone of the jet pipe cowling (fig.5, item 5) may occur quite early in the life of the aircraft. This failure has no adverse effect, either structurally, or on performance. The cracks are to be repaired by stainless steel welding. Dents are to be left.

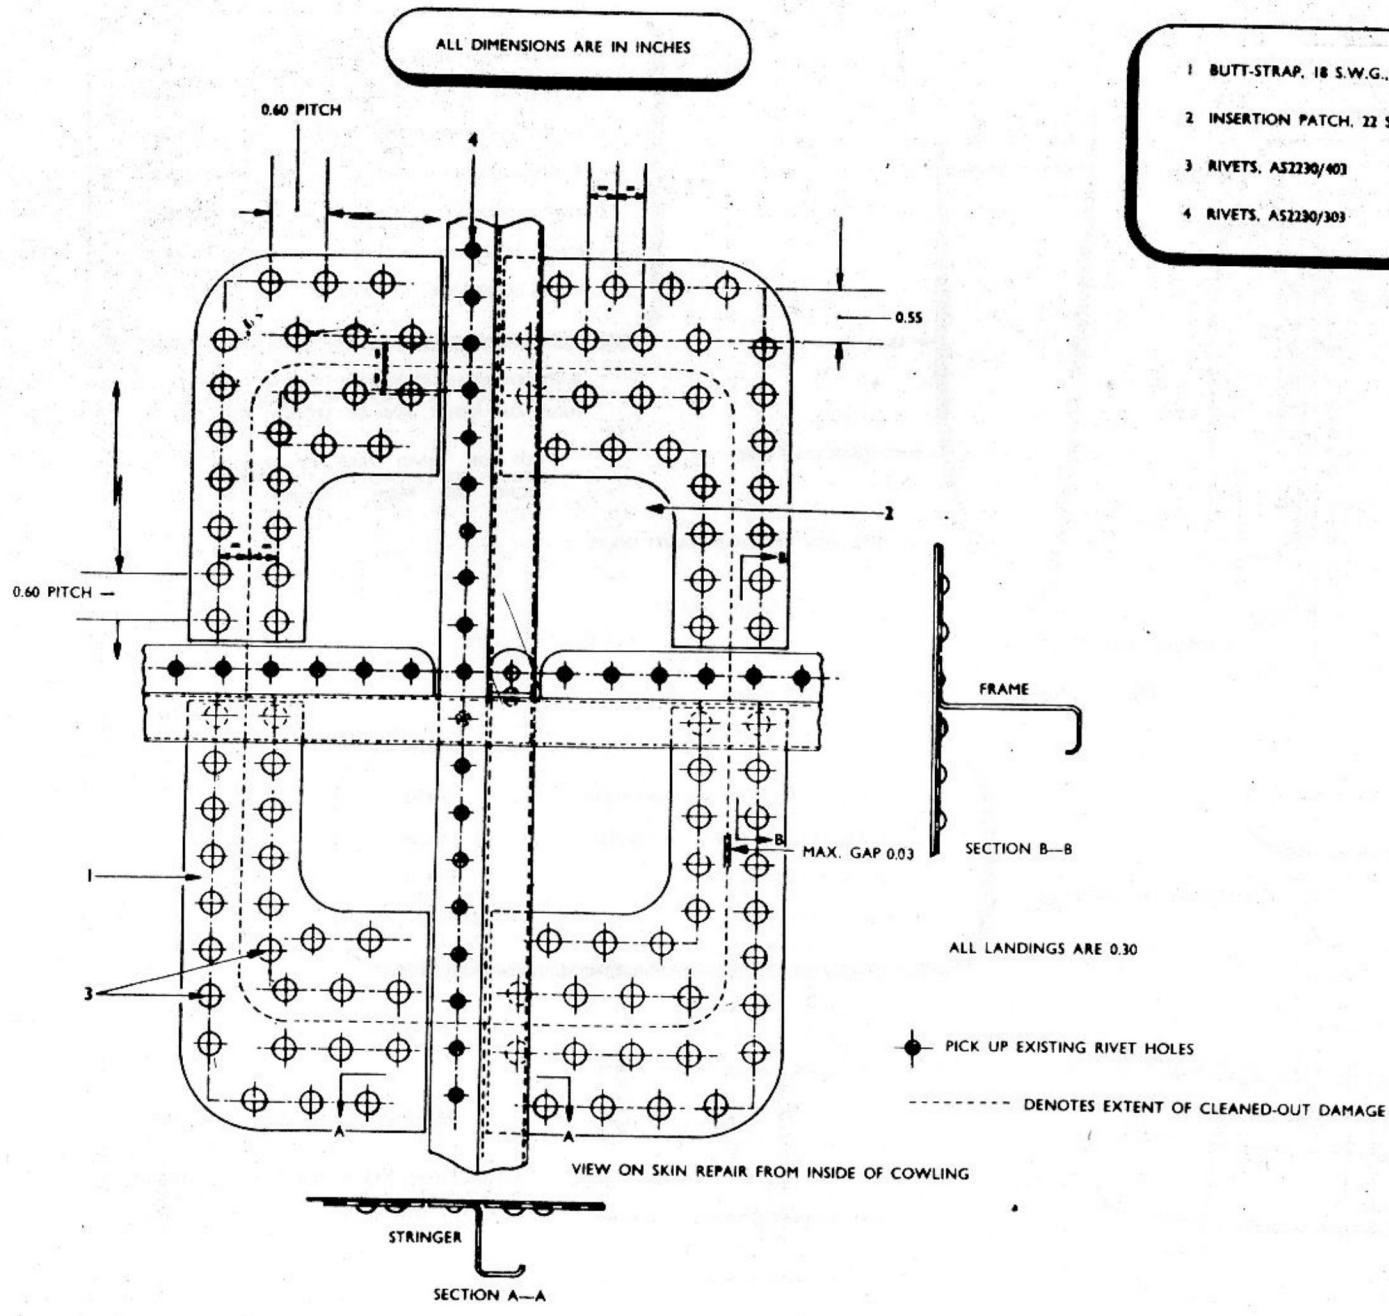
A.P.4326, Vol. 6, Part 1, Chap. 6 (AL.27) 1 BUTT-STRAP, 18 S.W.G., D.T.D.610 4 OFF 2 INSERTION PATCH, 22 S.W.G., D.T.D.610 1 OFF 3 RIVETS, A52230/403 AS REQUIRED 4 RIVETS, A52230/303 AS REQUIRED

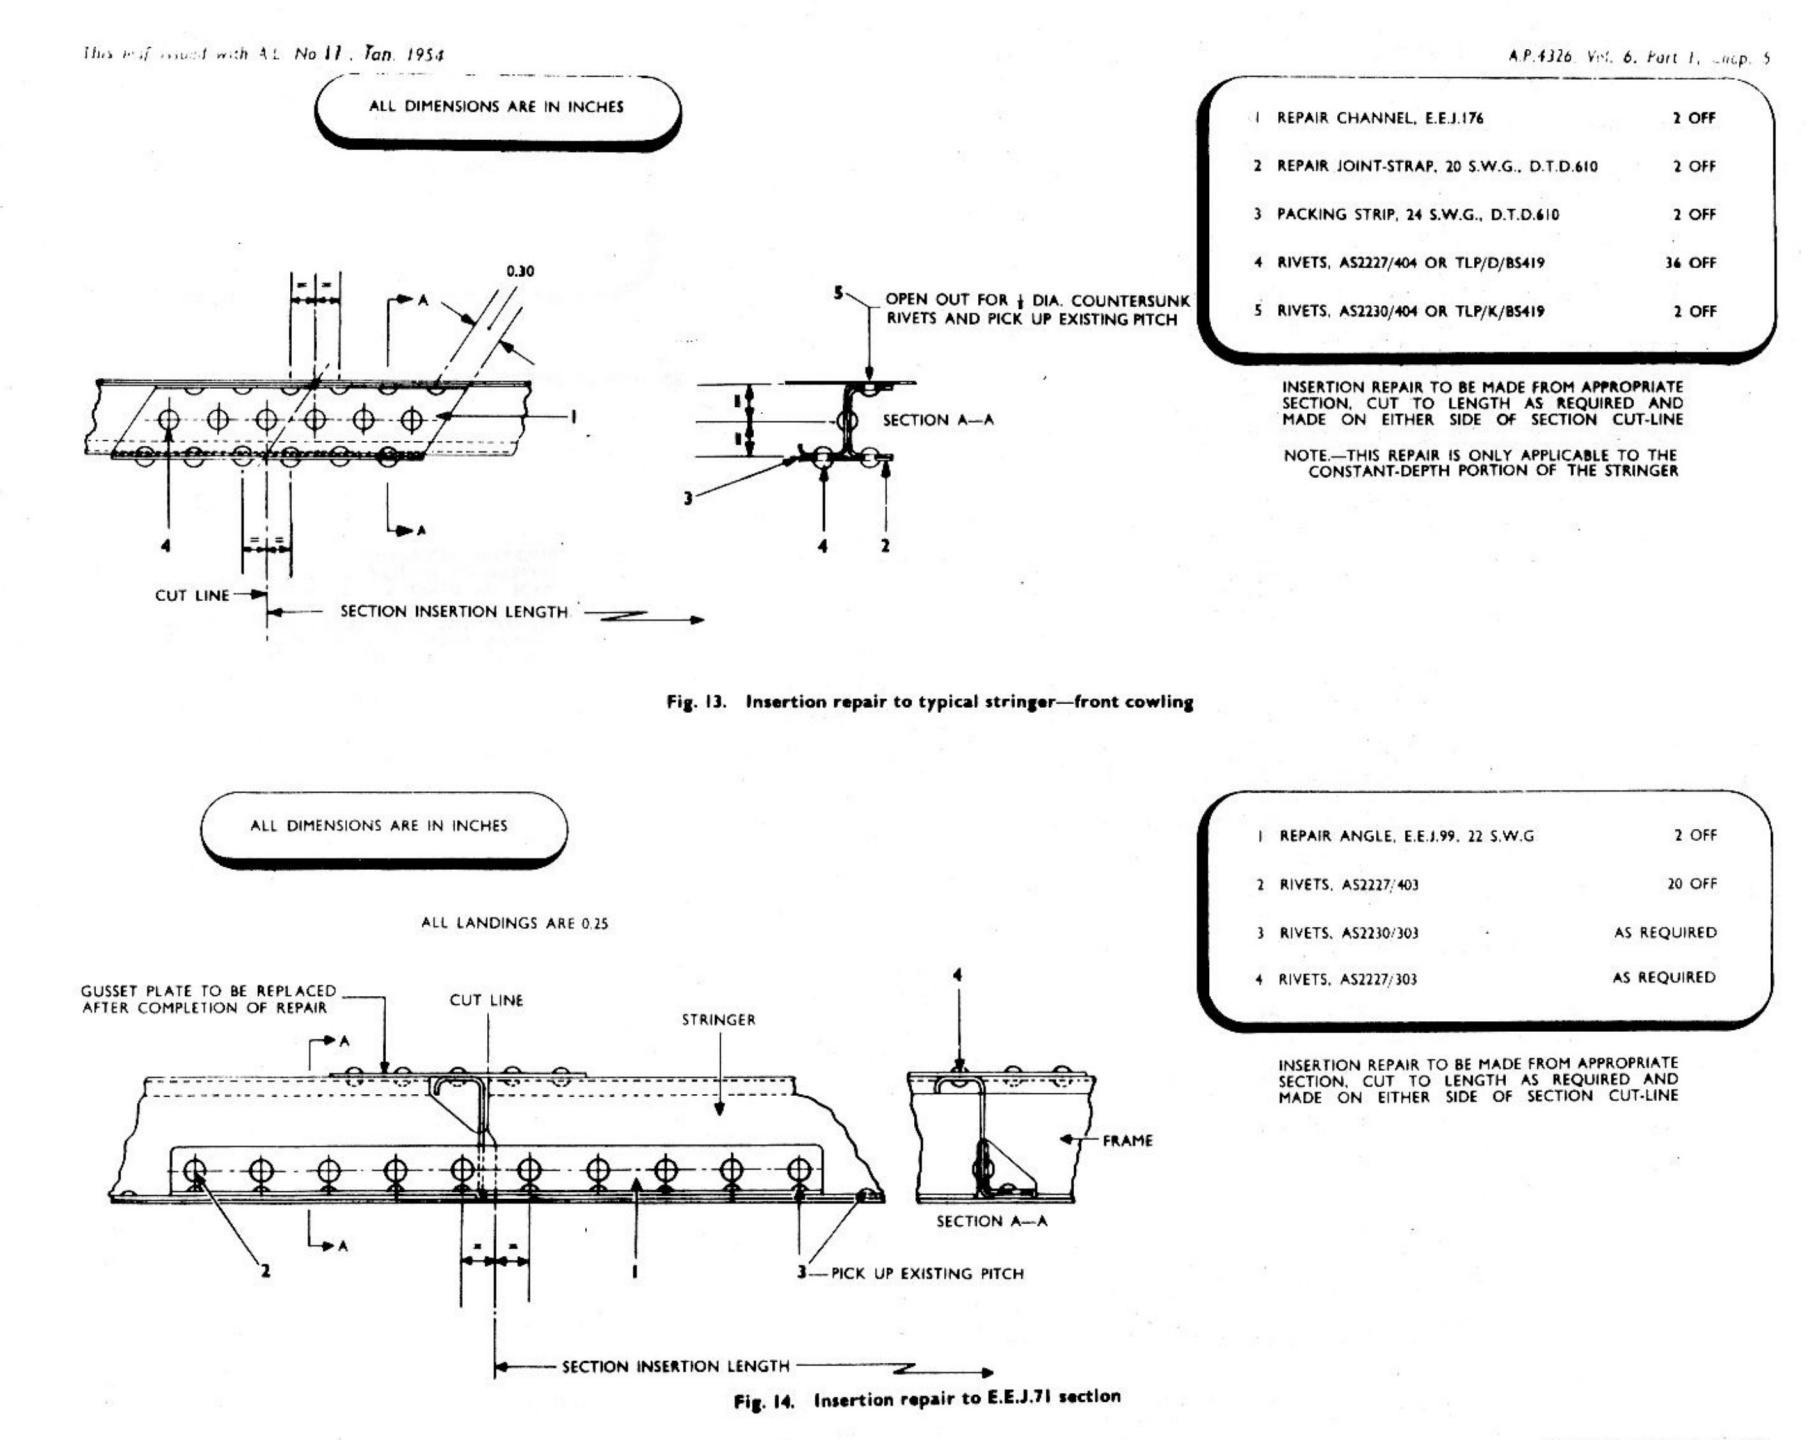
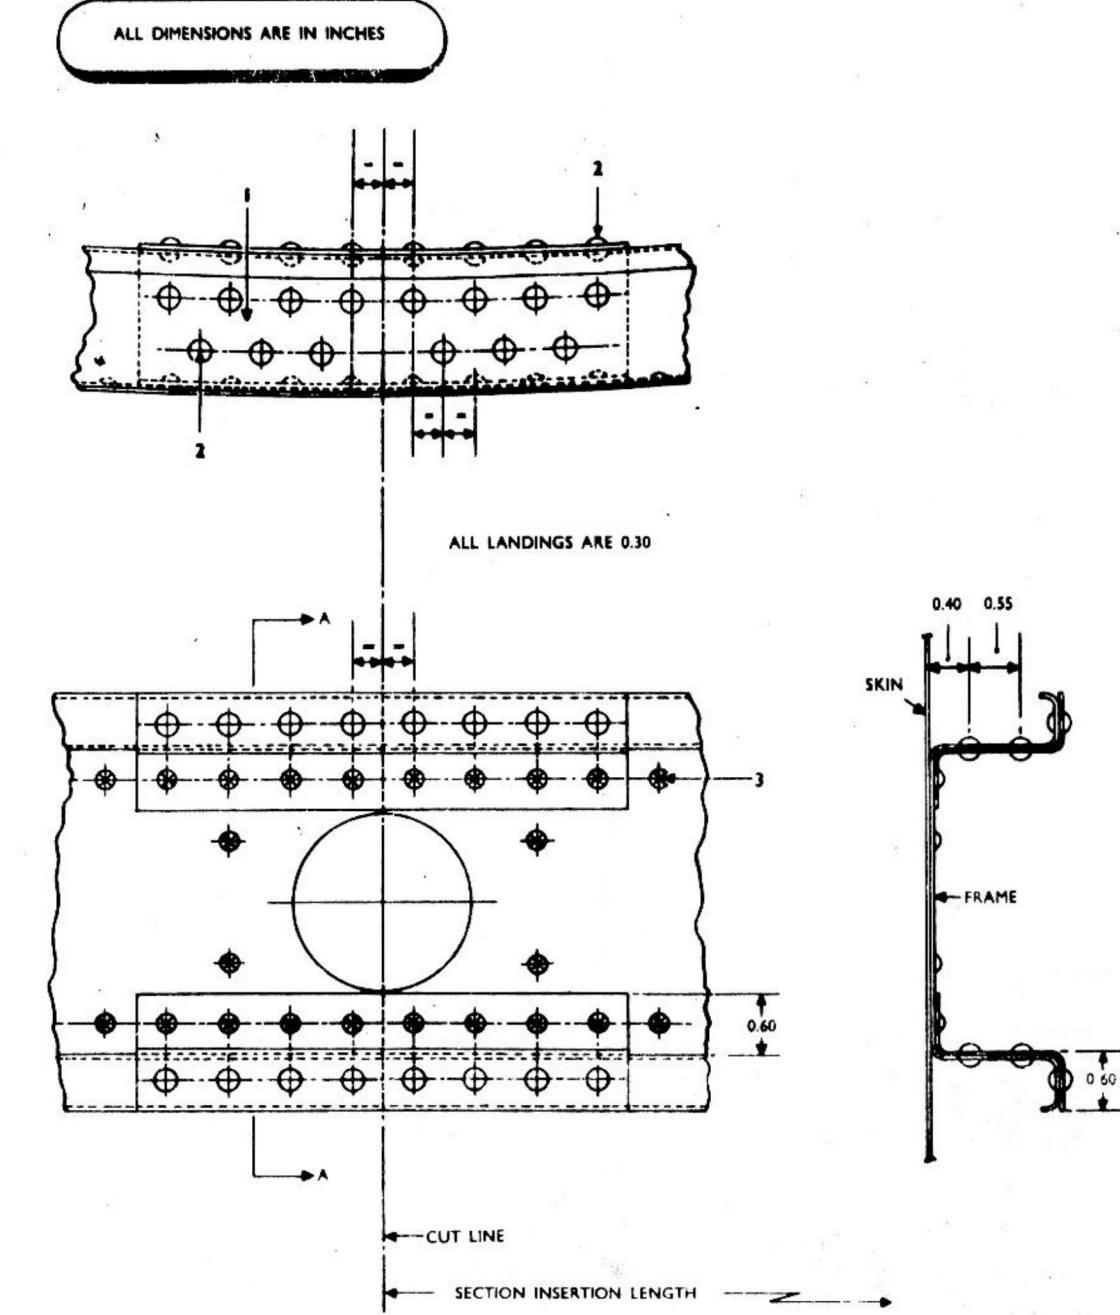
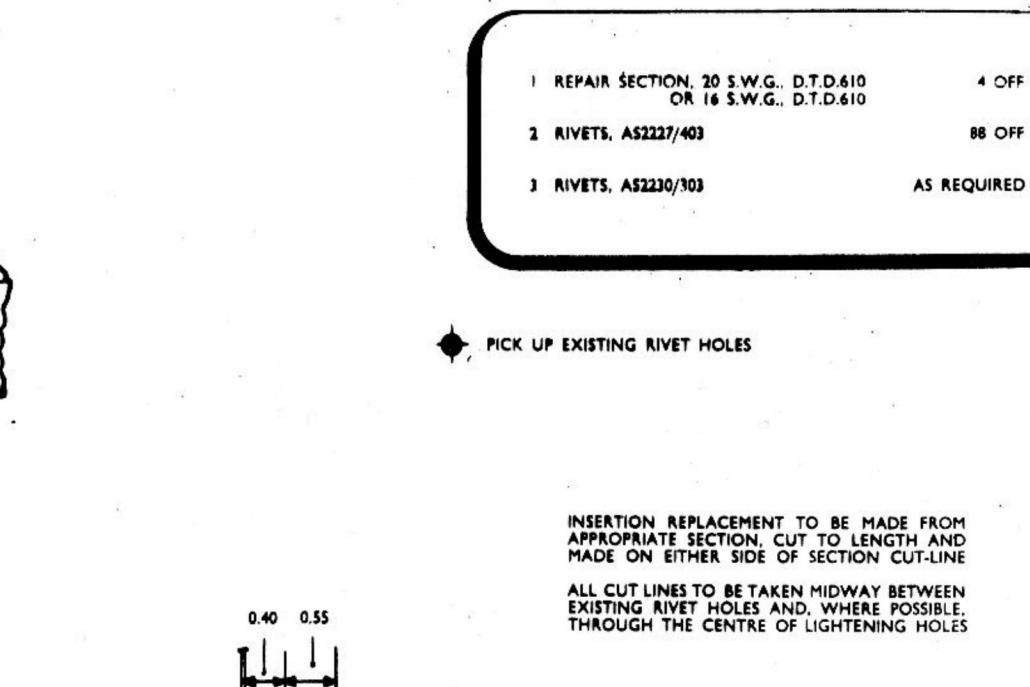
to. Insertion repair to trames 1, 2 and 3-jet pipe cowling FIg.

THIS REPAIR IS NOT APPLICABLE TO FRAME 2, UPPER COWLING

I REPAIR ANGLE, 20 S.W.G., D.T.D.610	2 OFF
2 BUTT STRAP, 18 S.W.G., D.T.D.610	2 OFF
3 DOUBLING PLATE, 22 S.W.G., D.T.D.610	2 OFF
4 PACKING PIECE, 20 S.W.G., D.T.D.610	2 OFF
5 RIVETS, AS2230/404	32 OFF
6 RIVETS, AS2227/404	32 OFF

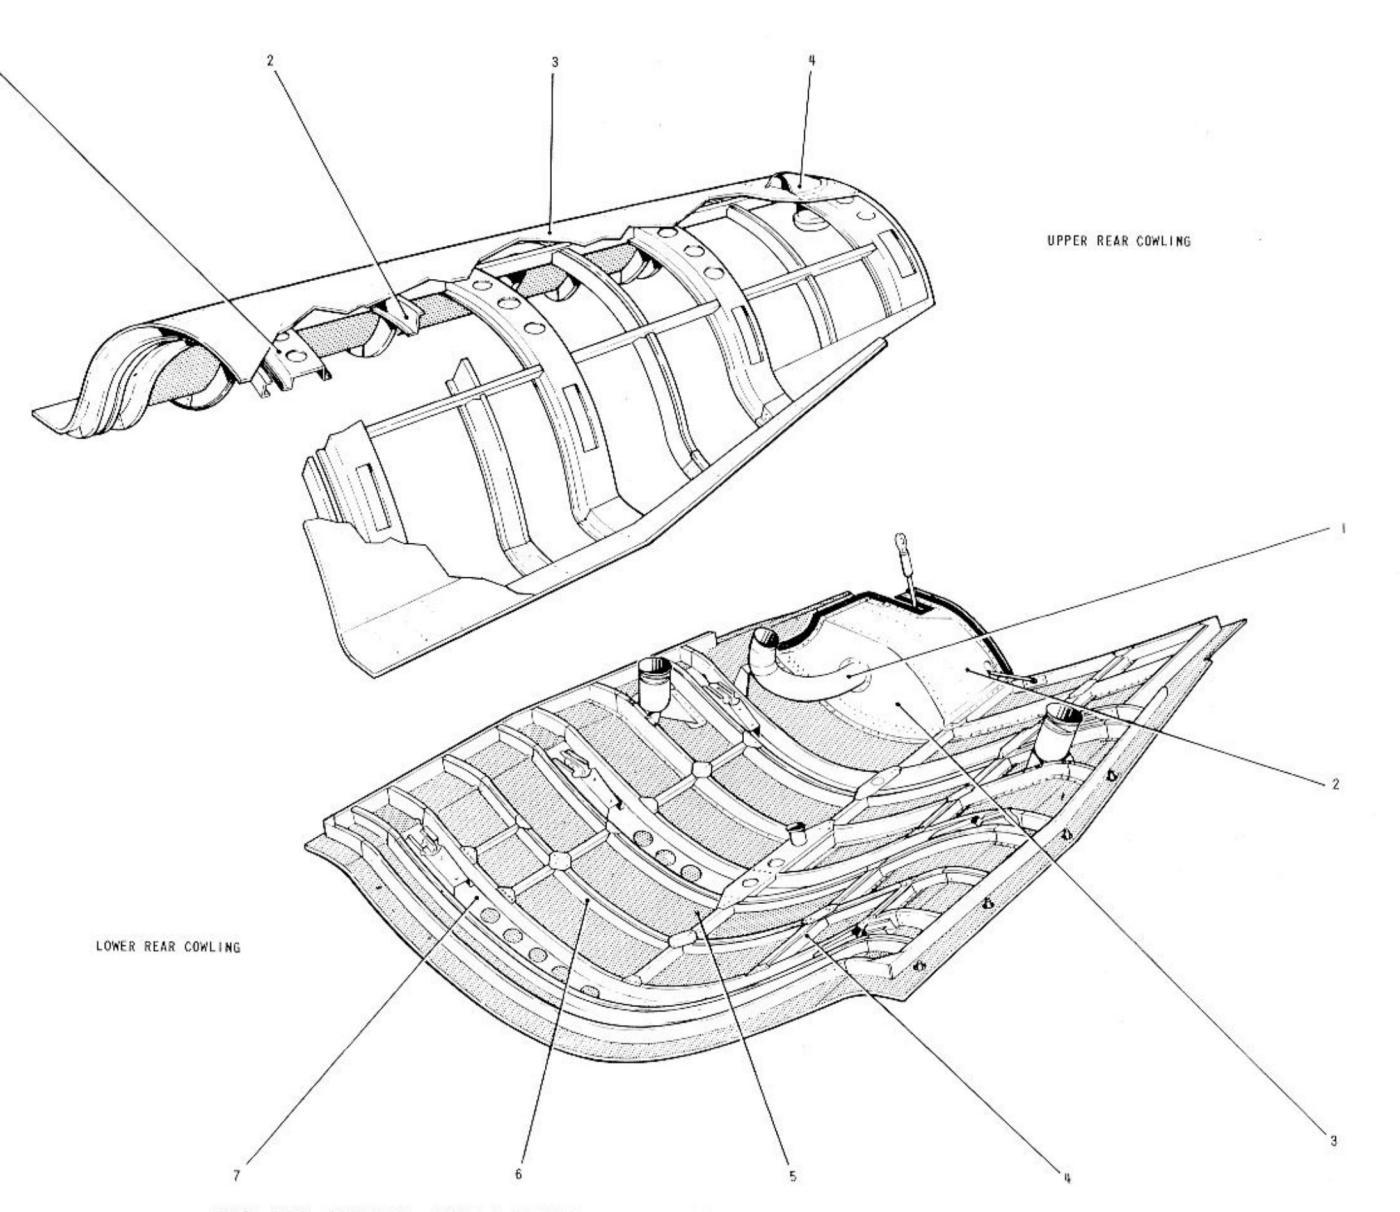
FIG. 603. UPPER AND LOWER REAR COWLING STUCTURE

Negligi	ble Damage		
	Mate	erial			Dent	s	Scra	tches	Но1	es
ltem	spec.	S.W.G.	Part No.	Description	Max. Depth	Min. Dia.	Depth	Spacing	Max. Dia.	Pitch Ratio
UPPER	REAR COWLI	NG		· · · ·						
1	L.72	22	E.A6.50.475 (port) E.A6.50.476 (starb.) (FEJ.70)	Frame 1	0, 10	1.0	0.010	1.0	0 200	
2	L.72	22	E.A6.50.473 (port) E.A6.50.474 (starb.)				0.010	1.0	0.200	15.1
3	L. 72	22	(EEJ.71) E.A6.50.471 (port)	Frame 1A	0.10	1.0	0.005	1.0	0.125	16:1
			E.A6.50.472 (starb.)	cowl skin	0.03	0.5	0.003	2.0	-	-
4	L.59	-	E. B6. 50. 95	Spar cooling intake assembly	-	-	-	-	-	-
LOWER	REAR COWLI	IG								
1	L.59	20	E.B6.50.55 (port) E.B6.50.56 (starb.)	Pipe	0,04	0.7	0.005	1.5		
2	L.72	20	E.B6.50.33 (port)				0.005	1.5		
3	L.72	20	E.B6.50.34 (starb.) E.B6.50.35 (port)	rop plate	0.05	1.0	0.005	2.0	-	-
4	L. 72	22	E.B6.50.36 (starb.) E.A6.50.491 (port) E.A6.50.492 (starb.)	End plate	0.05	1.0	0.005	2.0		-
			(EEJ. 191)	stringer	0.10	1.0	.0.005	1.0	0.200	15:1

KEY TO FIG. 603 (UPPER AND LOWER REAR COWLING STRUCTURE)

Note: - All dimensions are in inches. Skin dents must not exceed 4 inches in dia. and must be separated by not less than 5 times the least dimension of damage.

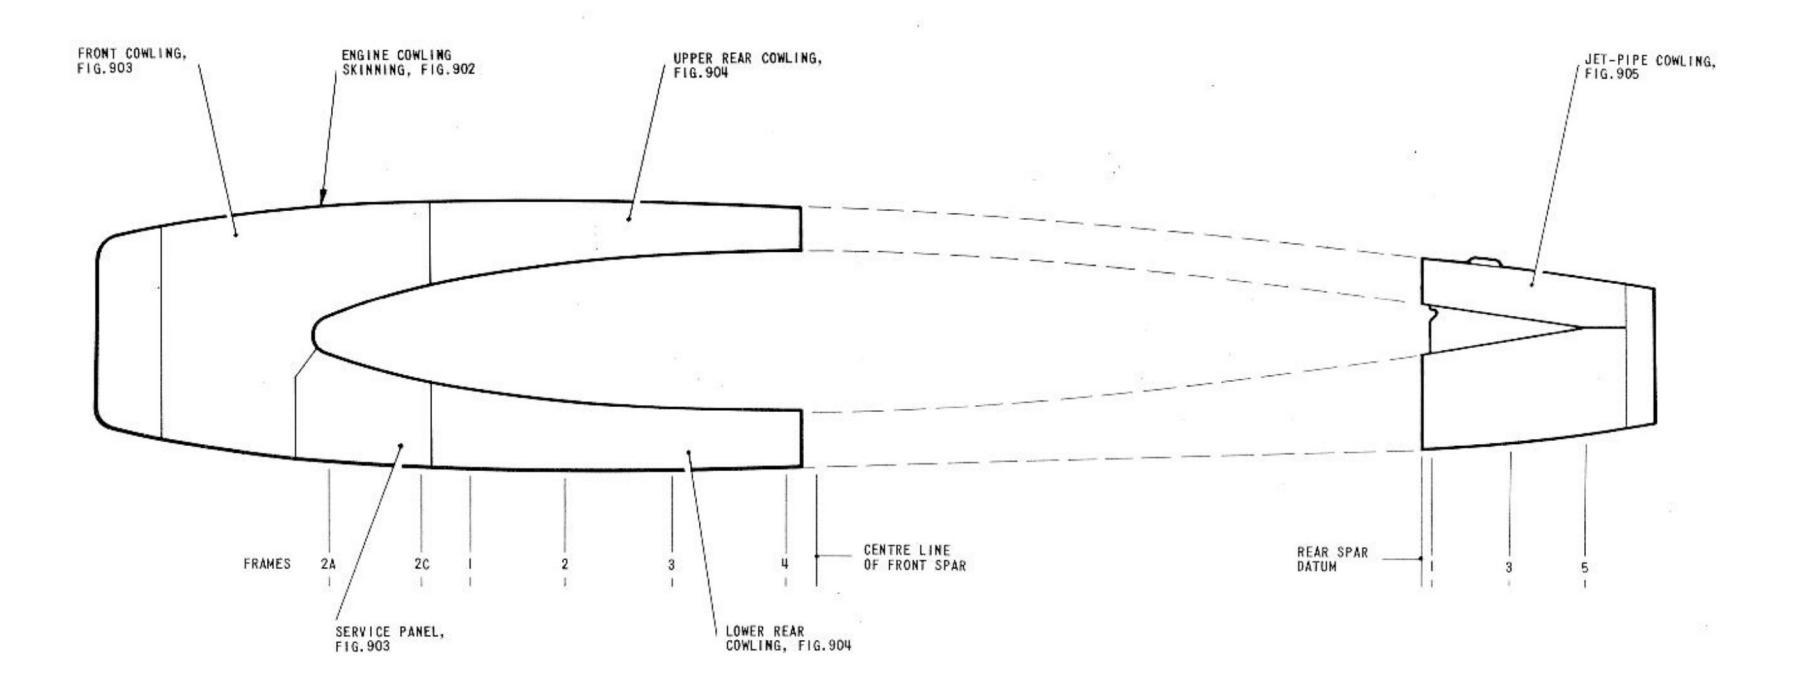
FIG.901 KEY DIAGRAM

1. A method of pictorial indexing is employed in this chapter to simplify the identification of structural items, and in the key, give details of these items together with negligible damage definitions, repair figure numbers and repair recommendations.

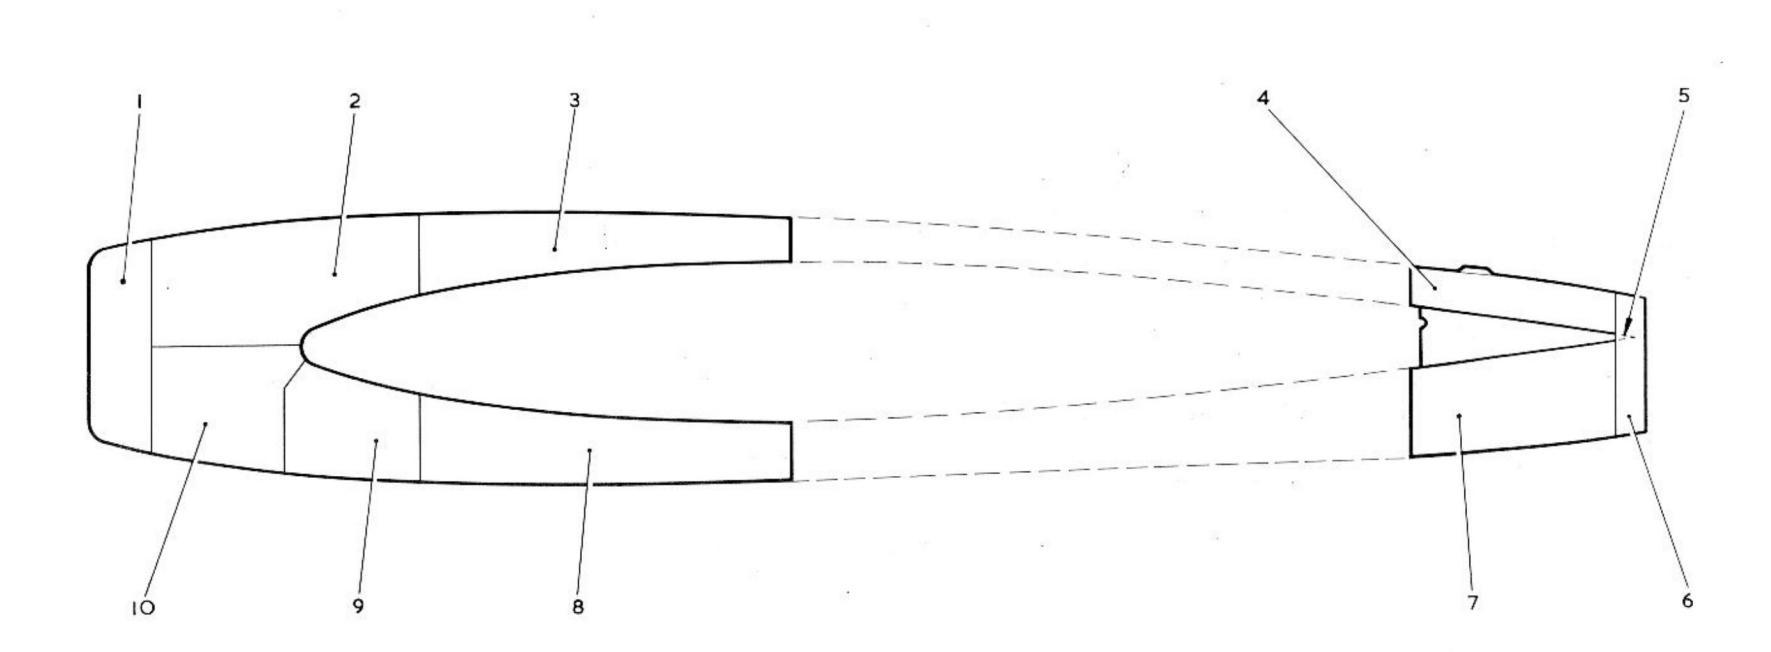
FIG . 902 ENGINE COWLING SKINNING

N	egligibl	e damage				
			Mater	ial	De	nts	Ser	atches	Ho	les		
Item	Description	Part No.	Spec.	S.₩.G.	Max. Depth	Min. Dia.	Depth	Spacing	Max. Dia.	Pitch Ratio	Repairable Damage	Repair Fig.No.
1	Spinning outer, air intake	EB8.50.179	L.59	18	0.05	1.00	0.005	3,00		-	Dents, cracks and holes in excess of negligible	Chapter 6, 7
2	Skin, upper, front cowl	EB8,50,1113	L.72	20	0.04	0.75	0.004	2.00		-]		
3	Skin, upper, rear cowl	EB8.50.1617	L.72	20	0.05	0.80	0.006	2.00				
4	Skin, top	EB8.50.1407	L.72	22	0.03	0.50	0.003	2.00	-	-		
5	Skin, wing stub	EB8.50.1243D	D.T.D.171	24	0.02	0.60	0.002	2.00	-	-	Holes, dents and	
6	Skin, outer cone	EB8,50,1243A	D.T.D.171	24	0.05	0.70	0.004	2.00			_cracks lose rivets	- Chapter 6, 0
7	Skin, bottom	EB8,50,1409	L.72	22	0.03	0.50	0.003	2.00		-	skin painting	
8	Skin, lower, rear cowl	EB8,50,1201	L.72	20	0.05	0.80	0.006	2.00	-	-		
9	Skin, service panel	EB8,50,953	L.72	20	0.05	0.80	0.006	2.00	14

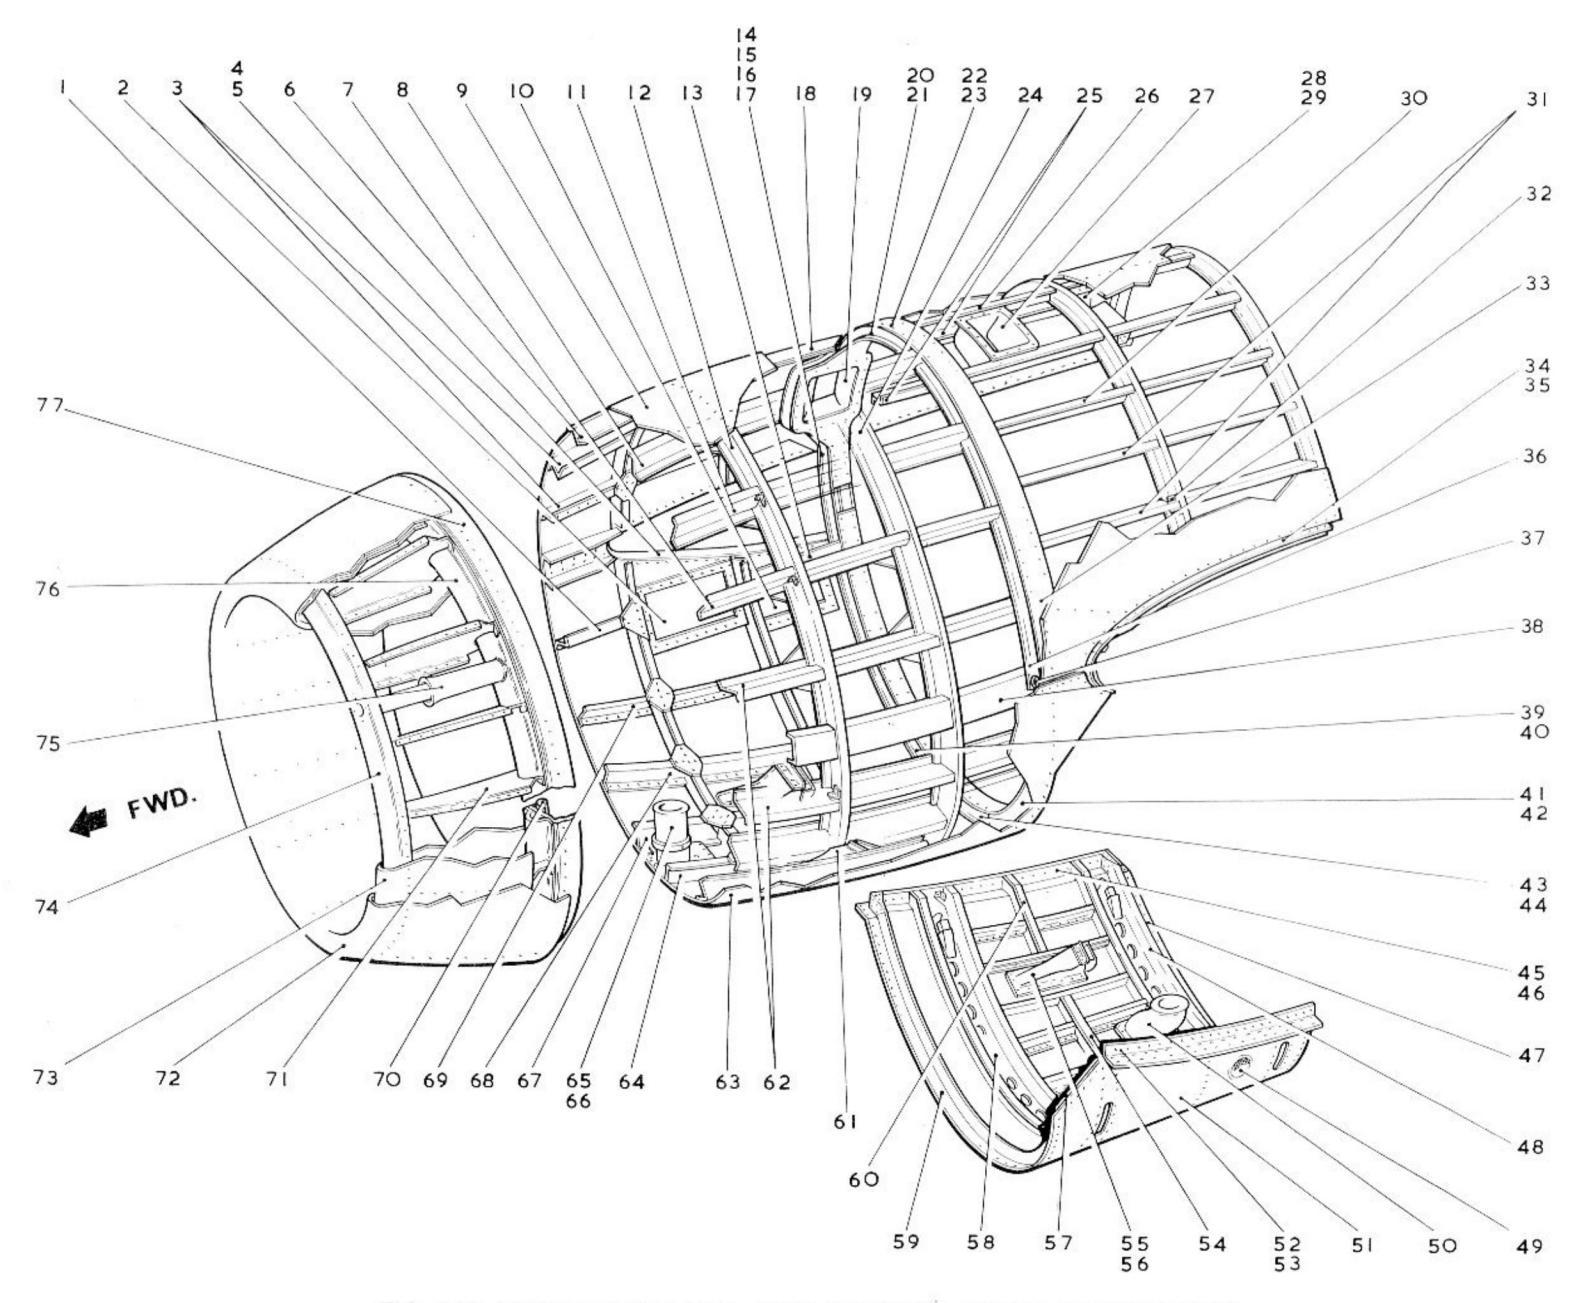
FIG. 903. FRONT COWLING AND SERVICE-PANEL STRUCTURE

KEY TO FIG.903 (FRONT COWLING AND SERVICE - PANEL STRUCTURE)

Neglig	ible Dama	ge			
			Mater	i a l	Der	its	Ser	at.ches	Ho	les		
Item	Description	Part No.	Spec.	S.W.G.	Max. Depth	Min. Dia.	Depth	Spacing	Max. Dia.	Pitch Ratio	Repairable Damage	Repair Fig.No.
1	Stringer R	EB8.50.887	E.E.J.336	18	0.06	0.75	0.006	0.125	0.130	15:1	Dents, holes and cracks in excess	Chapter 6, 19 use E.E.J.336
2	Land door access	EB8,50.1521	L.72	18	0.02	0.80	-	-	0.100	20:1	of negligible	18 s.w.g.
3	Stringer, A and B	EB8.50.829	E.E.J.336	18	0.06	0.75	0.006	0.125	0.130	15:1	Refer to item 1	Refer to item 1
4	Skin inboard edge	EB8.50.301	L.72	20	0.04	0.75	0.005	2.00	2	-	Dents, holes and cracks in excess of negligible	Chapter 6, 6
5	Member edge, inboard	EB8.50.253	E.E.J.297	16	0.05	1.00	0.010	1.00	0.125	24:1	Refer to item 1	Chapter 6, 9 use EEJ297, 16 s.w.g.
6	Stringer C	EB8,50,831	E.E.J.336	18	0.06	0.75	0.006	0.125	0.130	15:1	Refer to item 1	Refer to item 1
7	Stringer, F and K	EB8.50.907	E.E.J.336	18	0.06	0.75	0.006	0,125			Refer to item 1	Refer to item 1

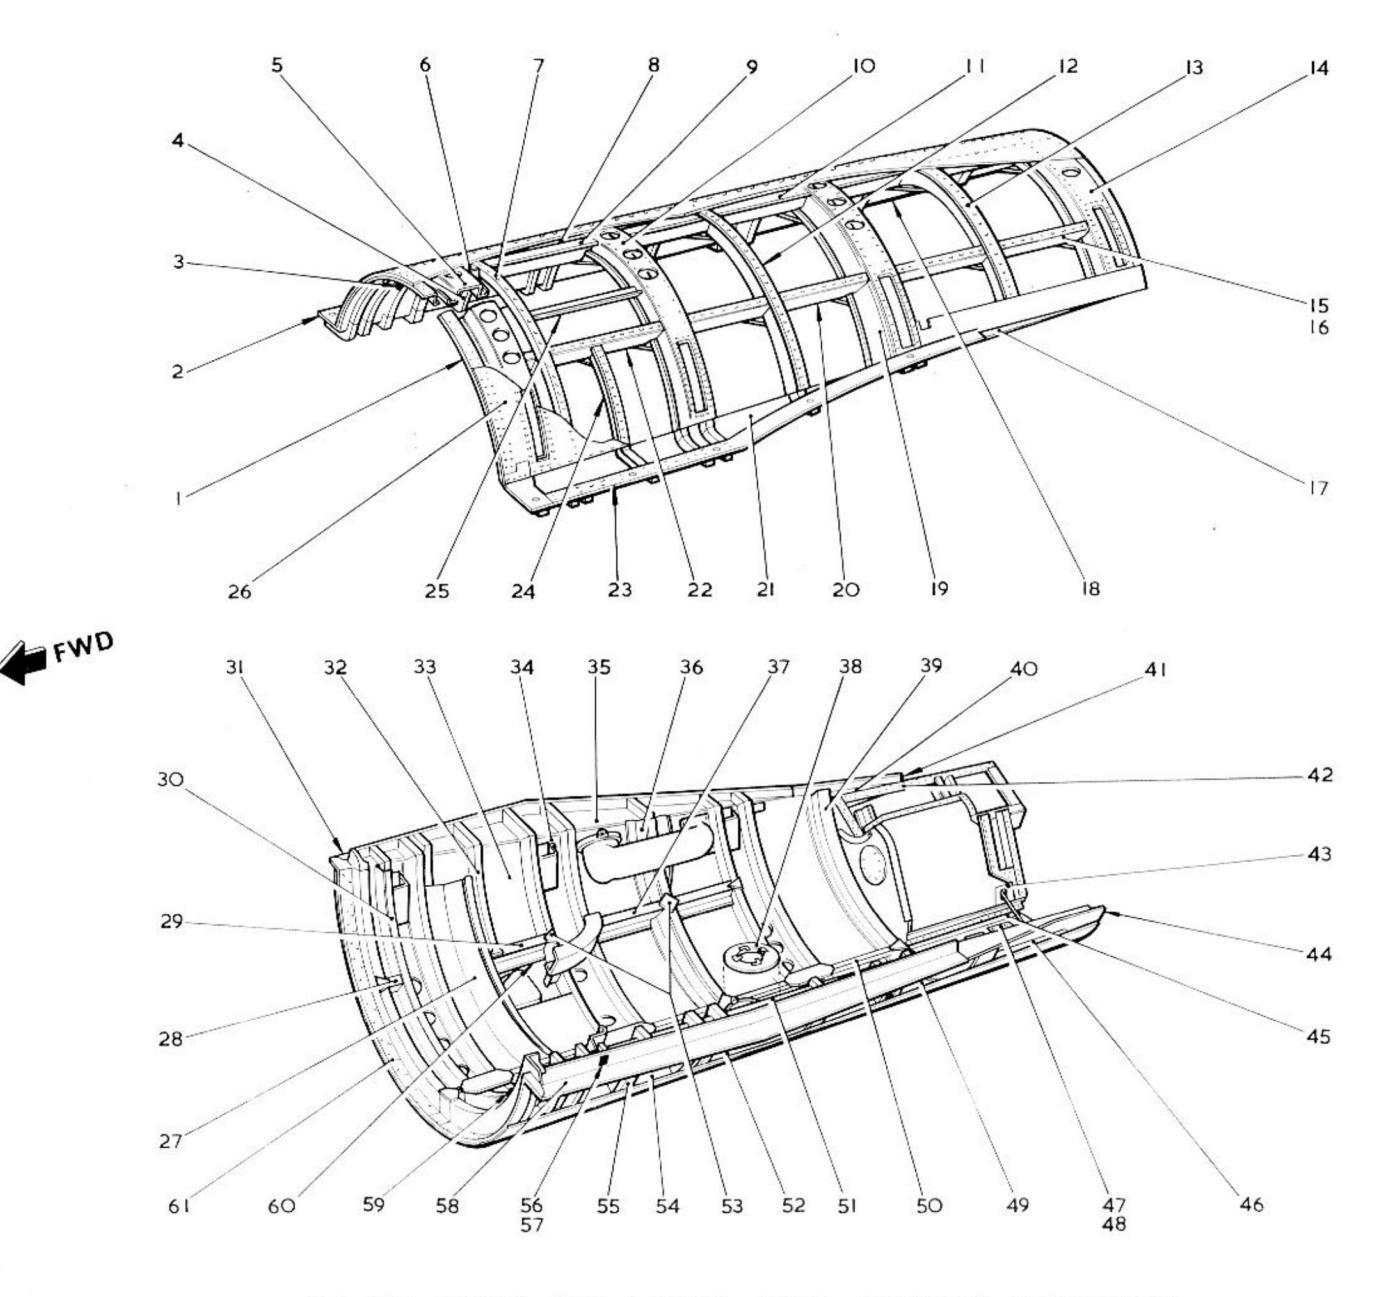
FIG. 904. UPPER AND LOWER REAR COWLING STRUCTURE

KEY TO FIG.904 (UPPER AND LOWER REAR COWLING STRUCTURE)

Negligi	ble Damag	e			
			Mater	ial	Der	nts	Scr	atches	Ho	les		
Item	Description	Part No.	Spec.	S.W.G.	Max. Depth	Min. Dia.	Depth	Spacing	Max. Dia.	Pitch Ratio	Repairable Damage	Repair Fig.No.
1	Stiffener, edge, forward	EB8.50.1019	E.E.J.353	16	0.04	1.00	0.010	1.00	0.125	32:1	Dents, holes and -cracks in excess	newal
2	Stiffener, edge, outboard port	EB8.50.41	E.E.J.297	16	0.04	1.00	0.010	1.00	0.125	32:1	of negligible \int^{re}	commended
3	Stringer, 1 to 2	EB8.50.63	E.E.J.71	22	0.10	1.00	0.005	1.00	0.125	16:1	Dents, holes and Ch cracks	apter 6, 14
4	Frame 1A	EB8.50.1043	L.72	16	0.10	1.00	0.010	1.00	0.20	15:1	Dents, holes and Re	newa]
5	Frame 1, port	EB8.50.1045	L.72	16	0.10	1.00	0.010	1.00	0.20	15:1	cracks in excess re of negligible Ch us	commended apter 6, 15, e E.E.J.70
6	Stringer, stub	EB8.50.69	E.E.J.71	22	0.10	1.00	0.005	1.00	0.125	16:1	Refer to item 3 Re	fer to item 3
7	Sealing, frame	EB8.50.1033	D.T.D.171	22	0.10	0.75	0,005	1.00	0.125	15:1	Dents, holes cracks in excess

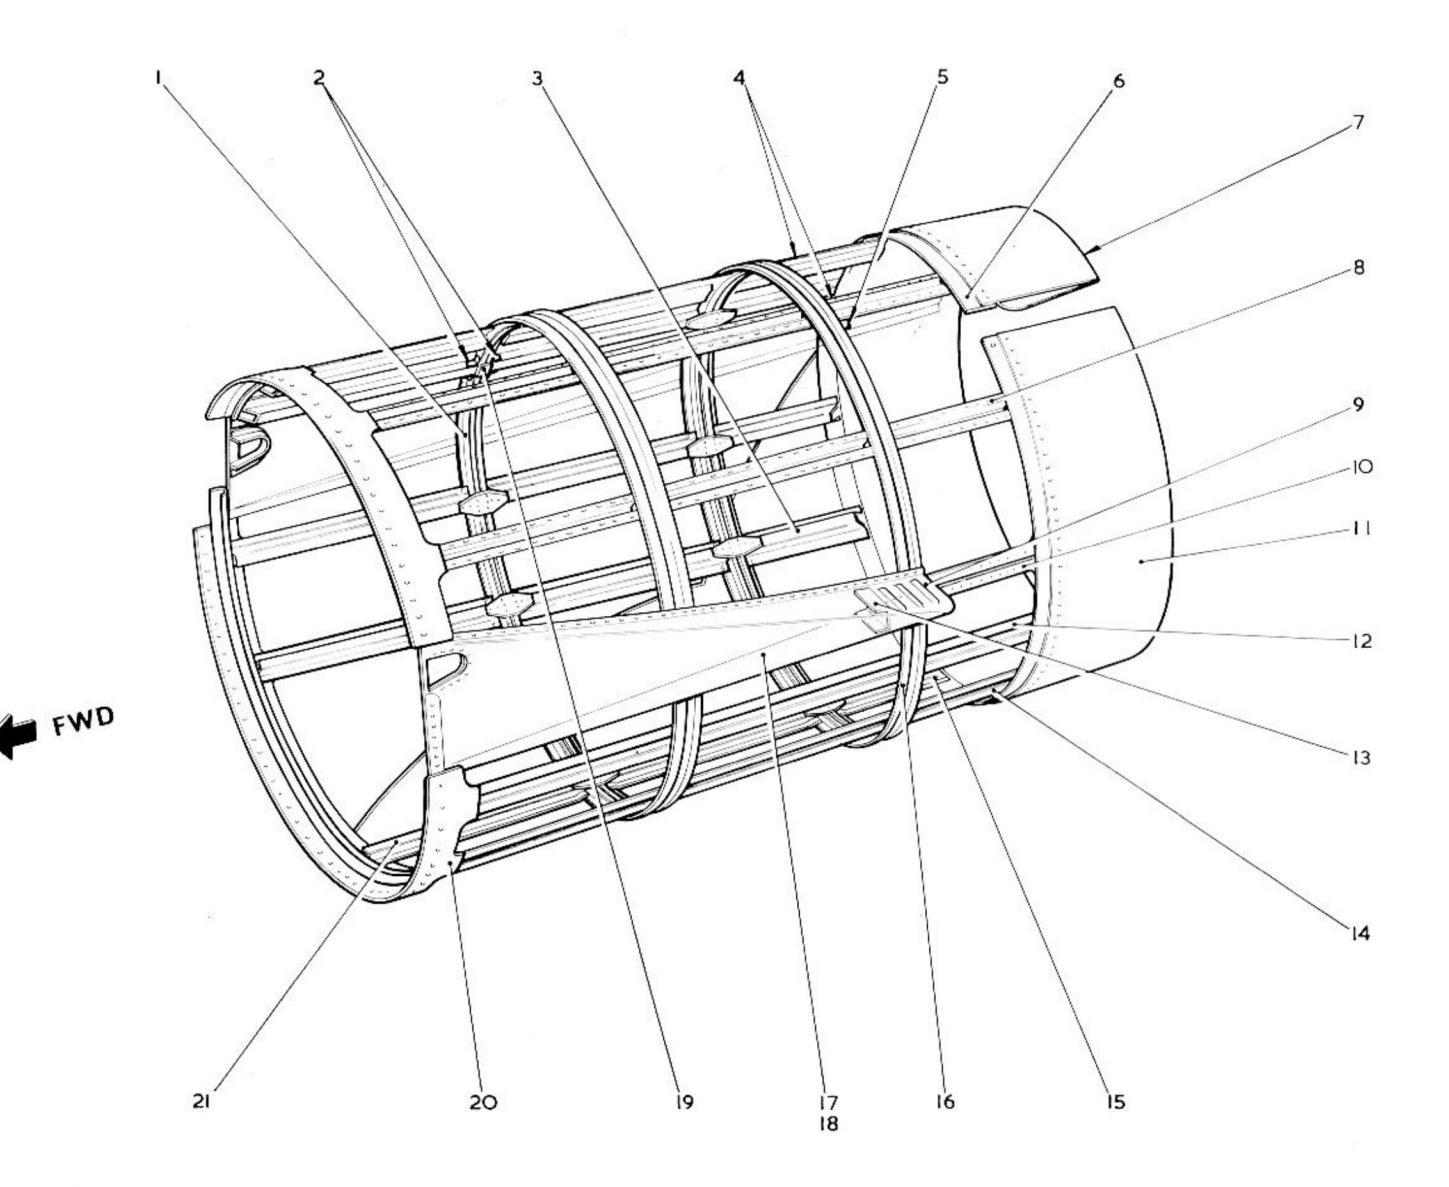
FIG. 905. JET PIPE COWLING STRUCTURE

KEY TO FIG.905 (JET PIPE COWLING STRUCTURE)

1	Vegligi	ble Damag	ge			
			Materi	ial	Den	ts -	Scr	atches	Hol	les		
Item	Description	Part No.	Spec.	S.W.G.	Max. Depth	Min. Dia.	Depth	Spacing	Max. Dia.	Pitch Ratio	Repairable Damage	Repair Fig.No.
1	Frame 2	EB8.50.1340	E.E.J.373	18	0.05	0.75	0.010	1.00	0,20	15:1		Chapter 6, 16
2	Cleat	EB8,50,1355	L.72	18	-	-	0.015	-	-	-	Renewal recommended	
3	Stringer, rear, lower	EB8.50.686	E.E.J.373	18	0.10	1.00	0.010	1.00	0.125	16:1	-	Renewal
4	Stringer, rear, upper	EB8,50,1253	E.E.J.373	18	0.10	1.00	0.010	1.00	0.125	16:1	- None	recommended
5	Riblet	EB8.50.1244E	D.T.D.171	24	0.025	0.50	0.005	1.00		-]		1
6	Cone, inner, forward	EB8.50.1243B	D.T.D.171	24	0.05	0.70	0.005	1.00	-	-		
7	Cone, outer	EB8.50.1243A	D.T.D.171	24	0.05	0.70	0.005	1.00	-	<u></u>	- Non e	Renewa) recommended
8	Stringer, rear, upper	EB8.50.1252	E.E.J.373	18	0.10	1.00	0.010	1.00	0.125	16:1		Teconinended
g	Skin, wing stub	EB8.50.1244D	D.T.D.171	24	0.04	0.75	0.006	1.00	0.25	10:1
