A.P.4326, Vol. 6, Part

ENGINE NACELLE

Chapter 6 ENGINE NACELLE - AVON MK.I

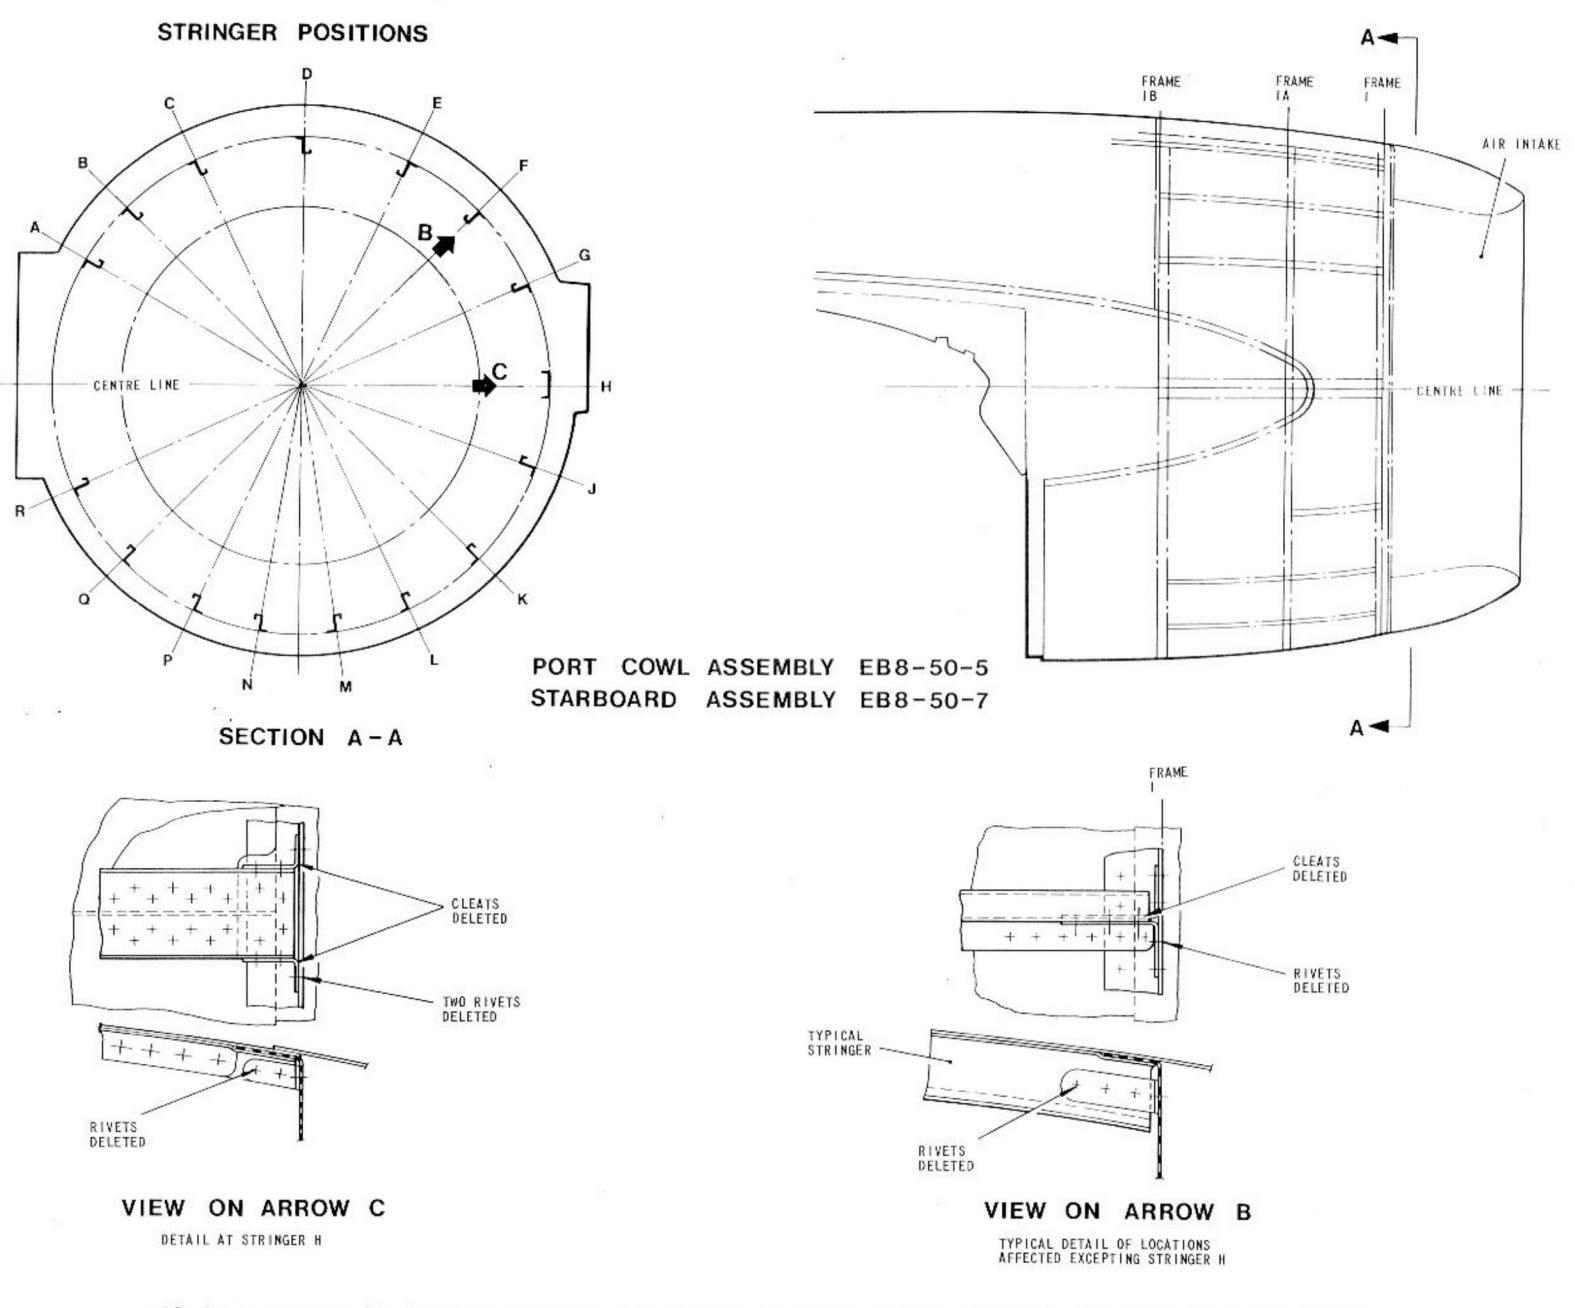
FIG. 906 DELETION OF AIR INTAKE SECURING CLEATS FROM FRAME 1 OF THE ENGINE COWL

3. Whenever an engine cowl assembly air intake assembly is replaced, the cleats securing frame 1 to the stringers at the positions indicated in the illustration must be removed by carefully drilling out the securing rivets and filling the redundant rivet holes with

The air intake assembly, Part No. EB8.50.467/8, must be renumbered as EB8.50.155, after completion of fitting to the engine front cowl assembly.
