GROUP D8

ALIGHTING GEAR INDICATOR (CODE U)

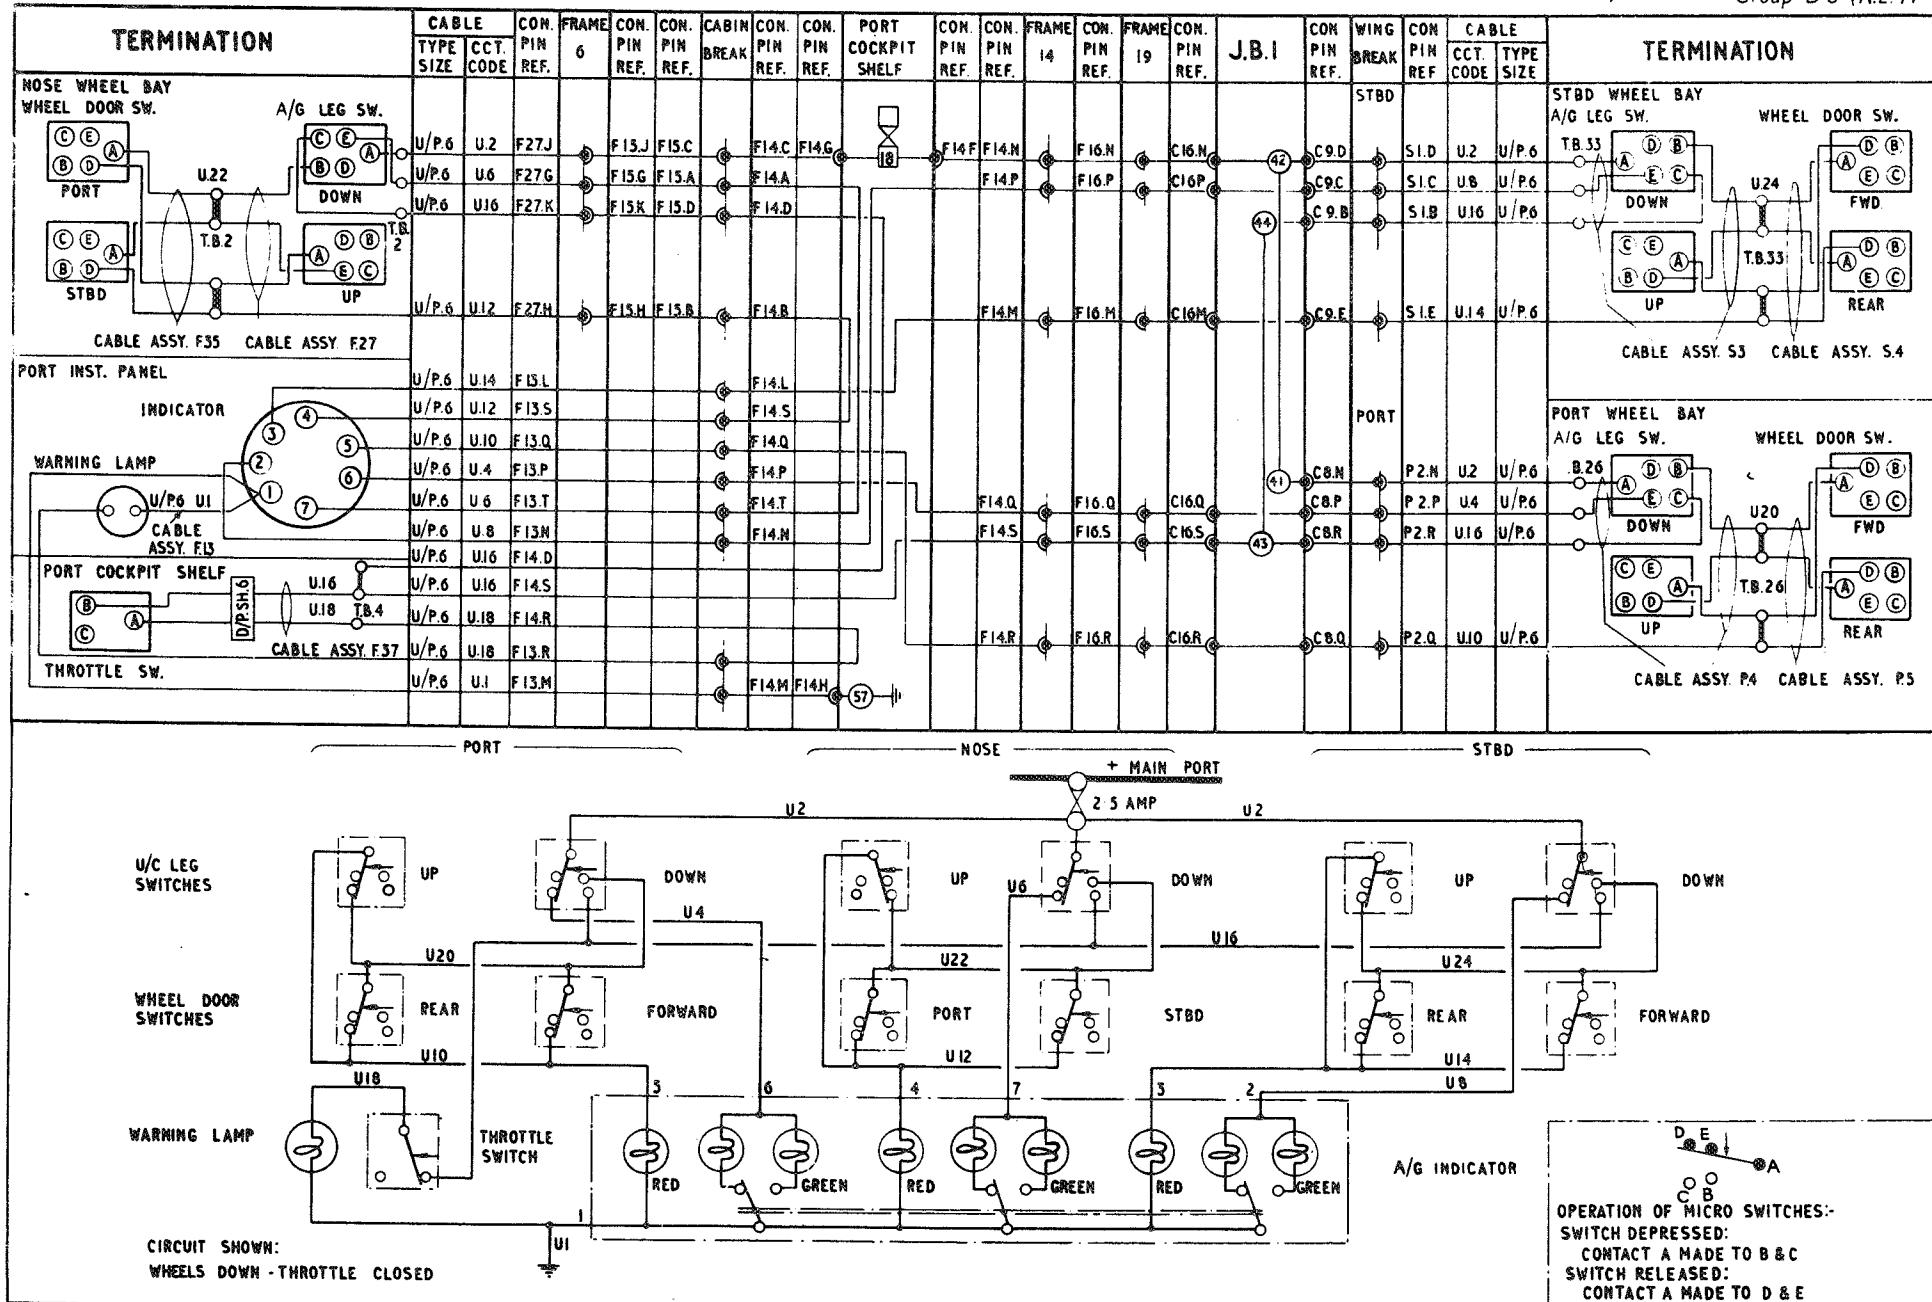
FIG. 1. ALIGHTING GEAR INDICATOR

3. The theoretical conception of the circuit (fig. 1) shows conditions when the aircraft is standing on its alighting gear with the throttle closed. The green indicator lamps are all illuminated as both the main undercarriage legs and the nose wheel leg down micro switches are making contacts A-E to supply these lamps. The throttle micro switch is making contacts A-B, but the alighting gear warning lamp is not illuminated as the supply is broken at contacts C of the down micro switches. The leg up and wheel door micro switches are all making

contacts A-D preparatory to illuminating the red indicator lamps when the circuit is completed by the down micro switches when in the "between locks" position.

4. When the alighting gear is between locks, the down micro switches are making contacts A-B-C to supply the up and wheel door micro switches, via contacts B, thus illuminating the red indicator lamps. Under this condition a supply is also made to the throttle micro switch, via contacts C of the down micro switches, thus the alighting gear warning lamp will illuminate if the throttle is closed (para. 5).

switches are in the same position as when between locks, but the leg up and wheel door micro switches are making contacts A-B-C, thus breaking the supply to the red indicator lamps. As the down micro switches are in the same position as when between locks, the supply to the throttle micro switch is maintained to illuminate the alighting gear warning lamp should the throttle be closed while the alighting gear is still retracted.
